**AGENDA**  
**CITY OF CREVE COEUR**  
**FACILITIES TASK FORCE**  
**CITY OF CREVE COEUR, MISSOURI**  
**MARCH 6, 2023**  
**10:00 AM**

**Dielmann Recreation Center  
11400 Olde Cabin Road  
Creve Coeur, MO  
Structural Evaluation**

## Executive Summary

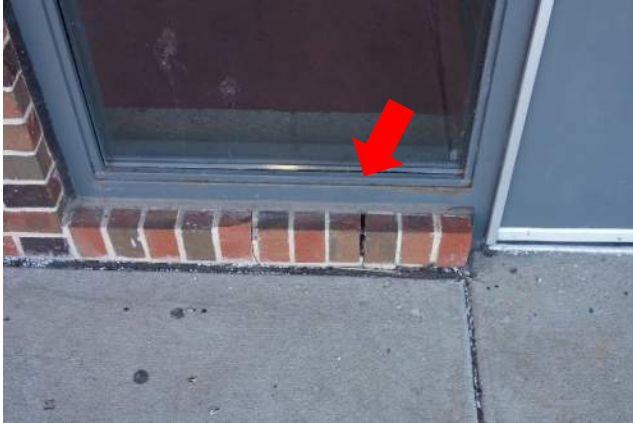
**Figure 4 – Mortar Joint Damage**

- Figure 4 – Mortar Joint Damage: Eroded mortar joint at base of walls.
- Figure 5 – Gutter Damage: Large quantities of rain, snow and ice tend to accumulate in roof valleys like this.

- Tuckpoint eroded joints and or seals around the base of the building exterior (see figure 4). Preferably any damaged joints from grade to 1' above grade. Any expansion/construction joints (see figure 9) should be sealed with a waterproof, exterior grade, caulking. This will help make sure rain and snow cannot penetrate the building envelope and damage the structure.

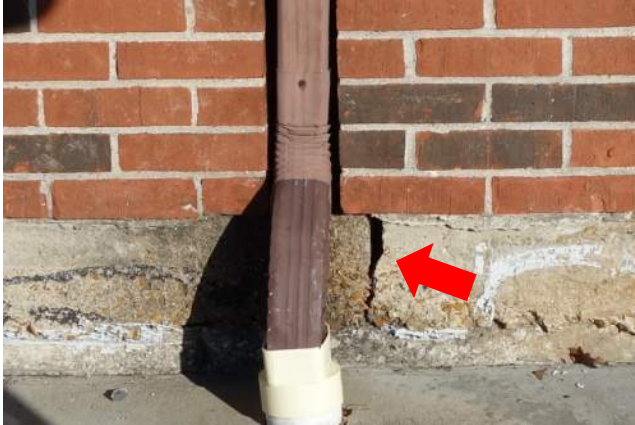
**Figure 9 – Foundation Joint Separation**

- Figure 9 – Foundation Joint Separation. Joint filler material missing or eroded.
- Figure 10 & 11 – Damaged Gutter Sections (Southwest corner of ice rink space). The gutter is damaged and separated from the roof. May be full of debris.

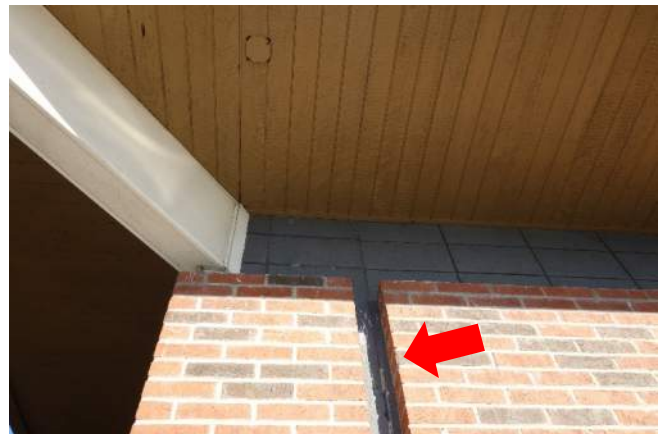
**Figure 12 – Vertical Masonry Joint Crack**

- Figure 12 – Vertical Masonry Joint Crack. Typical temperature and shrinkage cracks but not a structural issue.
- Figure 13 – Damaged Gutter Section (Southwest corner of ice rink space). The gutter is damaged and separated from the roof. May be full of debris.

- Tuckpoint vertical masonry joint cracks larger than 0.3mm. on the exterior. And the masonry joint cracks around the lintel beam on both sides (see figure 12 & 18) Repairing would mitigate any potential source for moisture that could harm the structure long term.

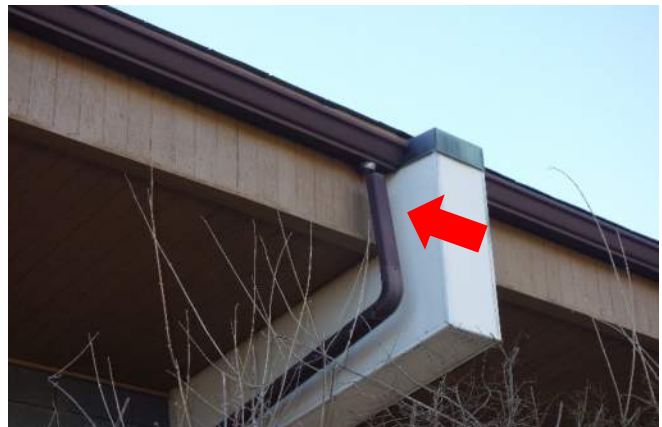
**Figure 14 – Gutter Separation  
(North Side of ice Rink)**

- Figure 14 – Gutter Separation. Downspout has separated from the Gutter Drop (North wall of ice rink space).
- Figure 15 – Gutter Damage. Water staining to the exterior façade is visible indicating that the gutter may not be draining properly. It could be incorrectly sloped or clogged (Northeast corner in mechanical space).

- Repair and replace damaged gutters and downspouts. This will help make sure rainwater is diverted sufficiently away from the structure (See figure 5, 10, 11, 13, 14, 15).

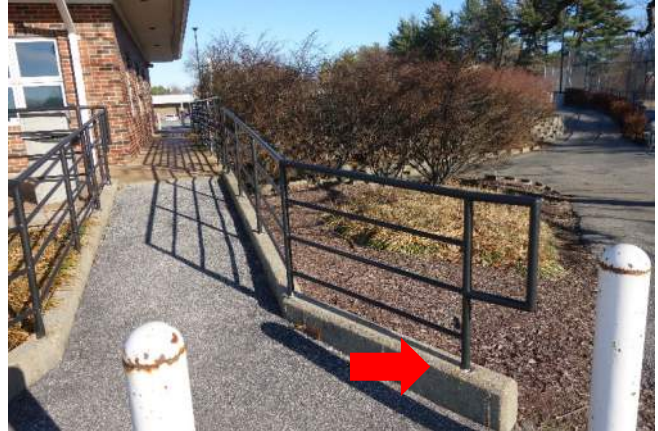
**Figure 16 – Loose Railing Section**

- Figure 16 – Loose Railing Section. The railing, when pushed against would move horizontally and may pose a safety issue.
- Figure 17 – Missing soffit. Located at the Southwest corner of the Golf club house section.

- Repair loose railing section by repacking the connection to concrete with new non-shrink grout (see figure 16).
- Replace missing soffit to ensure a properly sealed roof structure (see figure 17).

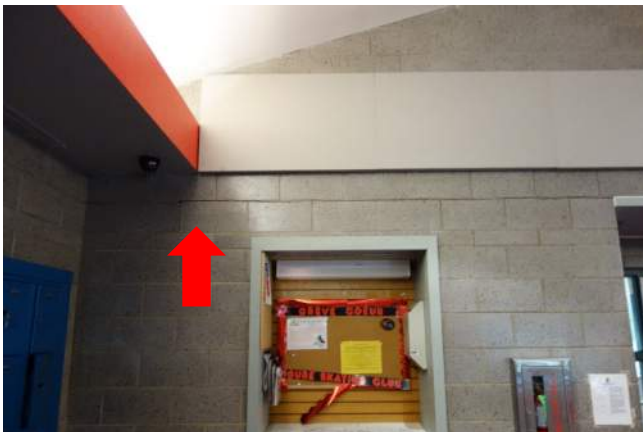
**Figure 18 – Lintel Joint Cracks**

- Figure 18 – Lintel Joint Crack. The masonry joint has separated between the blocks holding the steel lintel for the doorway to the ice rink space. This does not appear to be a structural issue but may have developed due to temperature differences between the lobby and the ice rink.

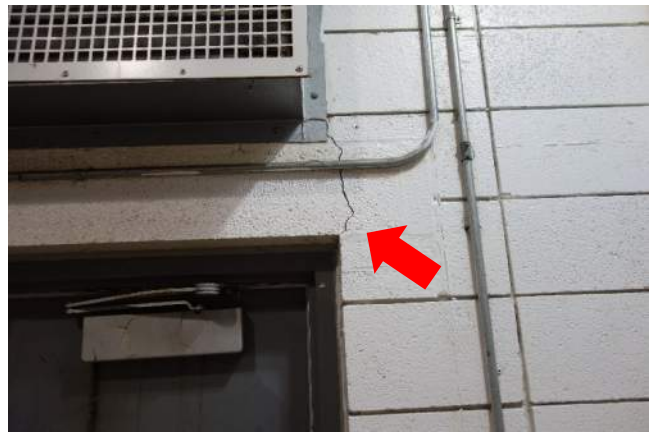
**Figure 19 – Concrete Header Beam Crack**

- A crack has developed in a concrete header beam for a maintenance door located on the northeast wall of the ice rink space. This header beam is not in the critical load path for the building structure; however, it does support the wall above the door. Sealing and monitoring the crack will help stop the issue from developing further.

- Figure 19 – Concrete Header Beam Crack. A crack has developed on the right side of an exterior maintenance door. Northeast corner.
- Figure 20 – Mass Timber Roof Beam. Evidence of previous repair and reinforcement. Beams seem stable and no visible structural issues apparent at the time.

- Seal the concrete header beam crack (see figure 19) with an epoxy injected sealant. After the repair, if the crack grows larger, or interferes with the opening of the door, remove, and replace the header beam with a new, engineered, reinforced-concrete, header beam.

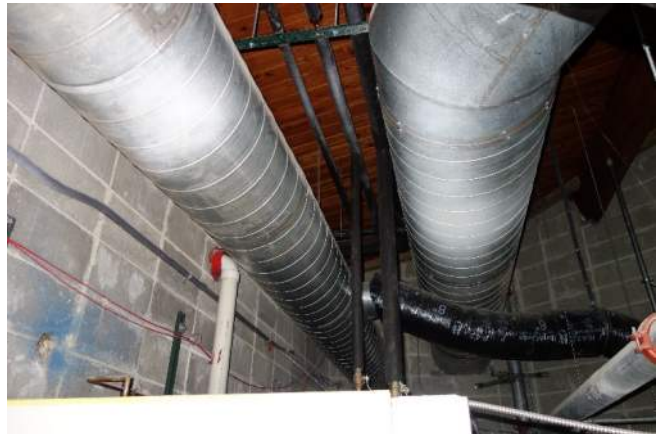
Figure 21 – Mechanical Area above Bathrooms

- Figure 21 – Mechanical Area Above Bathrooms (Northeast corner). No structural issues noticed above the public spaces.
- Figure 22 & 23 – Crack in Masonry Block. Block is not part of the critical load path of the structure and is not considered a structural issue.

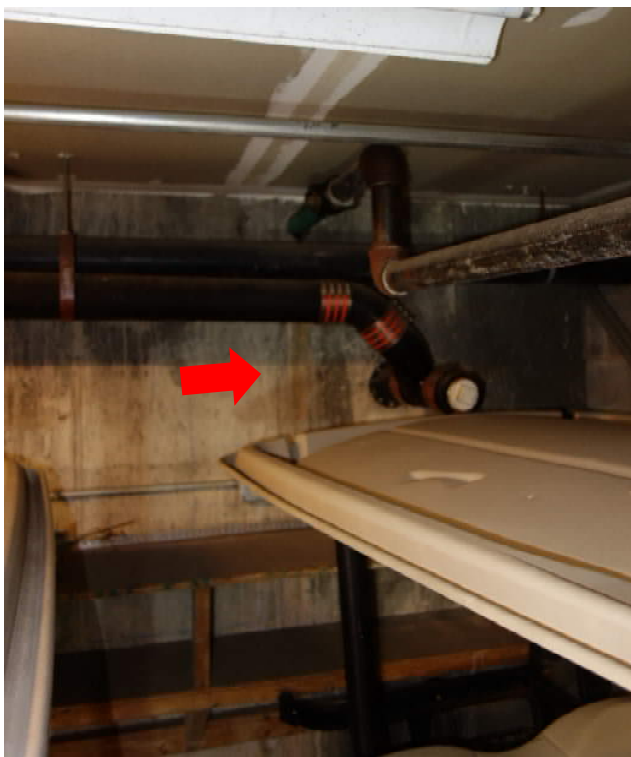
Figure 24 – Vertical Hairline Crack

- Figure 24 – Vertical Hairline crack in concrete basement wall. No evidence of water intrusion and is not considered a structural issue.
- Figure 25 – 28 – Falling/Molding Ceiling drywall. Drywall and drywall tape are separated due to high moisture content in garage and lack of water proofing. The molding sections appear to be damaged from a recent pipe burst event.

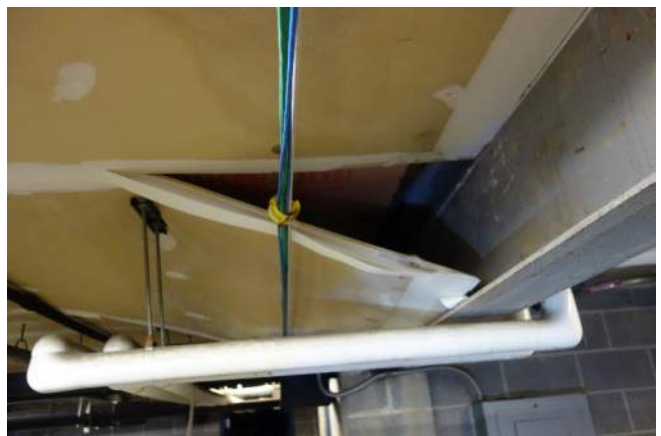
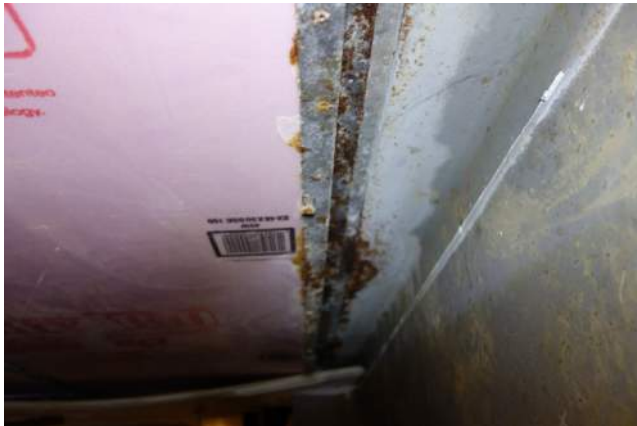
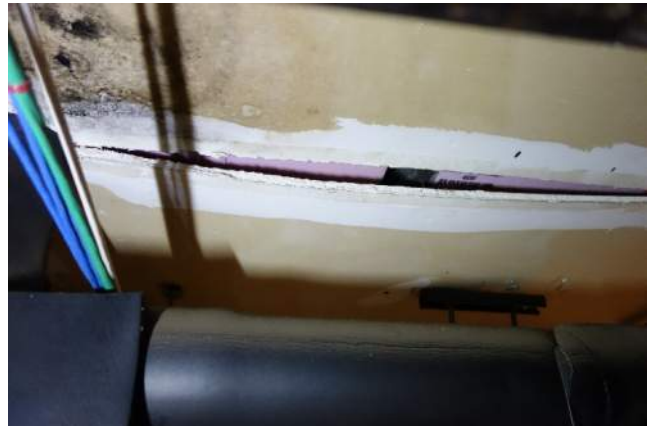
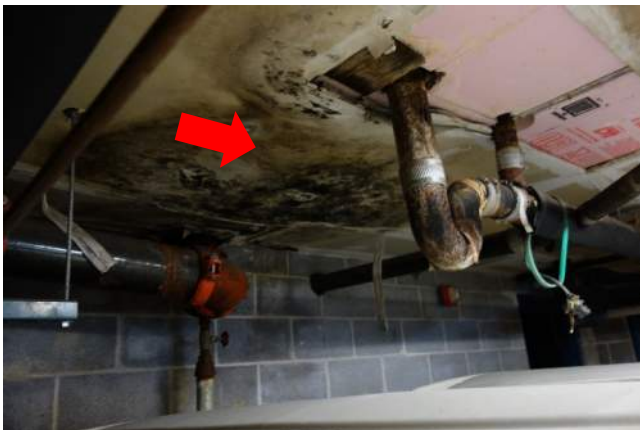
- The ceiling in the basement garage is in poor condition. The damaged drywall ceiling itself is not a part of the structural system and not considered a structural issue. However, they help to protect the underside of the floor above. Repairing and waterproofing the ceiling will ensure the floor system does not get compromised.

- The ceiling in the basement garage is in poor condition (see figures 25-28). While not a part of the structural system and not considered a structural issue, they help to protect the underside of the floor above. Repairing and waterproofing the ceiling will ensure the structural floor system does not get compromised. Repair as follows:

- o Replace water damaged and loose drywall boards on ceiling.
  - o Sand/grind off any rust that has developed on the floor support beams and any steel under the removed drywall boards. Repaint exposed metal with a rust preventive paint.

- o Re-tape and re-mud cracked joints between drywall sections.
  - o Prime the full surface area of the drywall ceiling with an exterior grade waterproof primer.

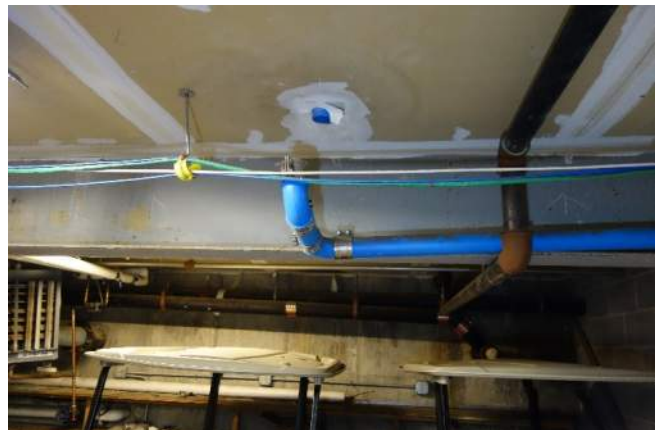
**Figure 29 – Detached Pipe**

- Figure 29 – Detached Pipe. Pipe appears to run to daylight. Possibly above the roof.
- Figure 30 – Vertical Hairline crack in concrete basement wall under stairs. No evidence of water intrusion and is not considered a structural issue.

- Consult a Plummer about reattaching the vertical pipe in the garage (See figure 29).
- Consult a Mechanical Contractor about the loose cover or the mechanical duct (see Figure 31).

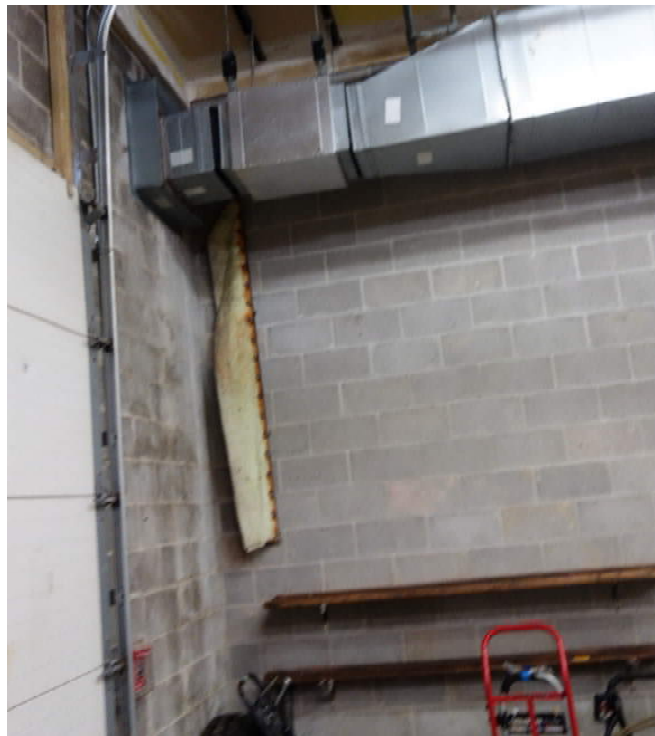
**Figure 31 – Mechanical Duct Cover**

- Figure 31 – Mechanical duct cover. May pose a mechanical issue. Consult a mechanical contractor.

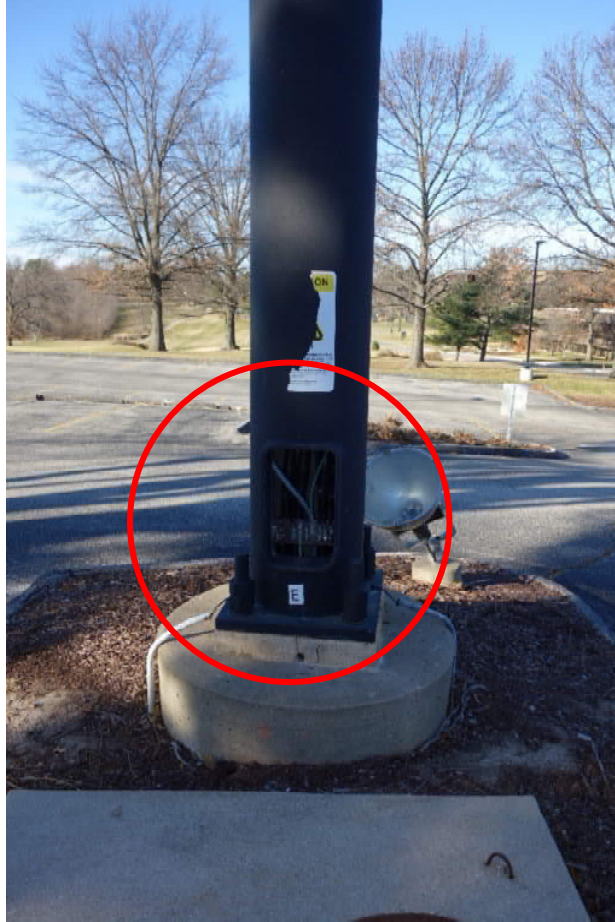
**Figure 32 – Missing Cover Plate to Light Pole**

- Figure 32 – Missing Cover Plate to Light Pole. Exposed wires accessible to the public pose a safety issue that could result in electrical shock.
