**EXISTING BUILDING ASSESSMENT
AND DEFICIENCY REPORT FOR:**

CITY OF
CREVE COEUR
MISSOURI

September 1, 2022

EXISTING FACILITY CITY OF CREVE COEUR GOVERNMENT CENTER 300 N. New Ballas Road, Creve Coeur, MO 63141

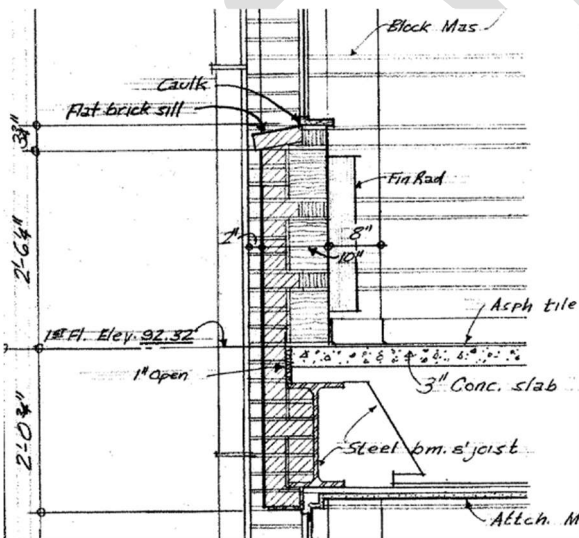
- The existing exterior envelope of the building has several energy code deficiencies compared to today standards and requirements. The exterior walls generally are comprised of an integral block and face brick exterior wall system. This type of wall is a solid wall system and lacks any type of continuous insulation or air space cavity utilized in current wall systems. The

Drawing showing masonry wall construction – No thermal break or continuous insulation

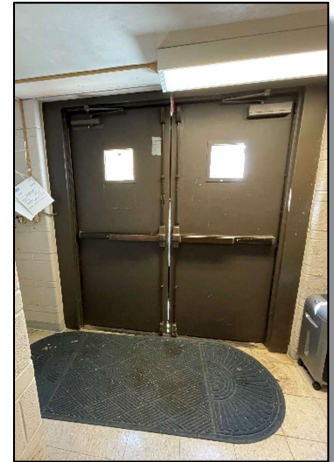
- A few the exterior doors also fall short of the energy code due to poor seals and weatherstripping. There are several that daylight can be seen from the inside of the building and therefore allow for the conditioned air to escape continuously. Conversely this allows for windblown rain to enter the building at those locations.

Photo showing large air gap between doors to allow air/weather infiltration

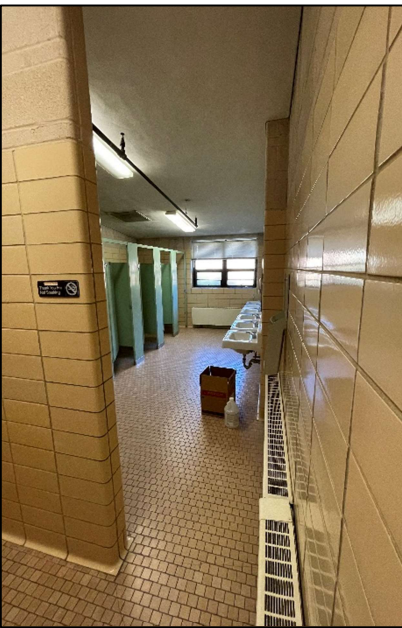
Existing Restroom with narrow passage and antiquated plumbing fixtures

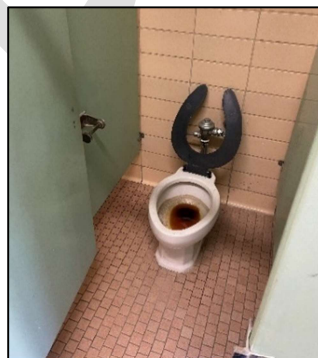
View of broken and abandoned toilet/restroom

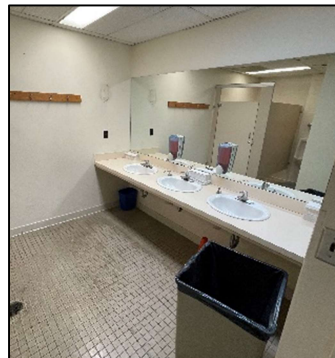
- The plumbing fixtures are also lacking proper drainpipe coverings under exposed lavatories and have toilet accessories that do not meet current code and ADA requirements throughout some of the restroom locations.
- Clearances and turning radii are limited in some of the areas such as restrooms, approaches to doorways and some of the corridor widths. Although the city has utilized the existing facilities and may have made accommodations as needed over the years with current staff, they are still at risk of violating some of the ADA laws.
- The existing building has a several areas that are not being occupied and are deteriorating and causing issues with continuous maintenance. Staff has reported that some of the areas have been shut off due to broken water valves and broken toilets, sinks and faucets.

View of exposed drainpipes under sinks

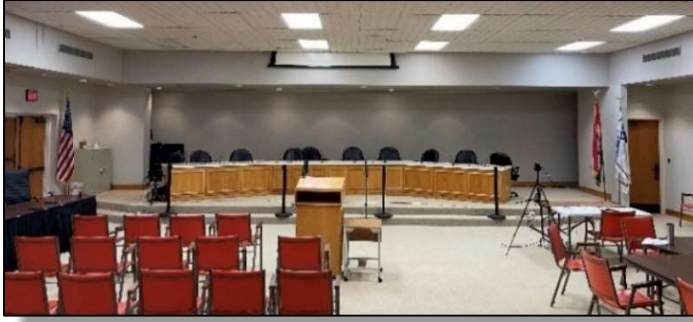
View of Council Chambers with non-accessible raised dais

- There are other accessible violations within the building including access to the council chamber's dais. In order to access the dais, the council person will need to ascend two steps one either side of the dais as well as any other citizen wanting to approach the front of the dais. This makes it impossible for disabled persons to utilize the council chambers and be participants with the council members during any of the meetings utilizing the dais.

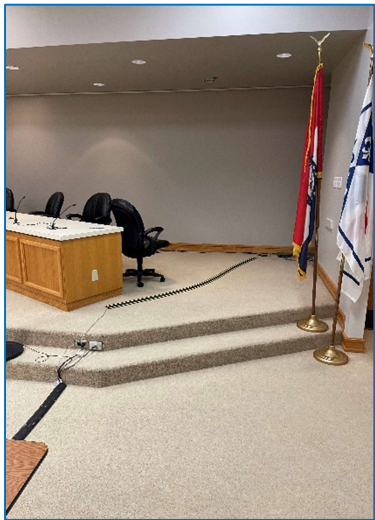
- Within the dais area, there are several electrical and AV chords/cables that transverse through the walking paths of the patrons. This is a tripping hazard to participants and the attending citizens utilizing the facility for functions within the room. The city has utilized tapered rubber surface covers and, in some cases, tape on to the carpet to limit and control the tripping hazard but has not eliminated it from the area.

View of Council Chambers showing wire and cables running on surface of floor.

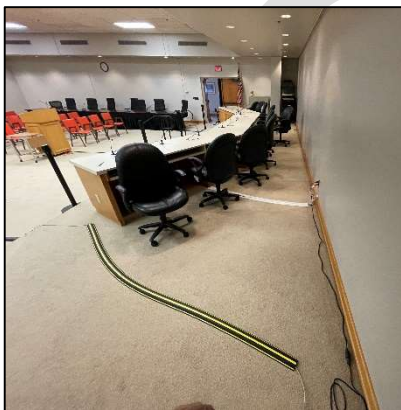
View of Council Chambers showing wire and cables running on surface of floor sometimes protected with tape on carpet.

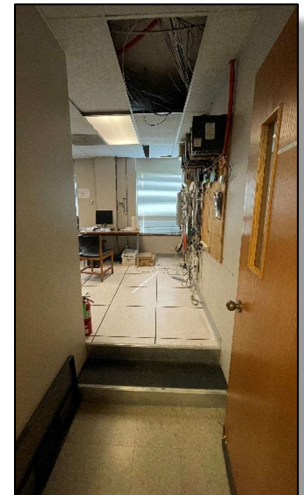
Photo showing 2 steps into Phone/IT Room

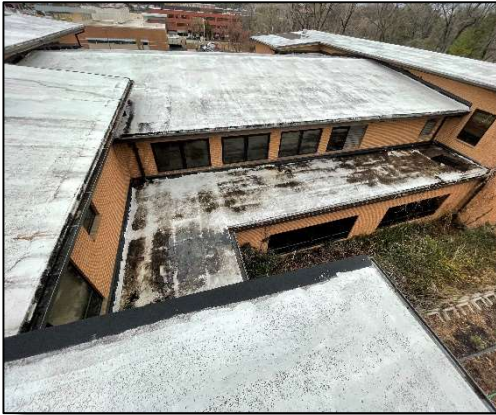
Example view of existing roof condition overlooking lower hallway and Gym.

- The roofing system has been patched and coated several times over the past number of years. The current condition of the roof is at the end of its life cycle and needs to be replaced. Staff has commented that they are continuously repairing leaks after major rain events throughout the year.

- The condition of the existing roof would not warrant adding an additional coating. An entire tear out and re-roof is recommended should the city wish to continue to utilize the building for the long term. This will allow for increased insulation to meet today's thermal standards and allow for waterproof conditions.

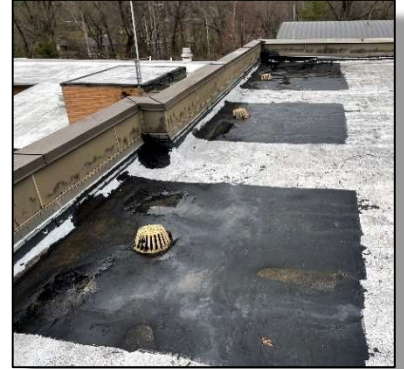
Existing roof condition were patched due to leaking.

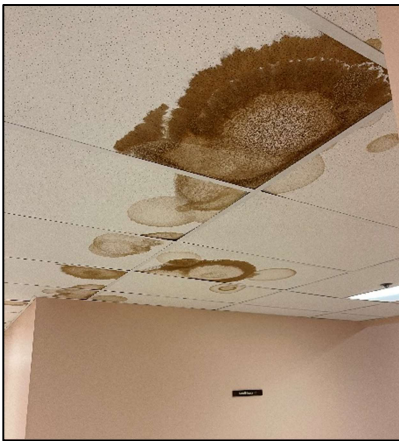
- Continuous leaking also leads to further deterioration of the roof deck and possible damage to the wall cavities. There are many ceiling areas where roof leaks appear to have occurred. Depending on the areas that are affected, the introduction of the moisture into the building materials can lead to the development of mold in the building, affecting the interior work environment and cause unhealthy conditions for the staff.

Views of water leaks above the ceiling

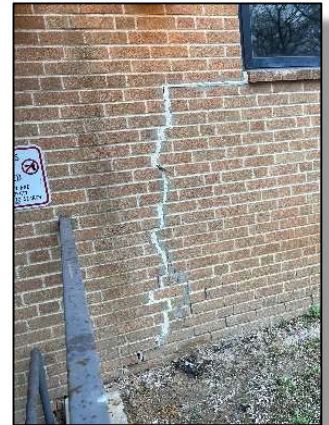
- The building is currently in need of major exterior improvements to the roof and several areas where the floor has settled and caused the exterior skin to shift and crack the masonry wall system.

View of cracks in Brick Veneer

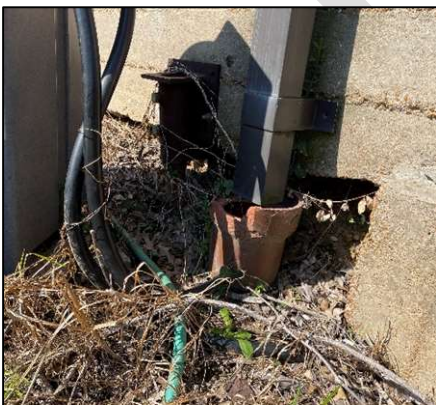
- The other area staff indicated movement in the floor is on the upper-level break room. That floor has dropped over time and is showing a gap between the floor and wall of about an inch. The exterior condition shows that some of the existing grade has eroded to the extent that additional foundation support was required to be installed to maintain the current condition of the floor. Staff has reported that the added structure to the outside of the building has appeared to have stopped the settling. The existing grade in the courtyard appears to continue to settle over time.

Photo showing foundation support of breakroom floor

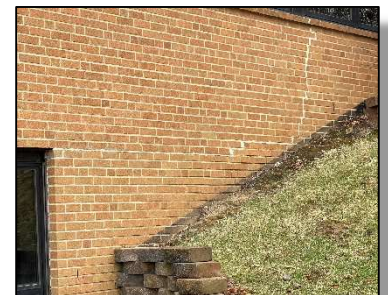
View of cracks in Brick Veneer

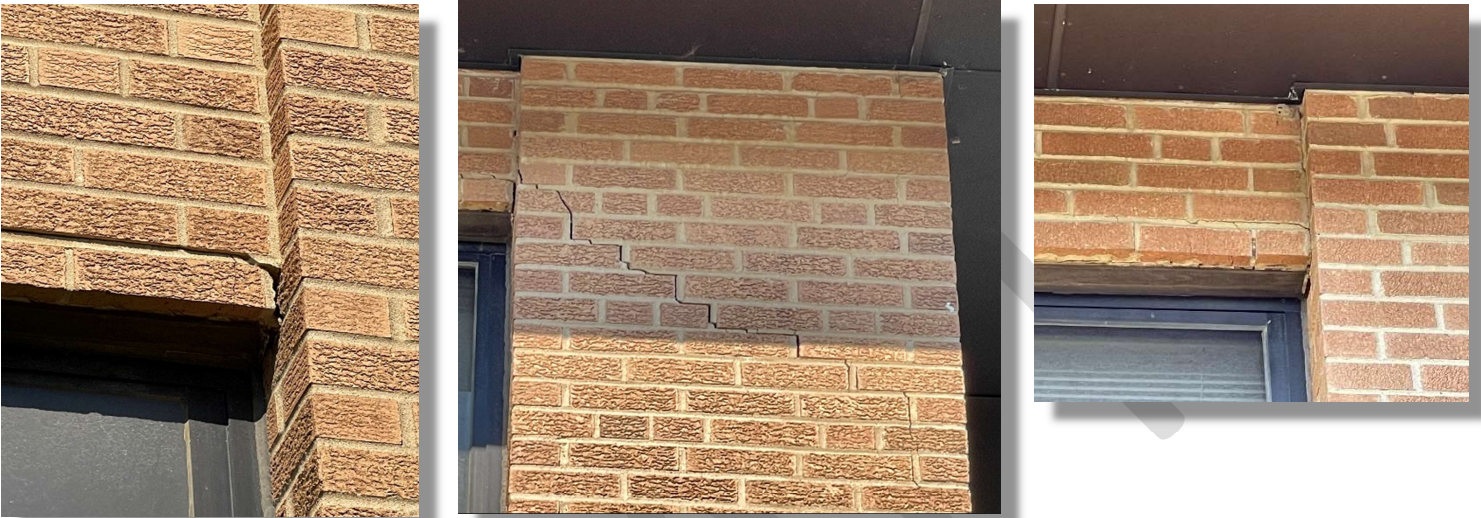
Other areas around the building that show signs of movement are on the east side of the building in multiple areas. The photos below are an example of these conditions. It would be recommended that these areas be addressed and should be caulked at a minimum to keep moisture from penetrating the wall system.

- Should the city decide to renovate this facility, further investigation of existing soil conditions, settling or movement should be monitored and determined the cause of the excessive cracking.

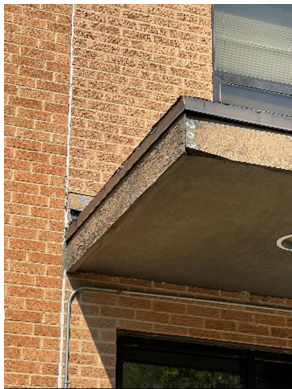
Peeling paint and deteriorating wood fascia on canopy

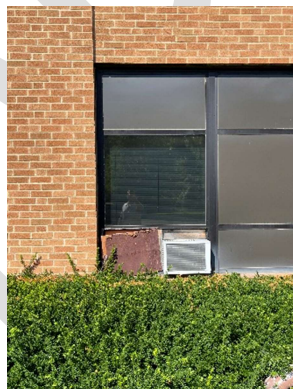
Plywood filler is falling out of window at air conditioner

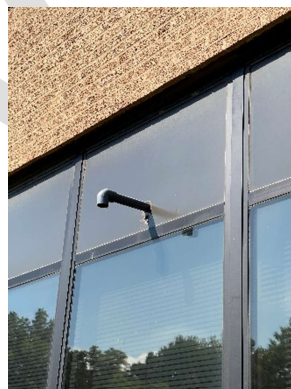
Condensation Drain out of window panel. No caulk around pipe / water & insect infiltration

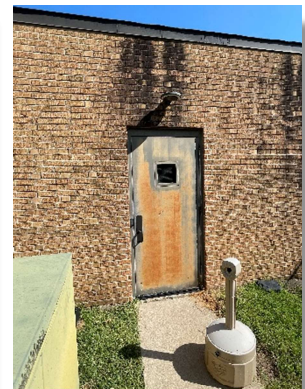
Southern employee entrance - Rusting Door and water damage to Masonry Veneer.

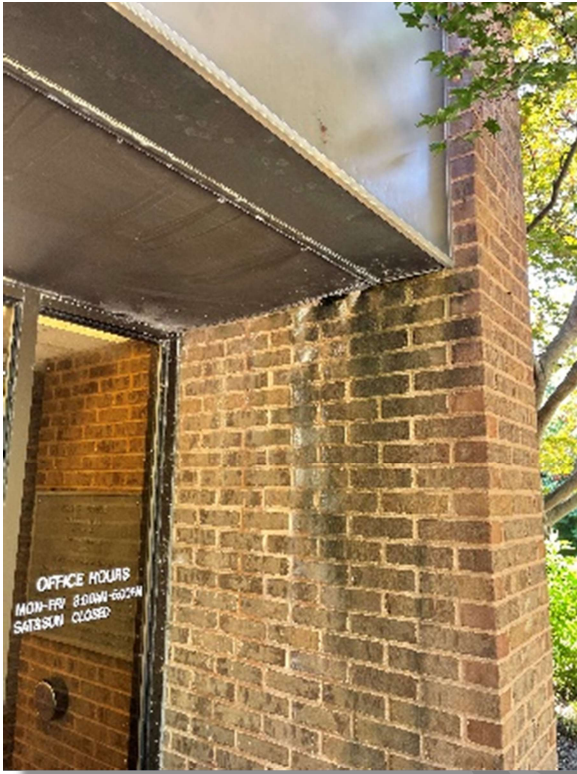
Water Damage to Canopy at City Hall Main Entrance

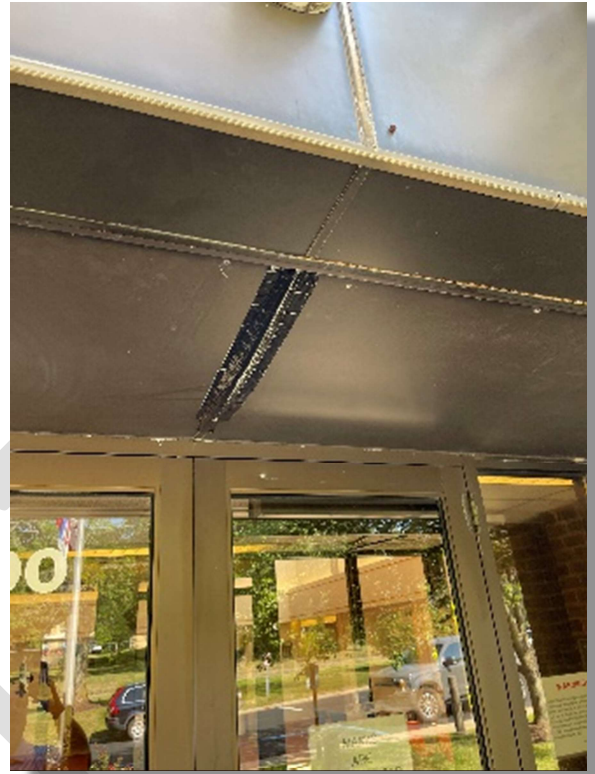
Entrance Canopy seam repaired with black duct tape at center of canopy over Main Entry Doors.

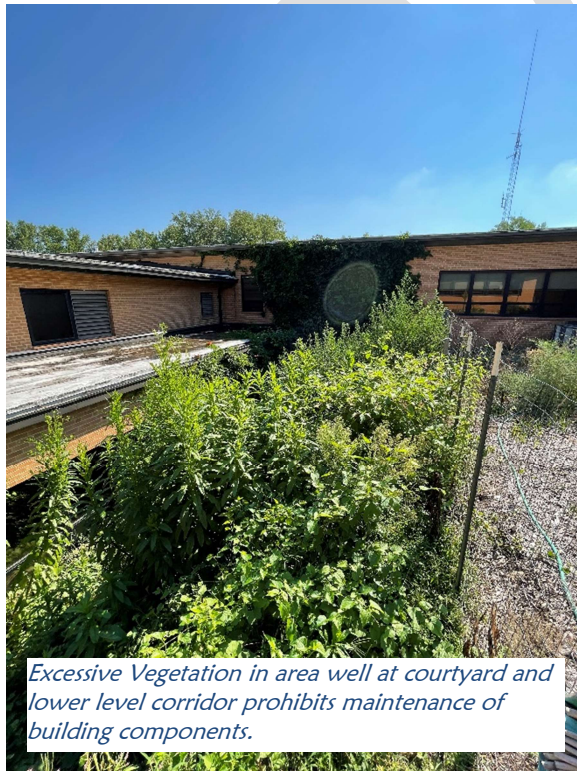
Excessive Vegetation in area well at courtyard and lower level corridor prohibits maintenance of building components.

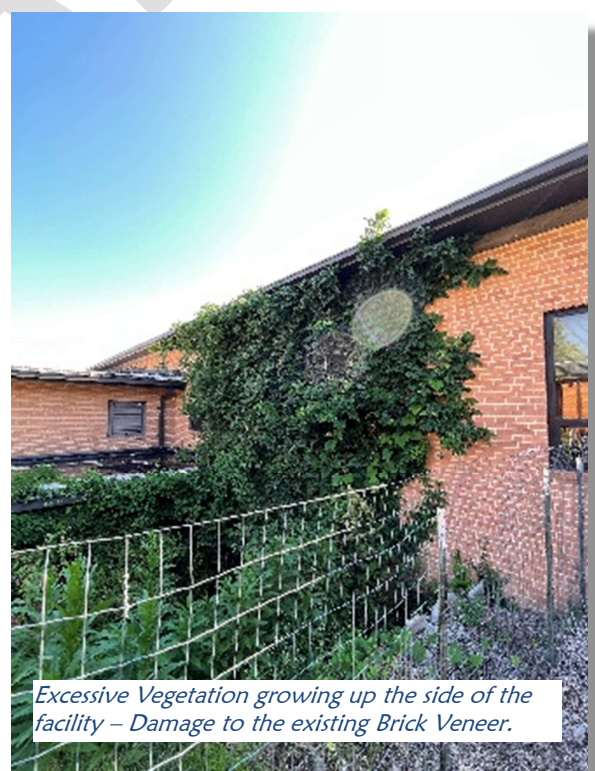
Excessive Vegetation growing up the side of the facility – Damage to the existing Brick Veneer.

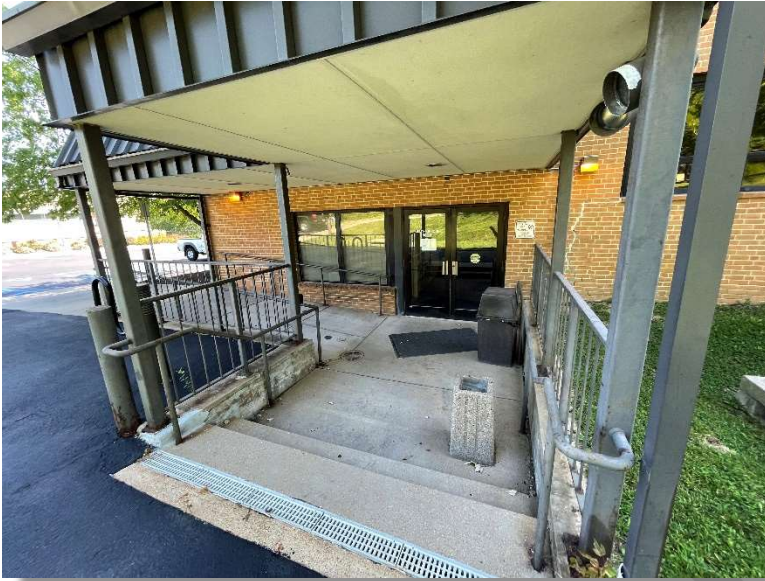
Existing Entry into Community Room – Despite drain at top of step and area drain at landing, entry doors are subject to flooding should area drain gets clogged or covered.

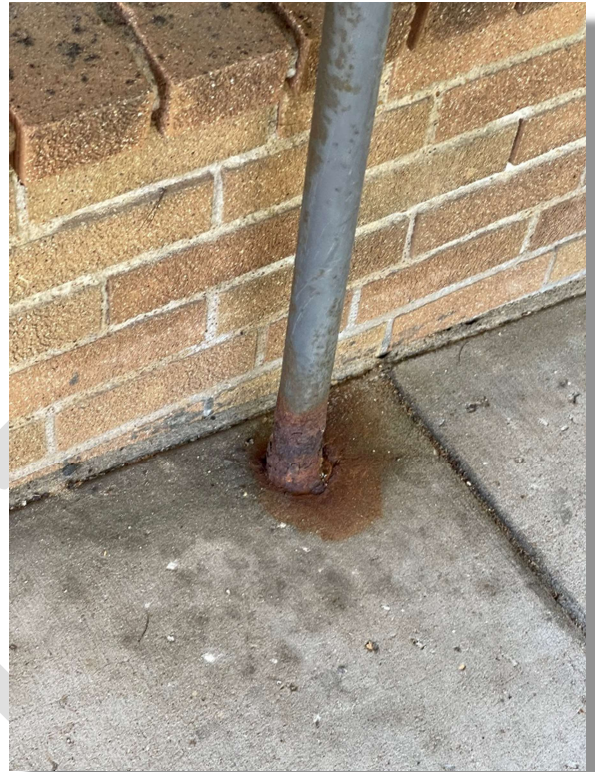
Many of the guard rails / handrails are rusting through and are not properly anchored

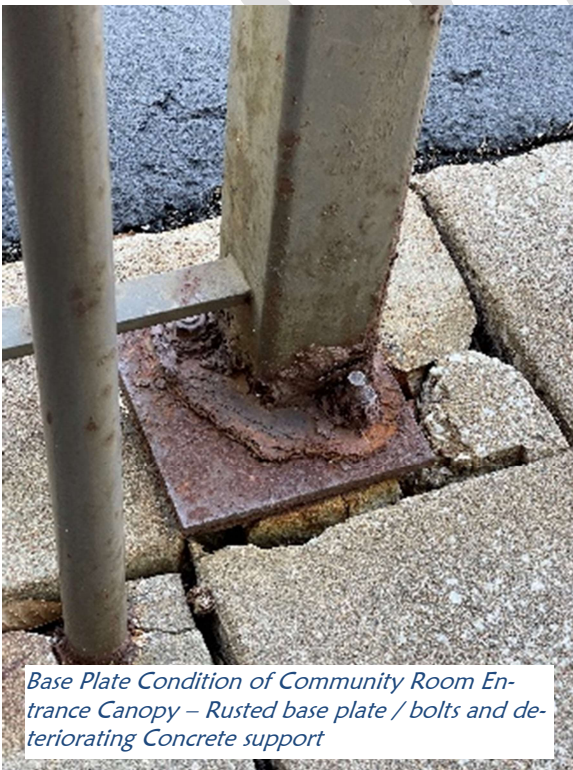
Base Plate Condition of Community Room Entrance Canopy – Rusted base plate / bolts and deteriorating Concrete support

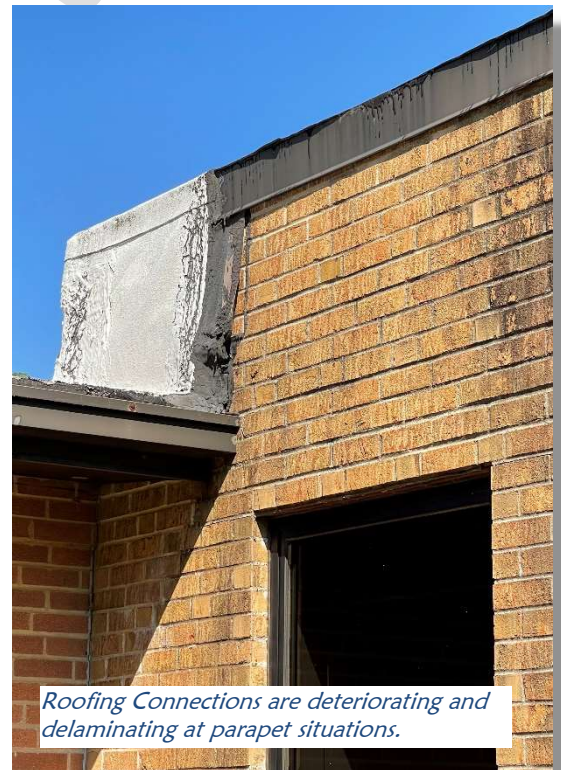
Roofing Connections are deteriorating and delaminating at parapet situations.

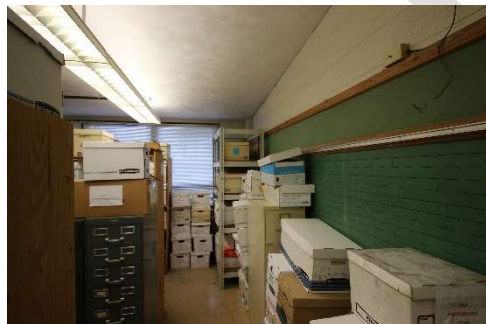
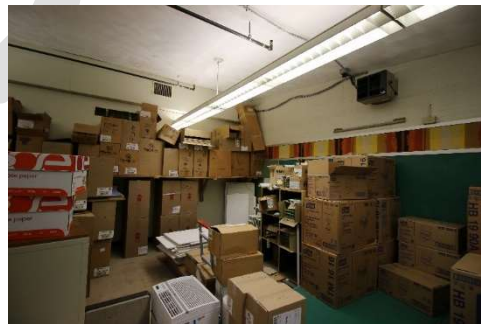
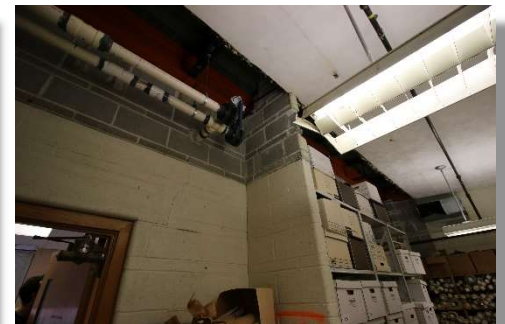
Excess space within the building has been utilized as storage space

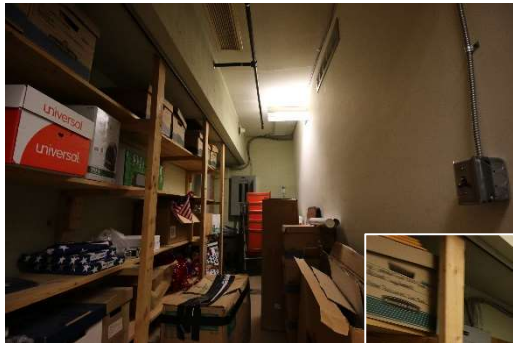
Electrical closet has been utilized as storage and now electrical panels cannot be accessed resulting in code violations.

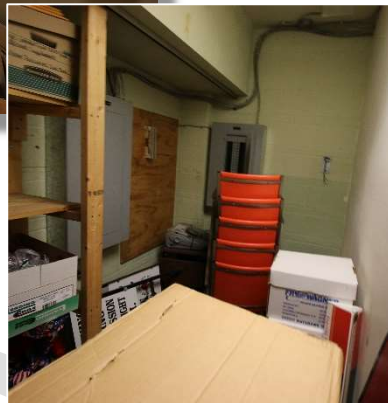
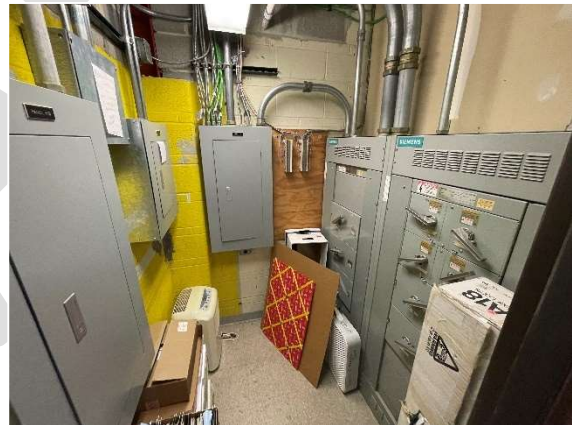
Electrical panels and switch gear is being blocked by storage items resulting in code violations.
