### **Historic Building Assessment**

Tim Kilby, the proprietor of the Country Gentleman Historic Restorations and Woodwright Shop, will present his assessment of the Clester Cabin, Hackmann Cabin, and Lake School House. The Parks and Historic Preservation Committee has been invited to participate in the discussion.

## *Clester Cabin in Conway Park*

## *Hackman Cabin in Conway Park*

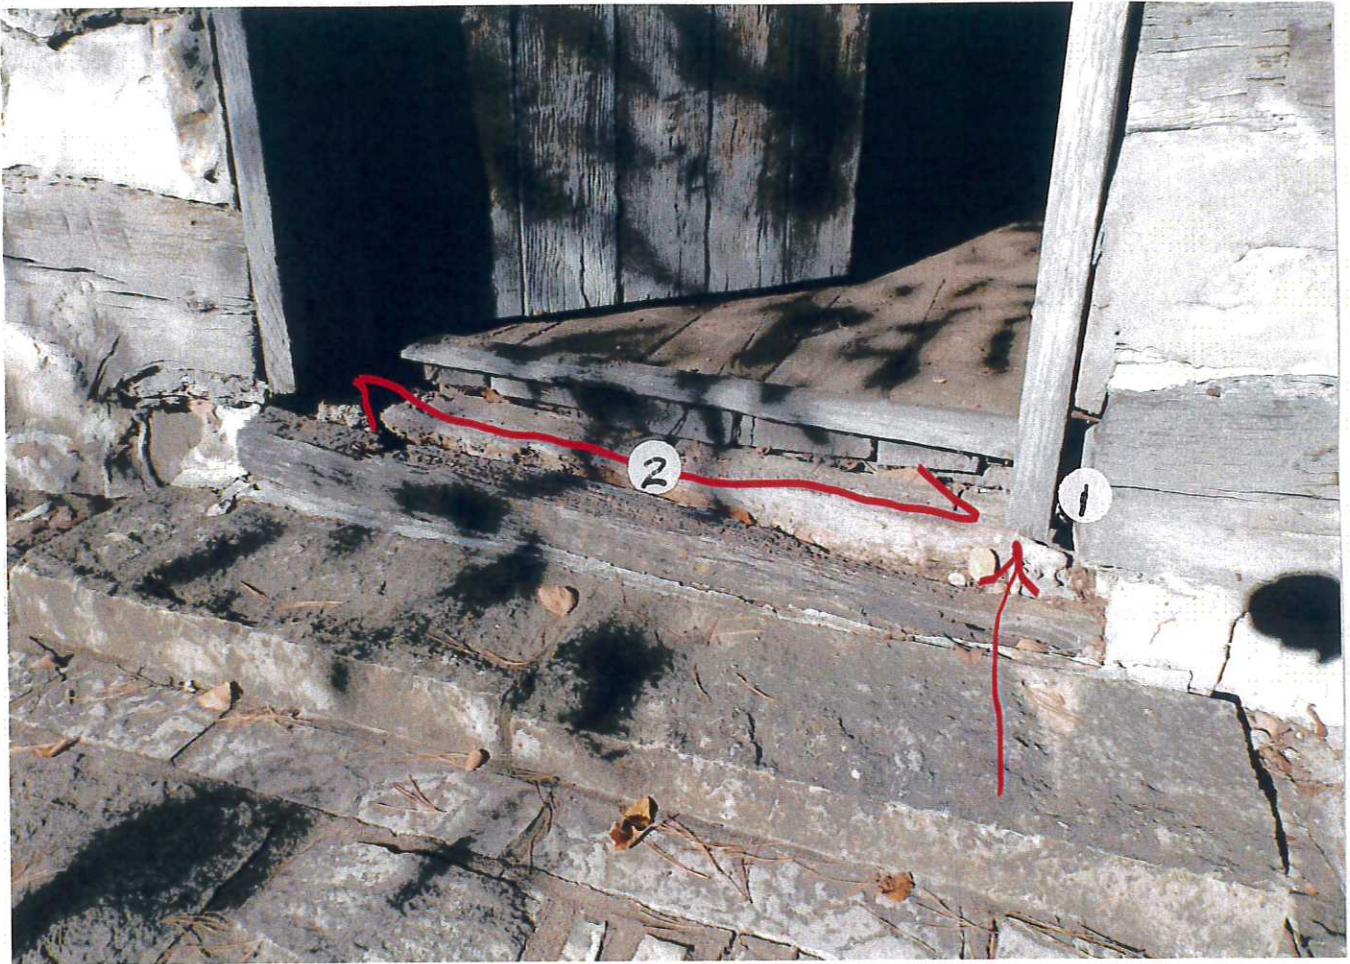
- 1) Latch side of door jamb has kicked out at the bottom about 4 1/2" misaligning the logs that are attached to it. The lower rows of chinking under the window will most likely need to be removed prior to pulling the jamb back to its original position. Once the jamb is repositioned it needs to be fastened to the original framing around it. Remove fasteners / chinking around window as needed to re-align logs and window unit and refasten.
- 2) The wood step between the upper stone step and the bottom of door threshold has rotted. Replace with new white oak timber approximately 9 1/2" wide. Field verify height. Fasten to adjoining logs.

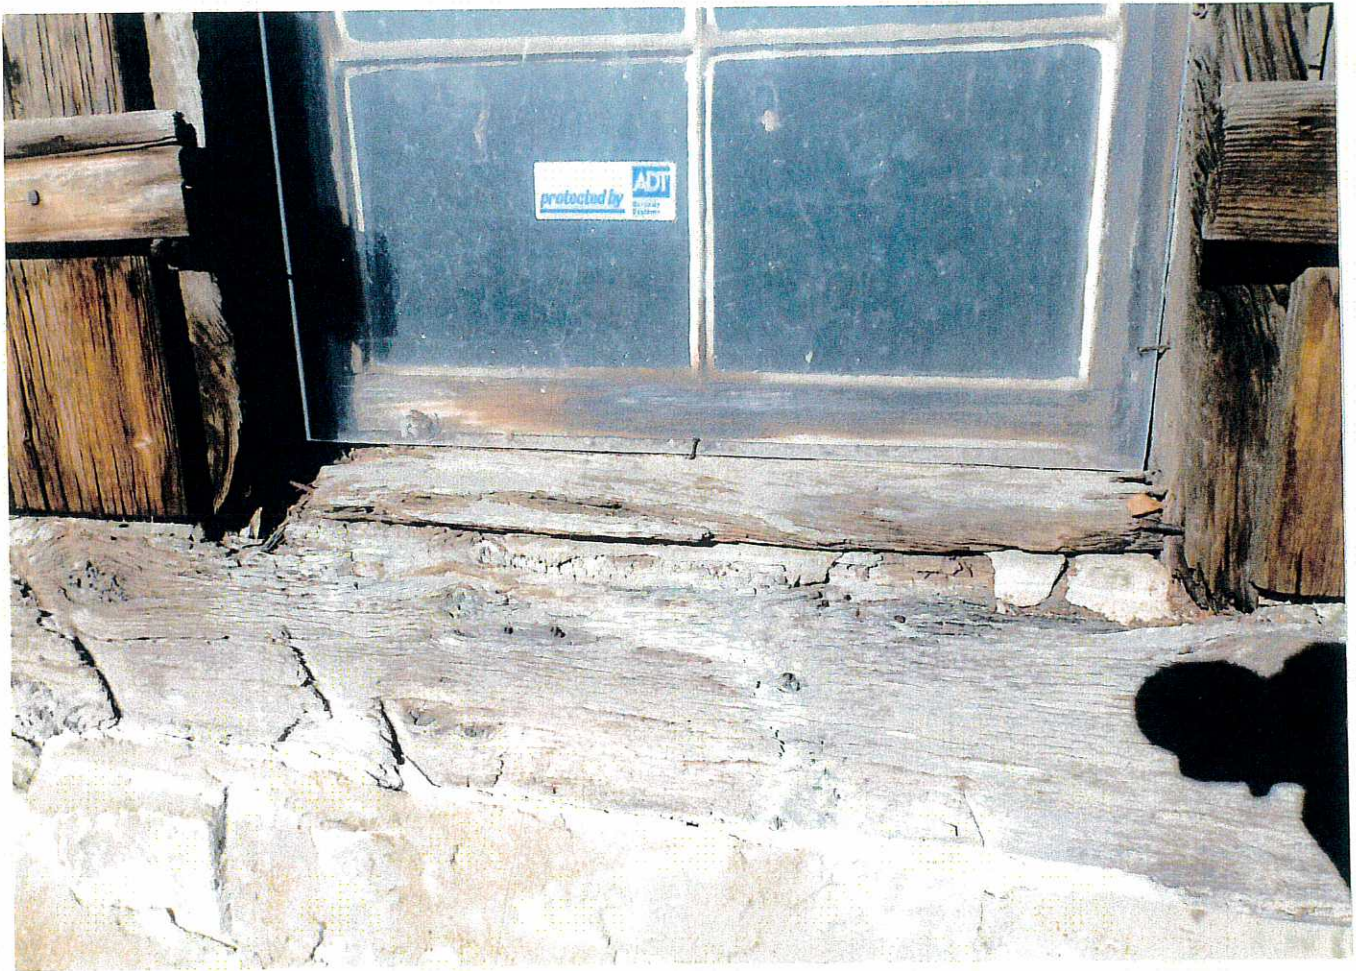
3) Replace window sill using white oak, white pine, walnut or fir.

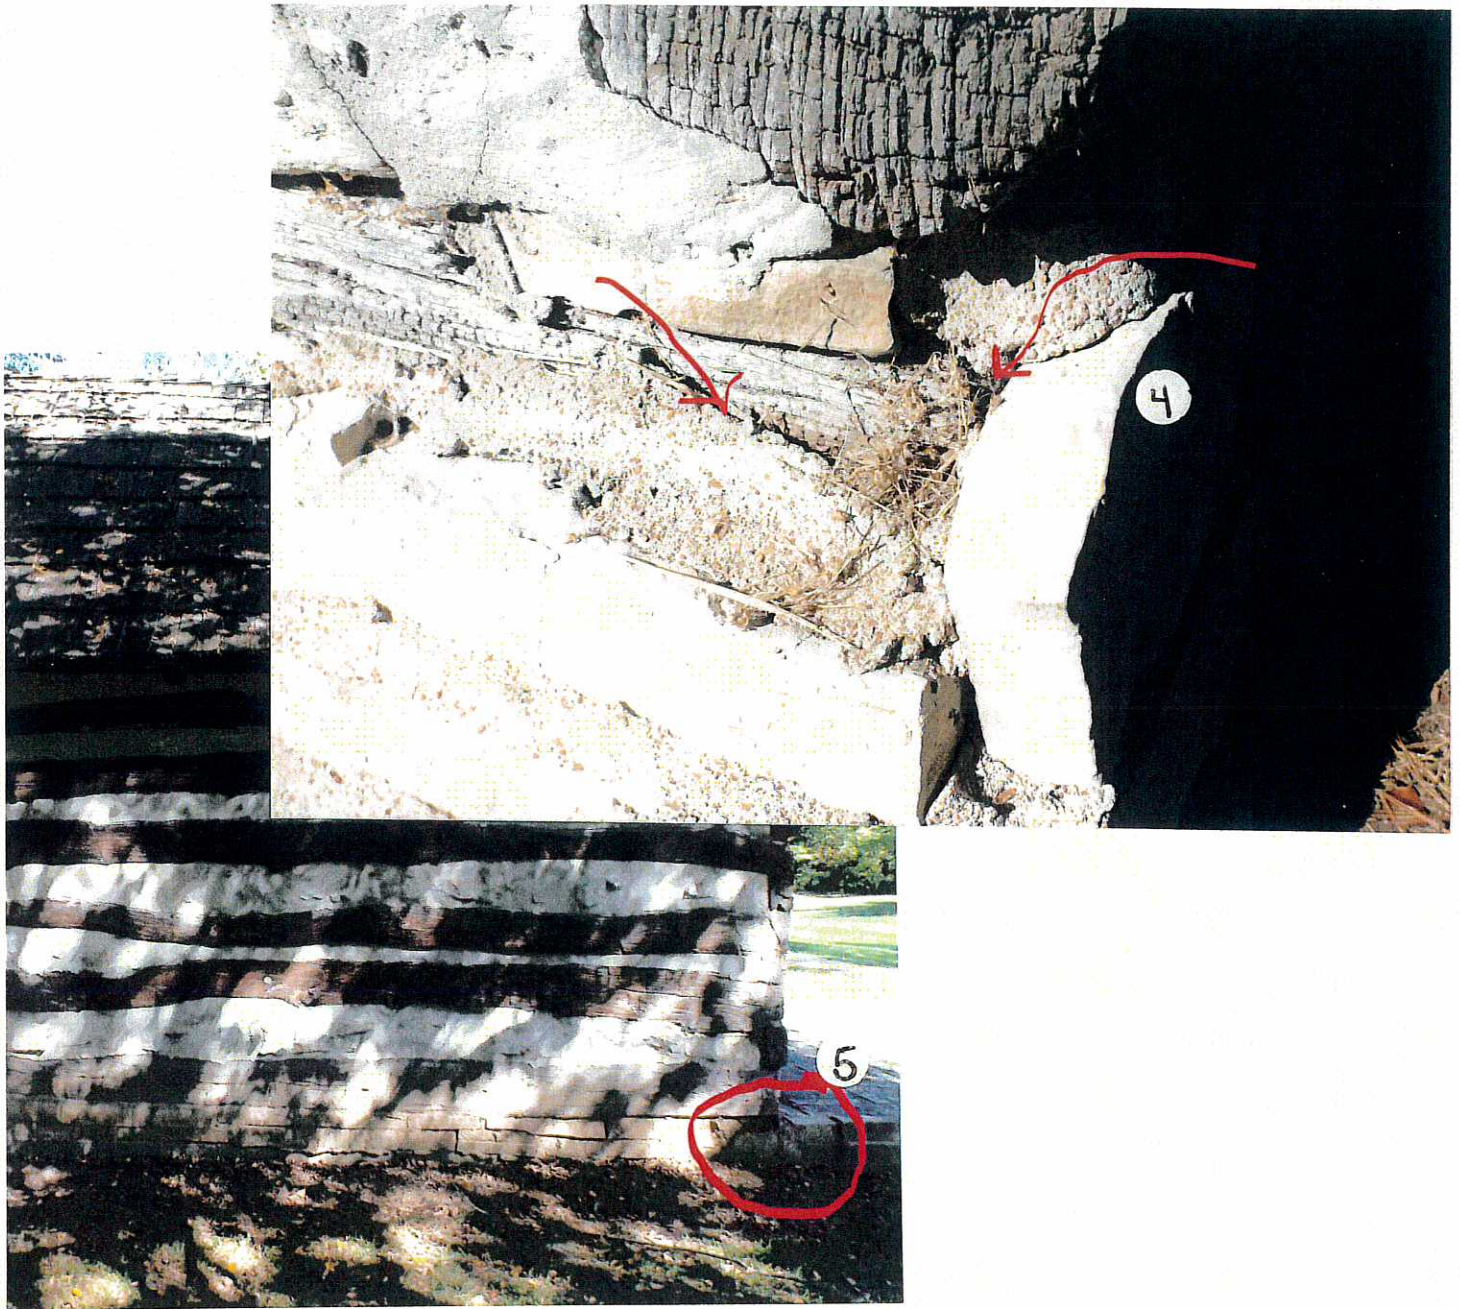
- 4) Most of the front sill (log 1-1) was not available for viewing due to the stone steps. It is possible it may need replacing in its entirety. At a minimum the right side needs to be exposed. The stone work has been built up around the end grain of this log creating a water trap.
- 5) The left side needs to have the concrete taken out, examined and epoxy repaired.

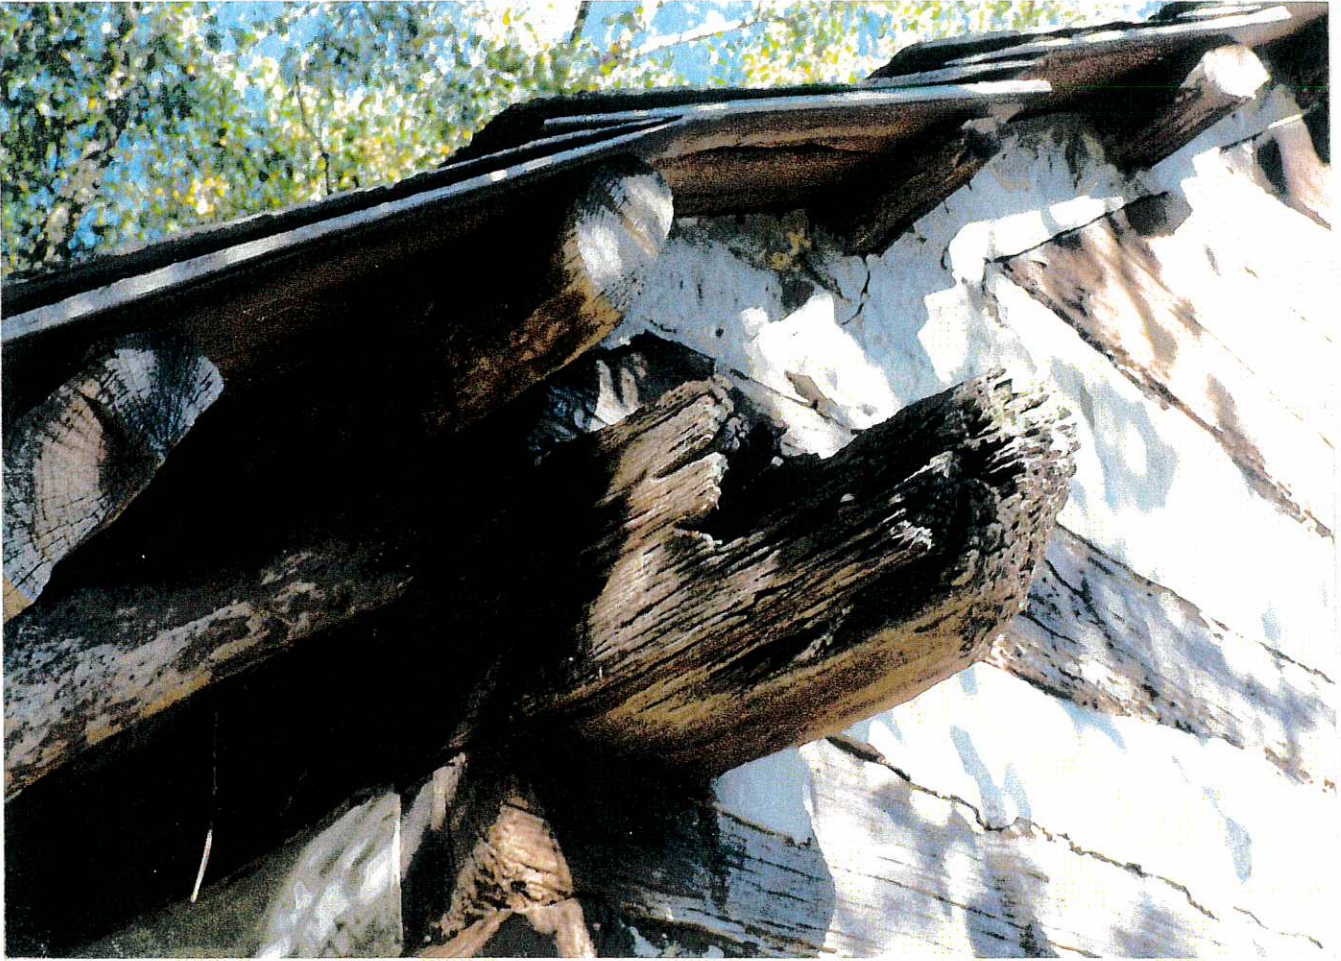
- 6) The top plate logs, on which the rafters sit (logs 4-7 & 2-7), cantilever past the wall and past the roof line for no structural reason. Being exposed to the weather these ends have started to rot and the rot is working its way back to the bearing point. The cantilever log on the front left will need to be cut off, using epoxy, fill in any void under the bearing point and a new end doweled in using  $\frac{3}{4}$ " fiberglass rods epoxied in. The remaining cantilever logs need only epoxy to fill the existing cracks on top. All 4 cantilever logs need to have Borate rods installed to prevent further rot.

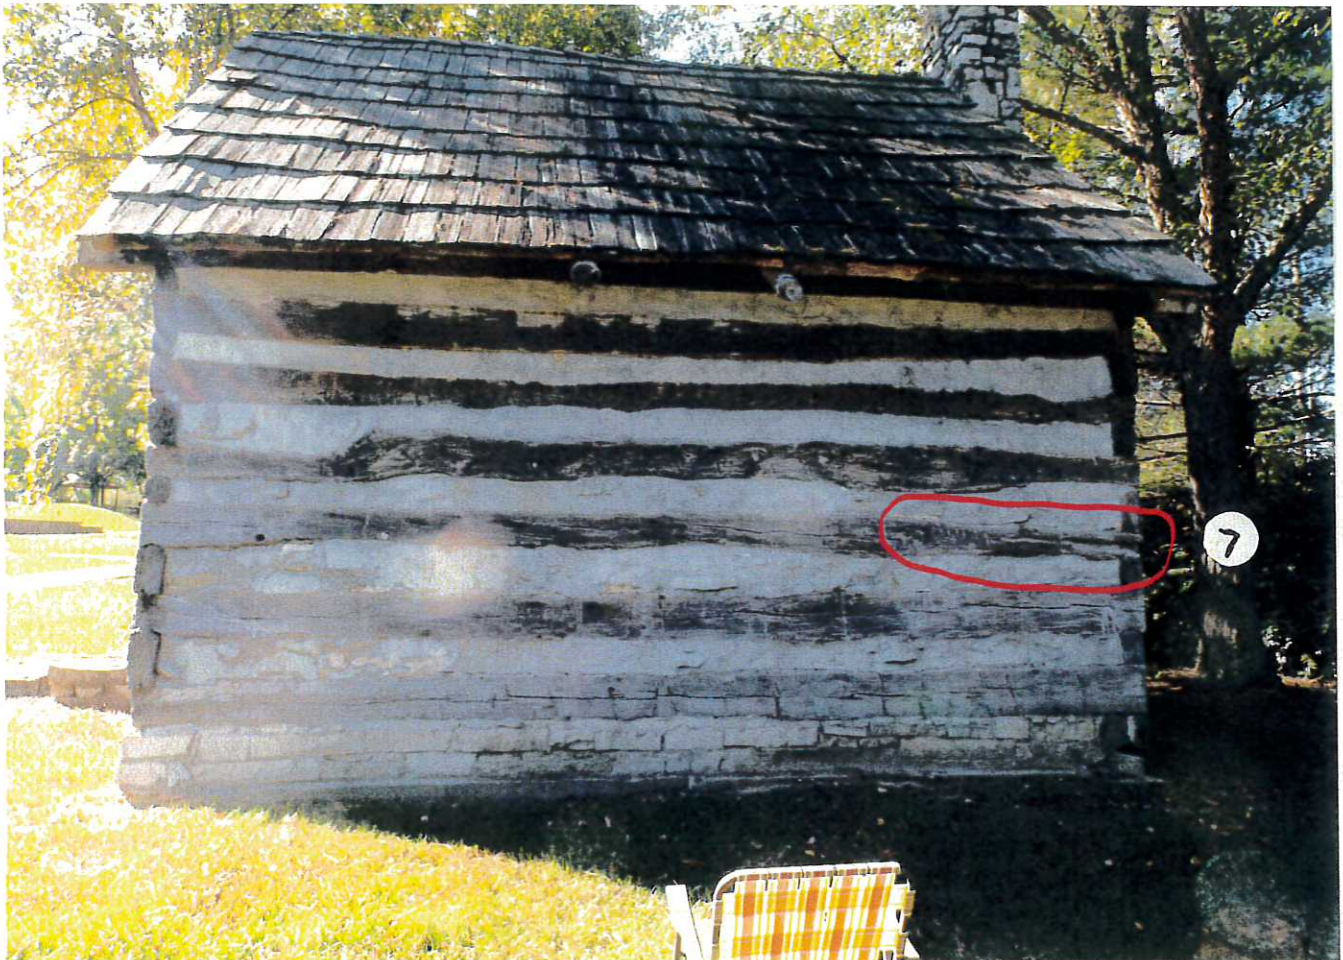
- 7) On log 2-3, the last 4 ft. is hollow and needs to be cut off and new section of like log doweled on using  $\frac{3}{4}$ " fiber glass rod epoxied in.

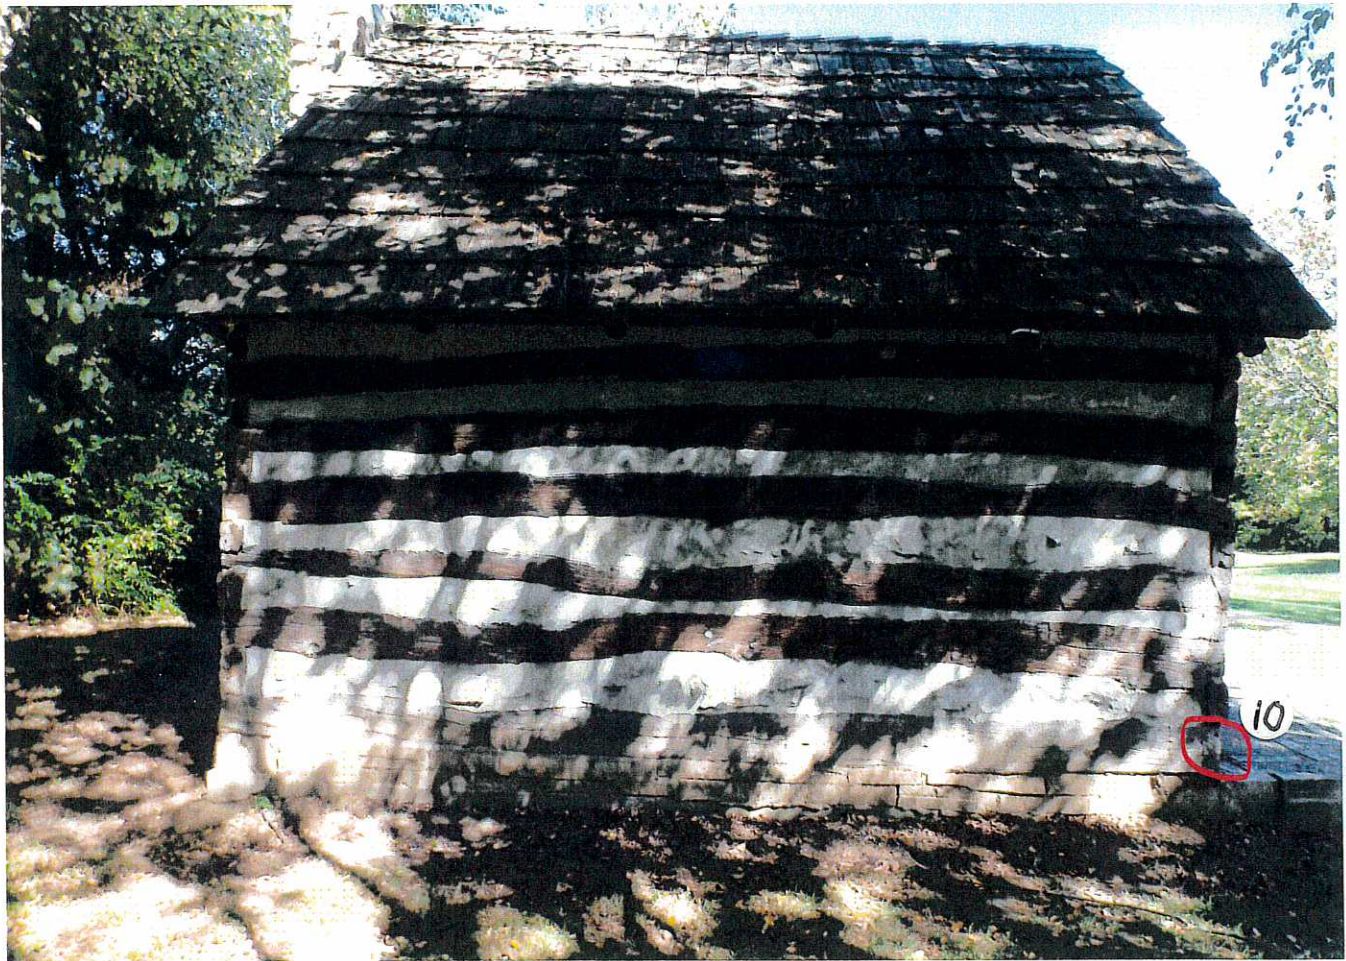
- 10) Log 4-1, remove and repair concrete repair on right end of log same as above.

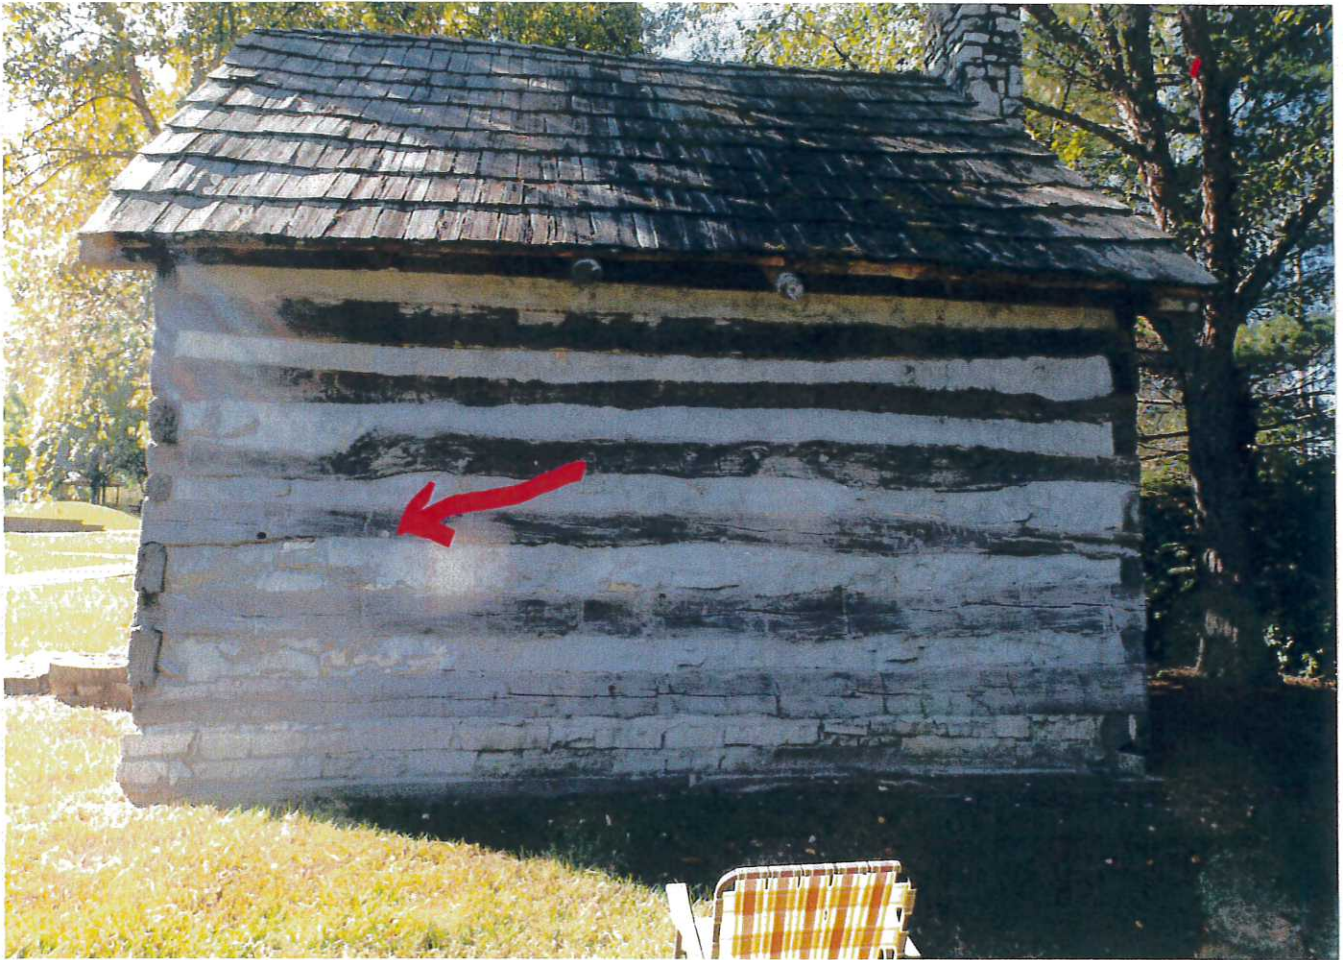
- 11) Throughout the cabin there are random holes approx. 2" in diameter that are filled with concrete. Remove all concrete plugs including end grain repairs and replace with epoxy in a way that it sheds water.

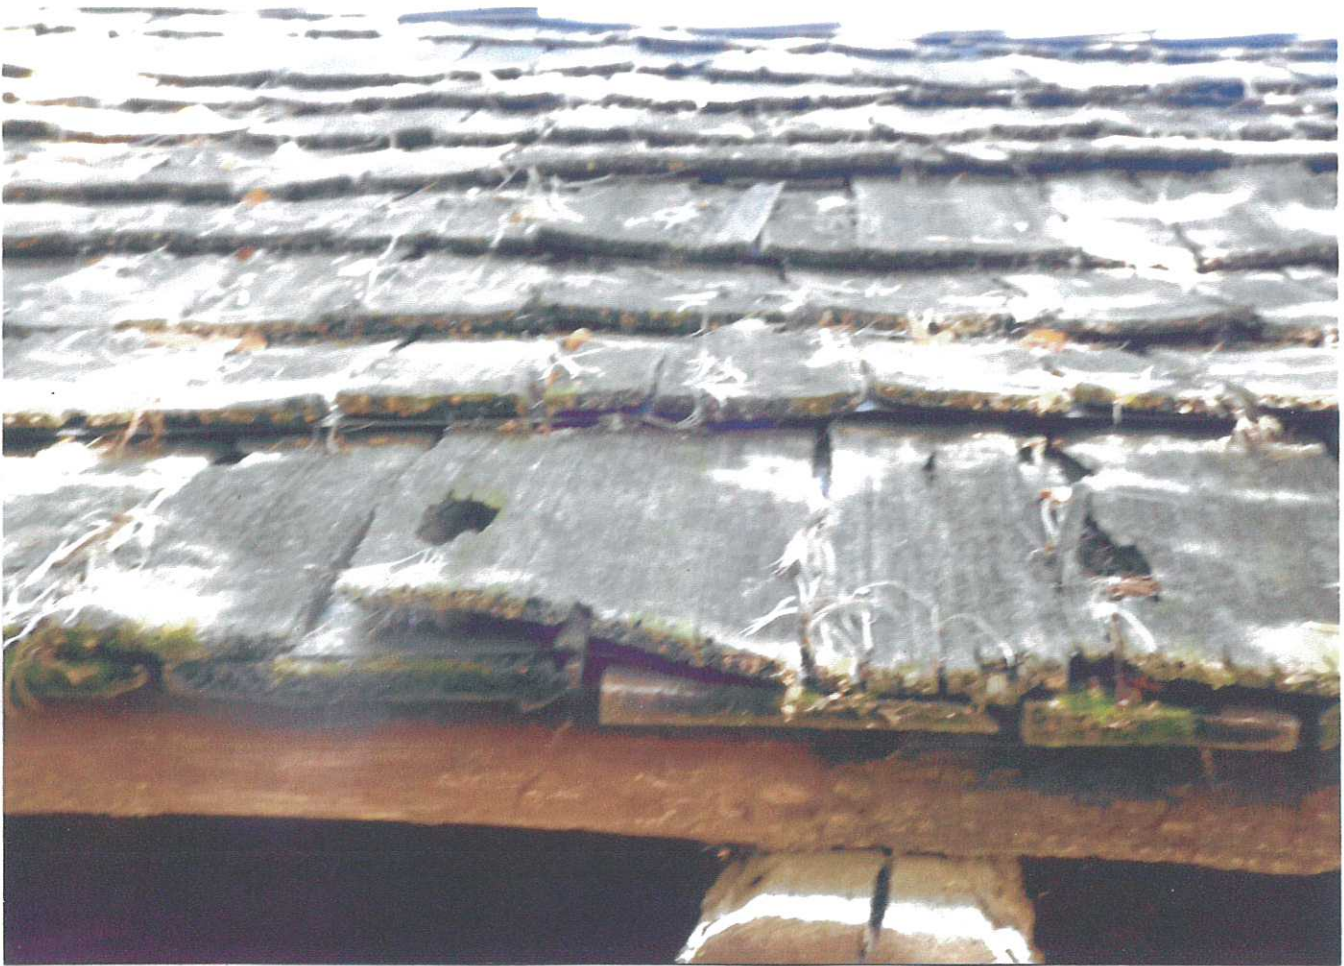
- 12) **Roof: The existing shake roof is in need of replacement** with a new treated CCA heavy shake roof. The current roof consists of two shake roofs. The bottom (interior) roof is actually laid upside down, with the butt of the shingle up vs. down. On top of the inner roof lays a layer of felt paper, then the outside roof which is laid in normal fashion with the butt of the shingle down. The spans of the shingles are at a maximum due to the spacing of the purlins. This makes the install of a new roof very delicate since the roofer will be supported by only the shingle itself. This will add to the labor of installing a new roof. Our best guess is this was done to enjoy the visual of the roof system and the shake roof from the inside and still be water tight. I did not see any sign of the roof leaking though.

- You may get a year or two more out of the roof, but it may as well get replaced during this restoration. Considering the cabin sits under the canopy of the trees, any wood roofs life span will be shortened. A new medium shake sill last maybe 15 years. You may want to consider going to a heavy shake instead (thicker shake). The heavy shake would be in keeping with the period of this structure and have more longevity.

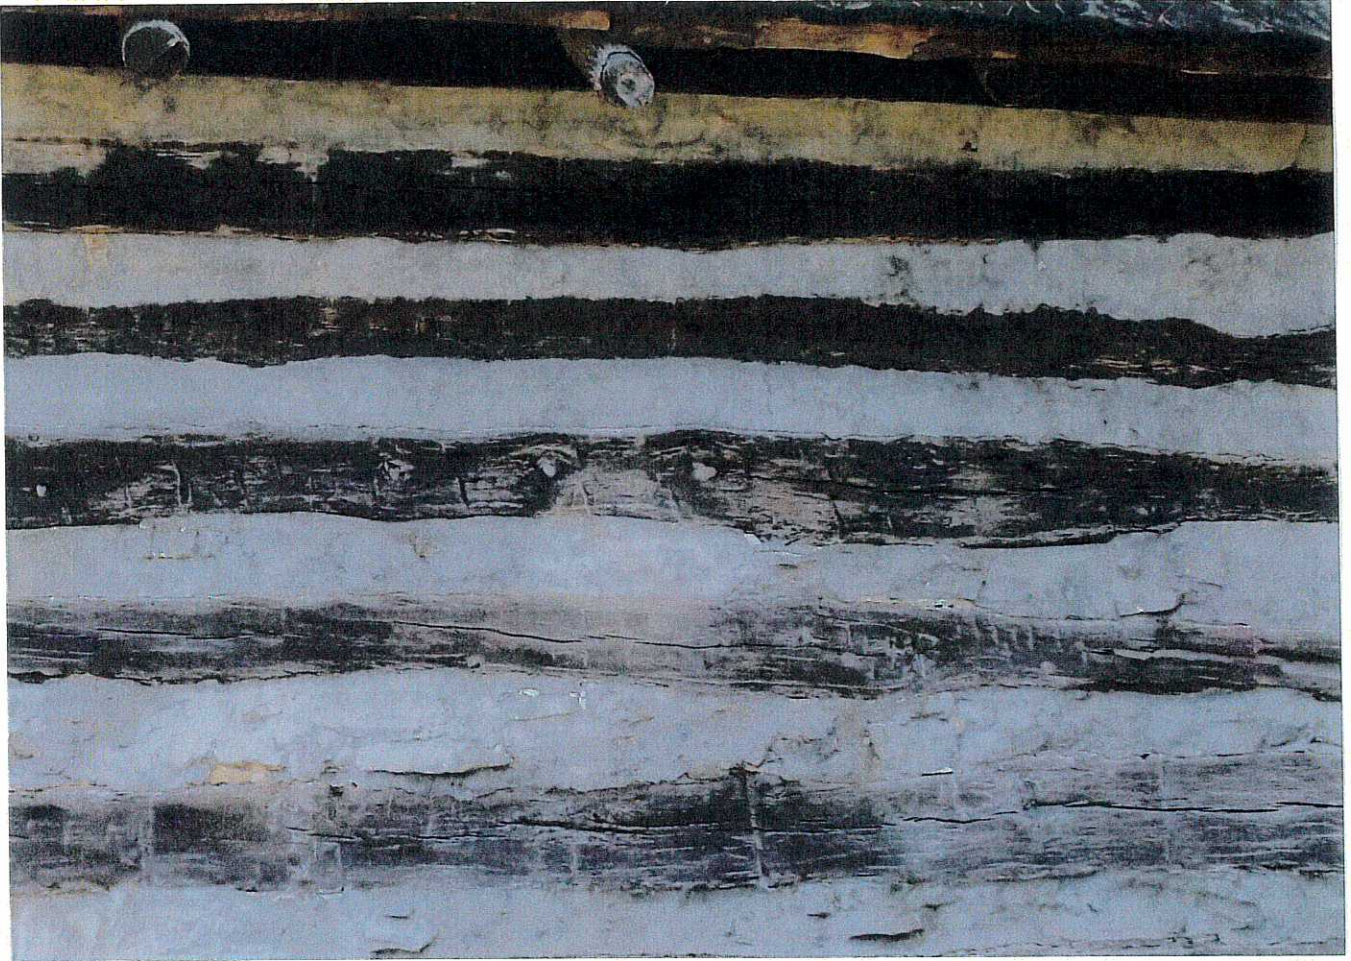
- 13) **Chinking:** Overall the chinking is in pretty sound condition. Although, it is not properly tucked in on the underside of the logs to allow the water to run freely down the wall and not get caught by chinking and run inside. To replace the chinking would be one of the most expensive aspects for this cabin. The inside chinking looks OK and is not subject to rain. I feel the outside chinking may be salvaged by chipping off the existing mortar parging and replace with new, tucking the upper edge under the log. Recommend doing a test piece in the rear.

- The chinking could remain but it is causing problems that we don't yet see.....recommend trying re-parging the exterior. It would be the most cost effective approach.

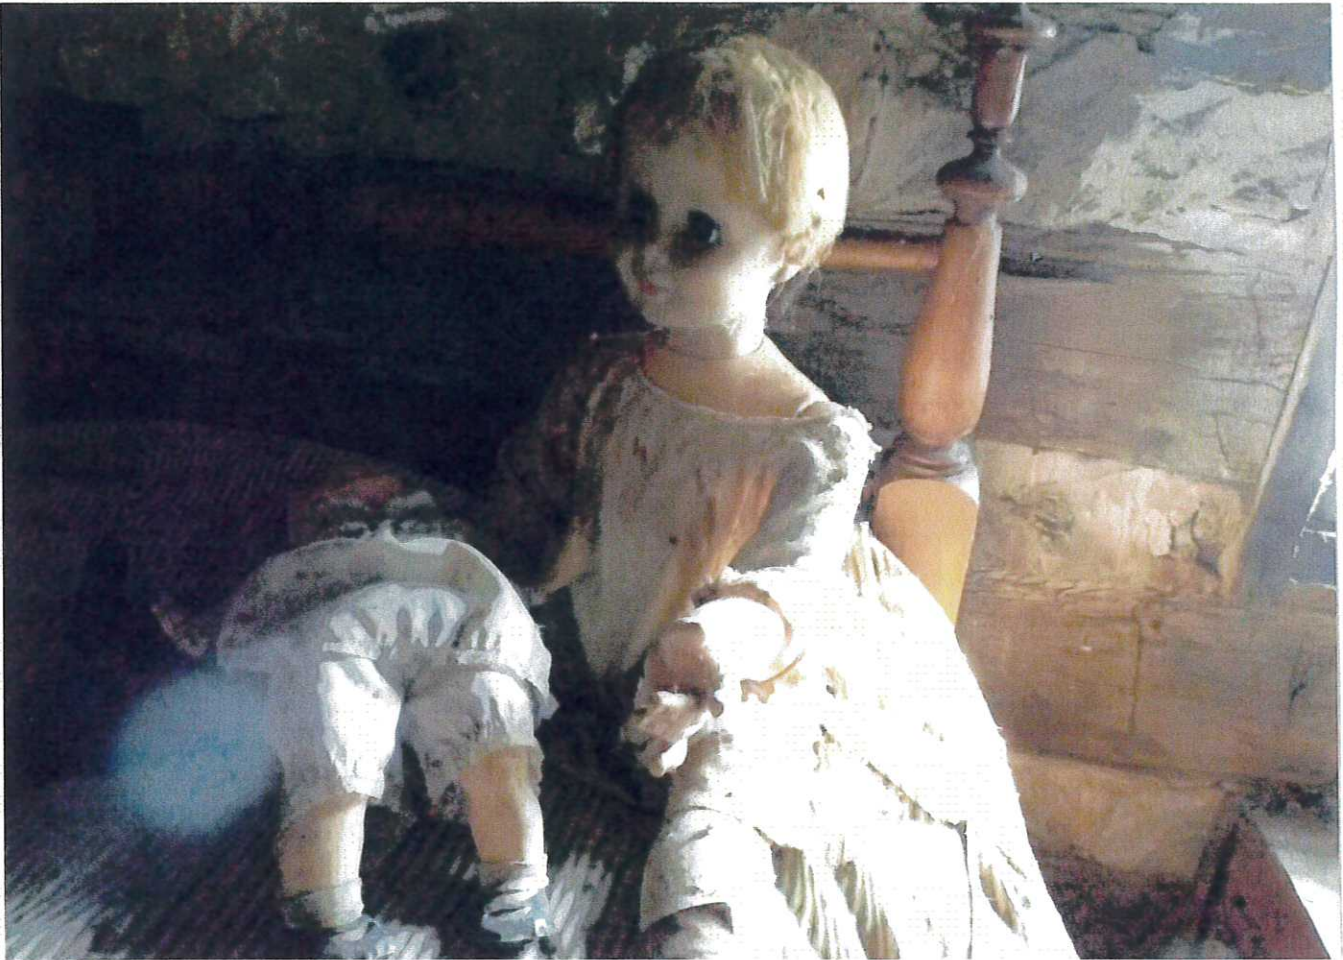
14) Remove spooky doll.

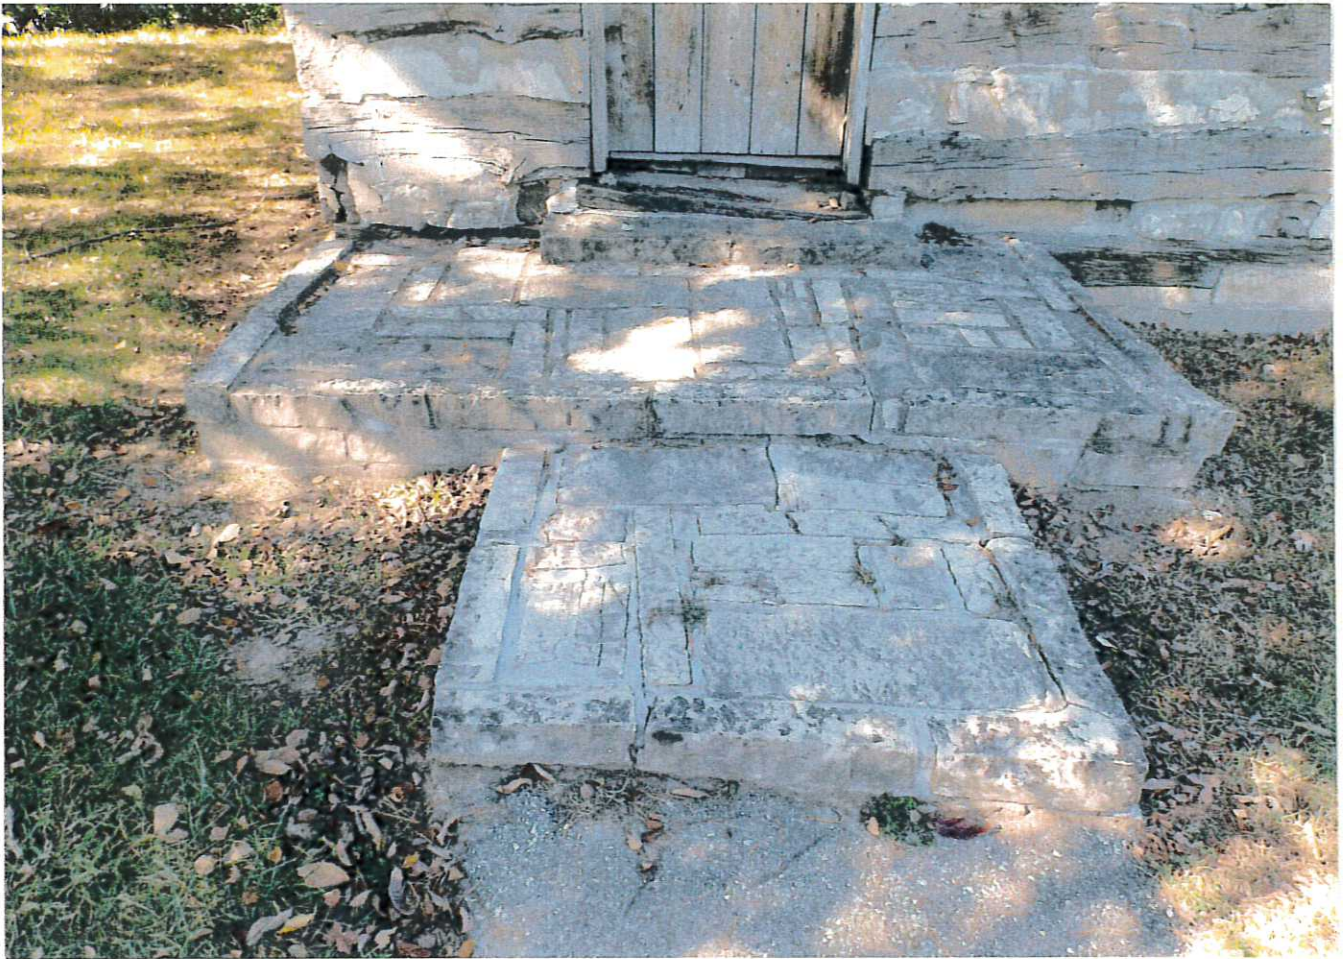
- 15) Stone walkway and steps: The existing stone entry is in good condition, though not ADA qualified. In addition, the stone work covers about one half of the front sill (log 1-1). This causes a very wet environment for the sill as well as no opportunity to inspect and apply treatments. **IF** the front sill needs to be replaced, it will be nearly impossible to do so with the stone work in place. I would recommend removing the stone work and install a ramp that will not trap moisture against the sill. (see Oge cabin at Drace park, Town & Country)

- The stone walkway *could* stay but the log sill (1-1) cannot be inspected and I fear it has issues. This is a load bearing log, supporting the floor system. The stone approach is not authentic and should not be touching the building.

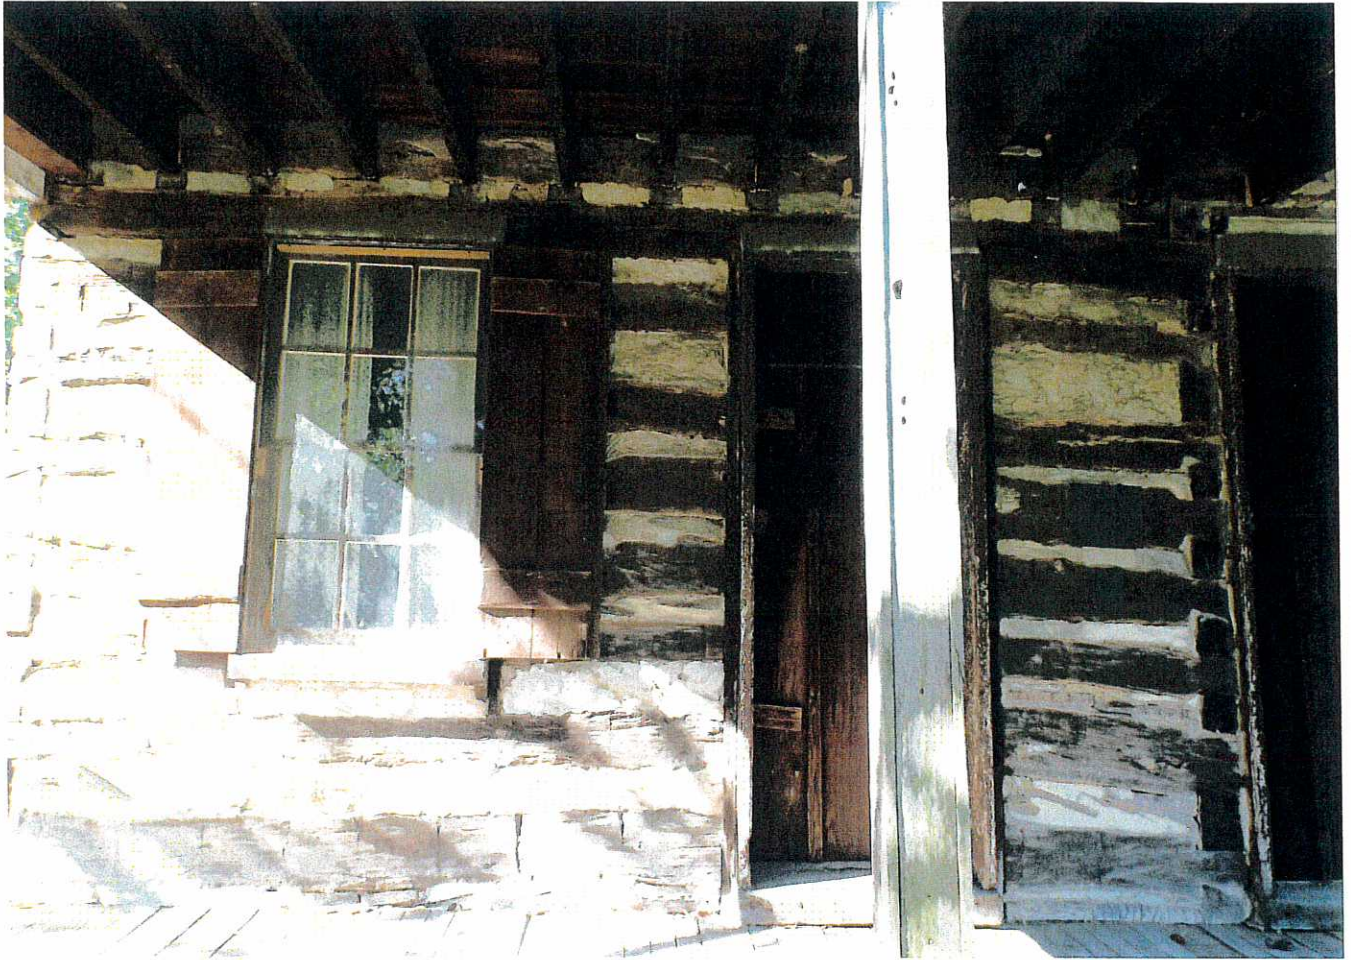
**Cabin 1**

**Wall 1:** logs are in very good condition.

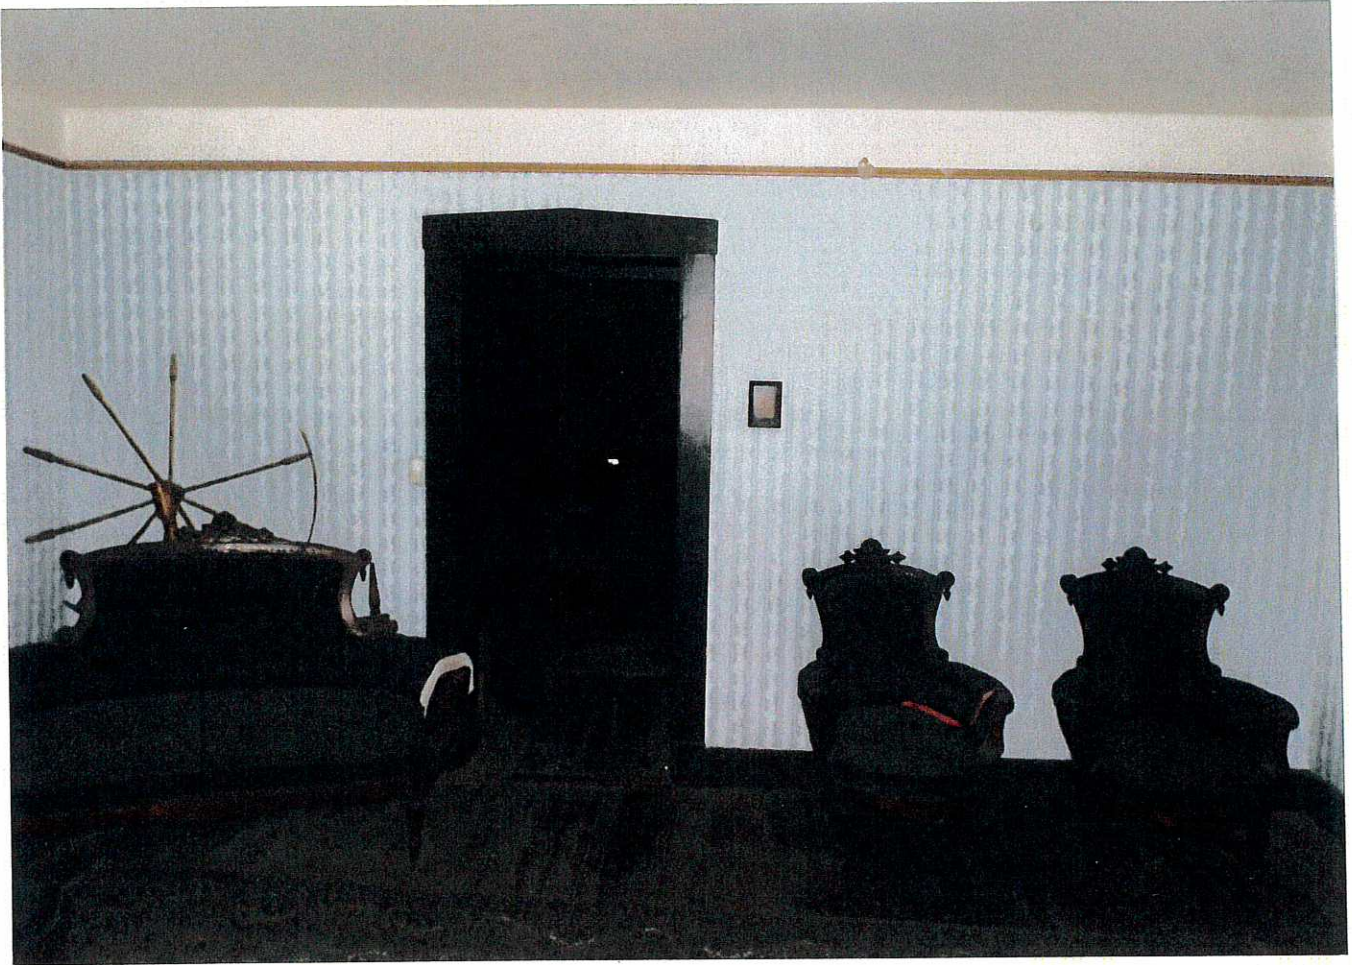
**Wall 2:** Interior wall. No issues visible on this wall.

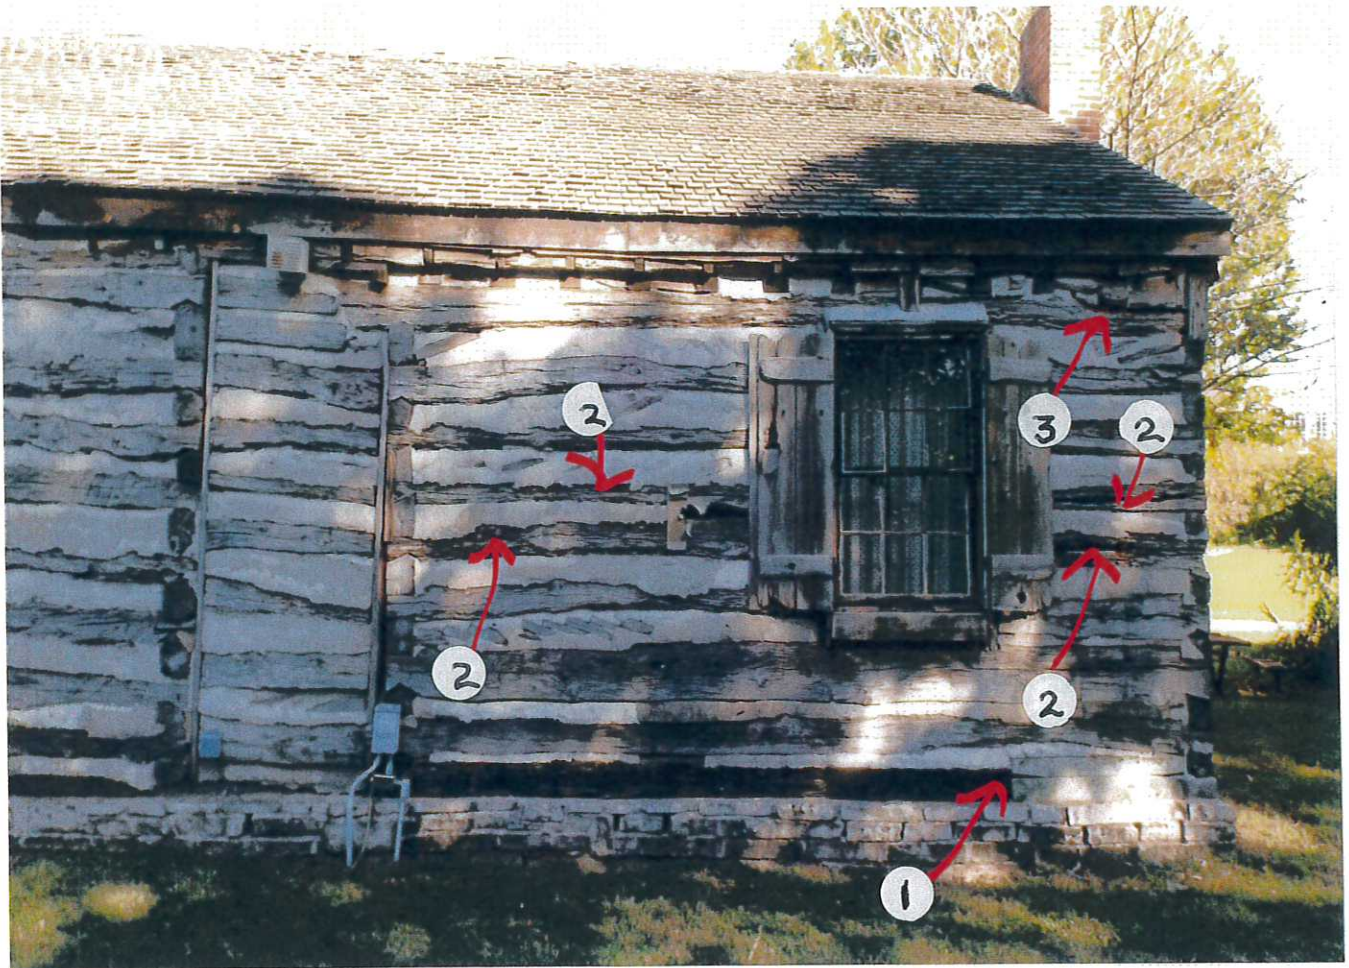
- 1) The sill log has been replaced prior using segmented timbers of different sizes. They appear to be in sound condition and stable.
- 2) Logs 3-5, 3-6, 3-10 and 3-11 need to be replaced with like logs.
  - A. **Option one**) This must be done very carefully, not harming the plaster interior.
  - B. **Option two**) If the interior half of the log is sound, it is acceptable to replace only the outer half with a new log face using like logs in order to protect the plaster.

- 3) Log 3-14 sounds punky on the right end. Recommending drilling a small test hole(s) to get a feel for its condition and probing the interior. Replace rotted section as needed with a like log.
- 4) The remainder of the logs on this wall are solid but cosmetically unattractive.

Choose which approach is less aggressive. Borate logs prior to install.

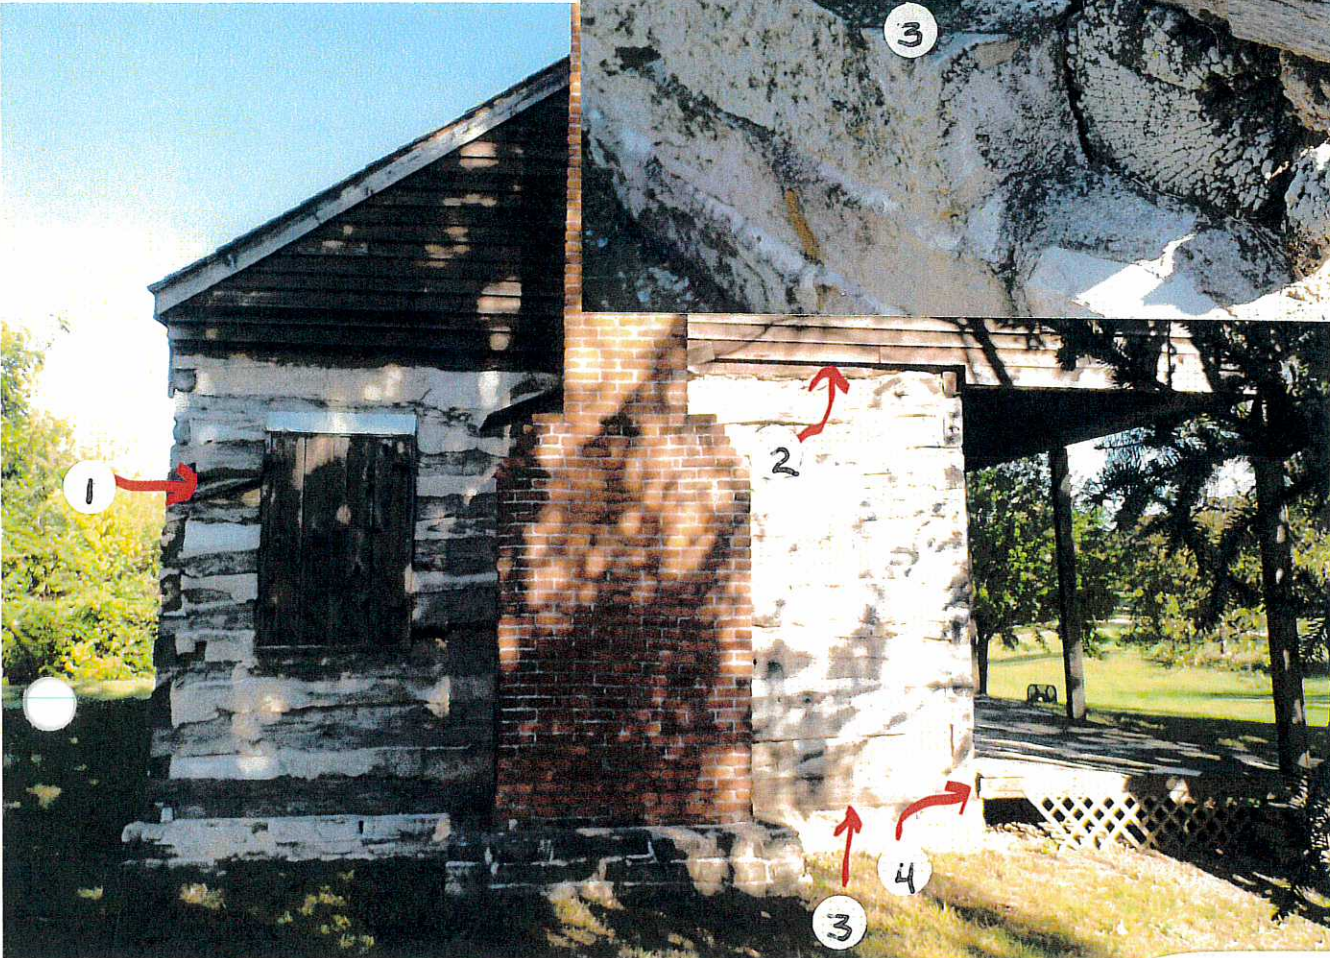
**Wall 4:** All logs are in stable and sound condition.

- 1) Two small rows of chinking are missing around the windows exposing the interior plaster to moisture. Chink spaces between logs 1-6 & 1-7 and between logs 1-3 & 1-19; clean and re chink.
- 2) One piece of lap siding has blown off. Replace. (missing piece is resting behind the chimney.)
- 3) The foundation is larger than the cabins, leaving an exposed portion of foundation top with logs sitting on top. This is a water trap and should be flashed or at a minimum sealed with a quality sealant.
- 4) Log 1-10: remove concrete repair at logs end, clean and borate then replace with epoxy repair, tooled to look like surrounding log.
