### **Historic Building Assessment**

Tim Kilby, the proprietor of the Country Gentleman Historic Restorations and Woodwright Shop, will present his assessment of the Clester Cabin, Hackmann Cabin, and Lake School House. The Parks and Historic Preservation Committee has been invited to participate in the discussion.

## *Clester Cabin in Conway Park*

## *Hackman Cabin in Conway Park*

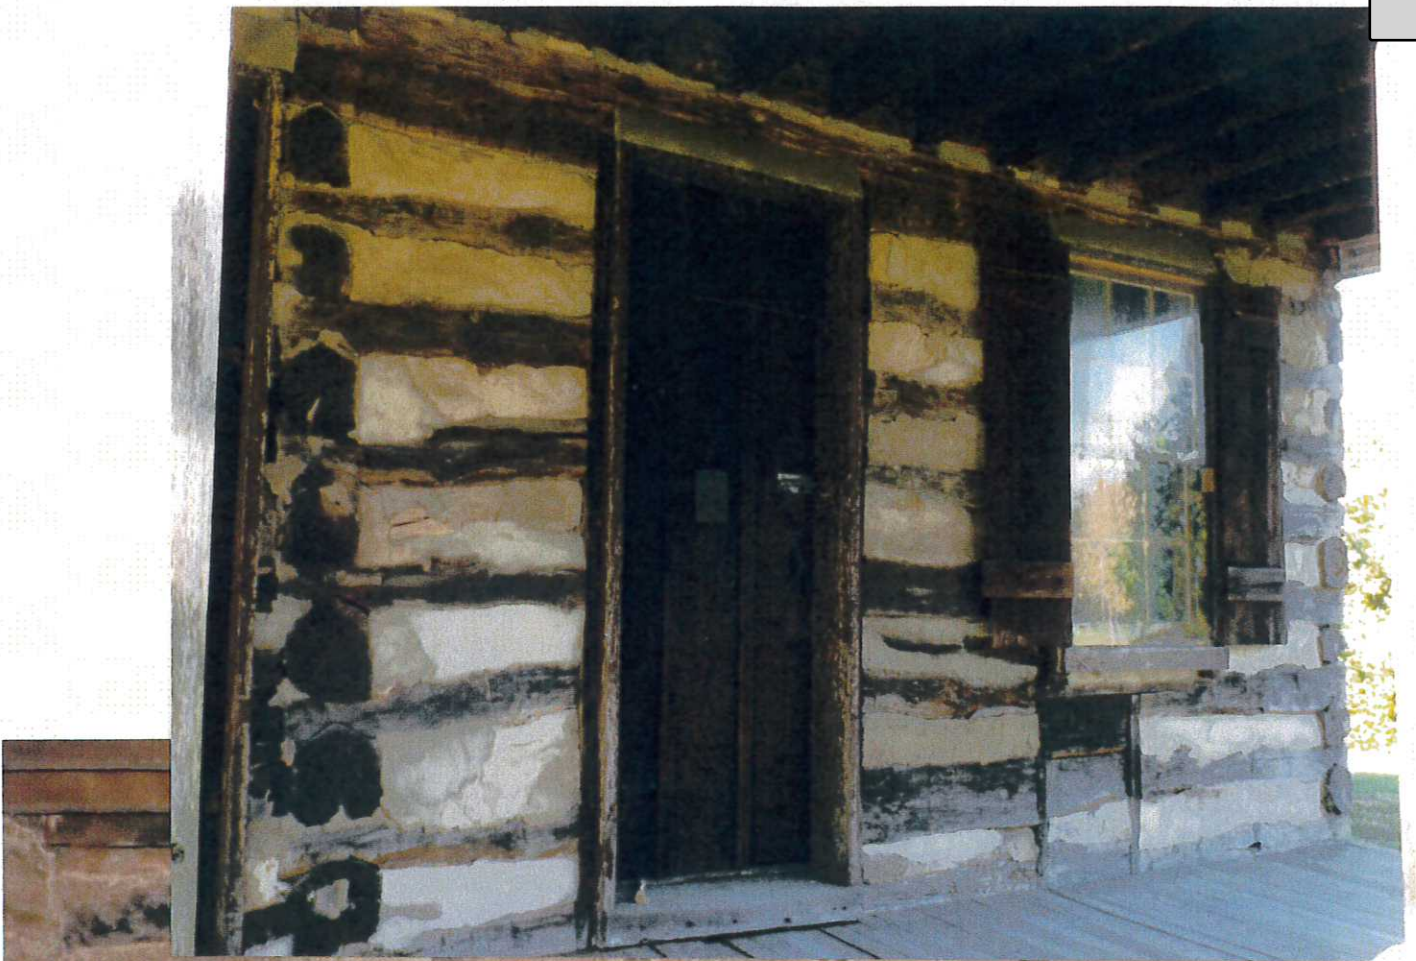
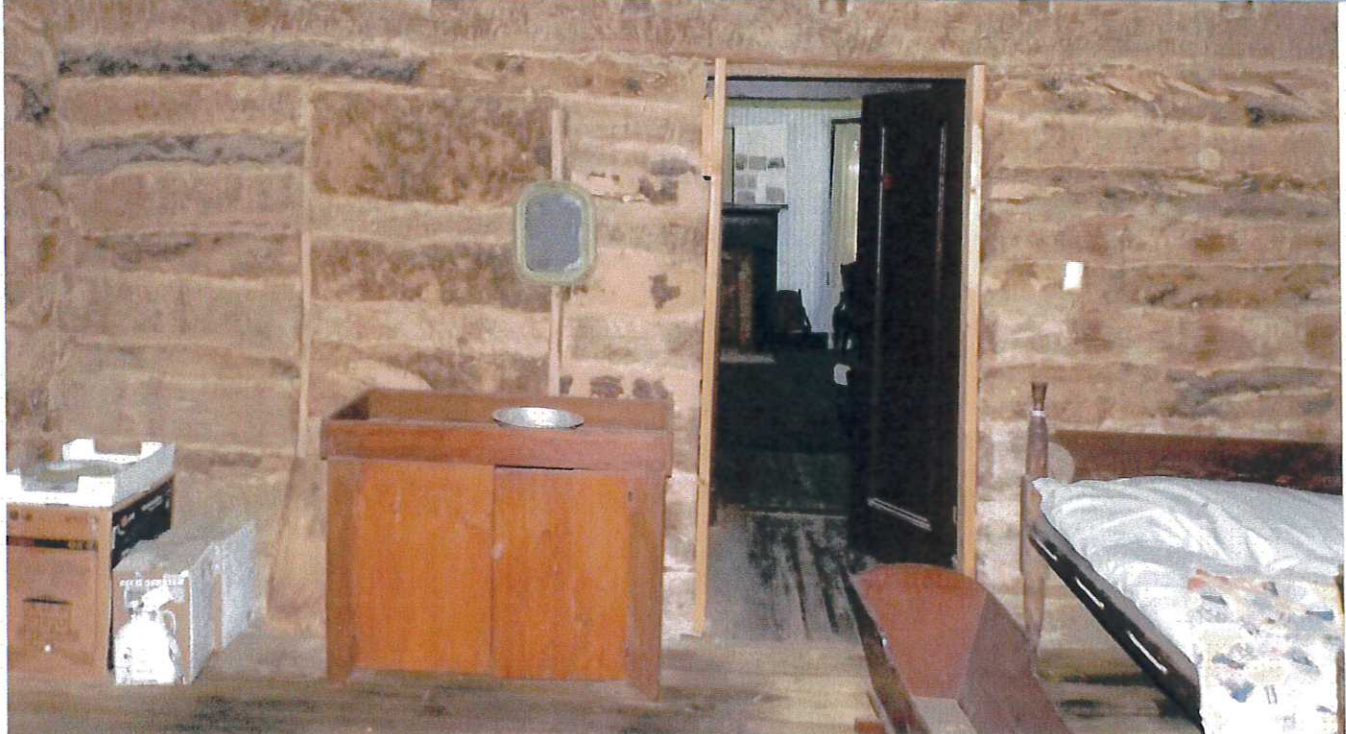
### Cabin 2

Wall 1: No log issues on this wall

Wall 4: Interior wall. No issues on this wall.

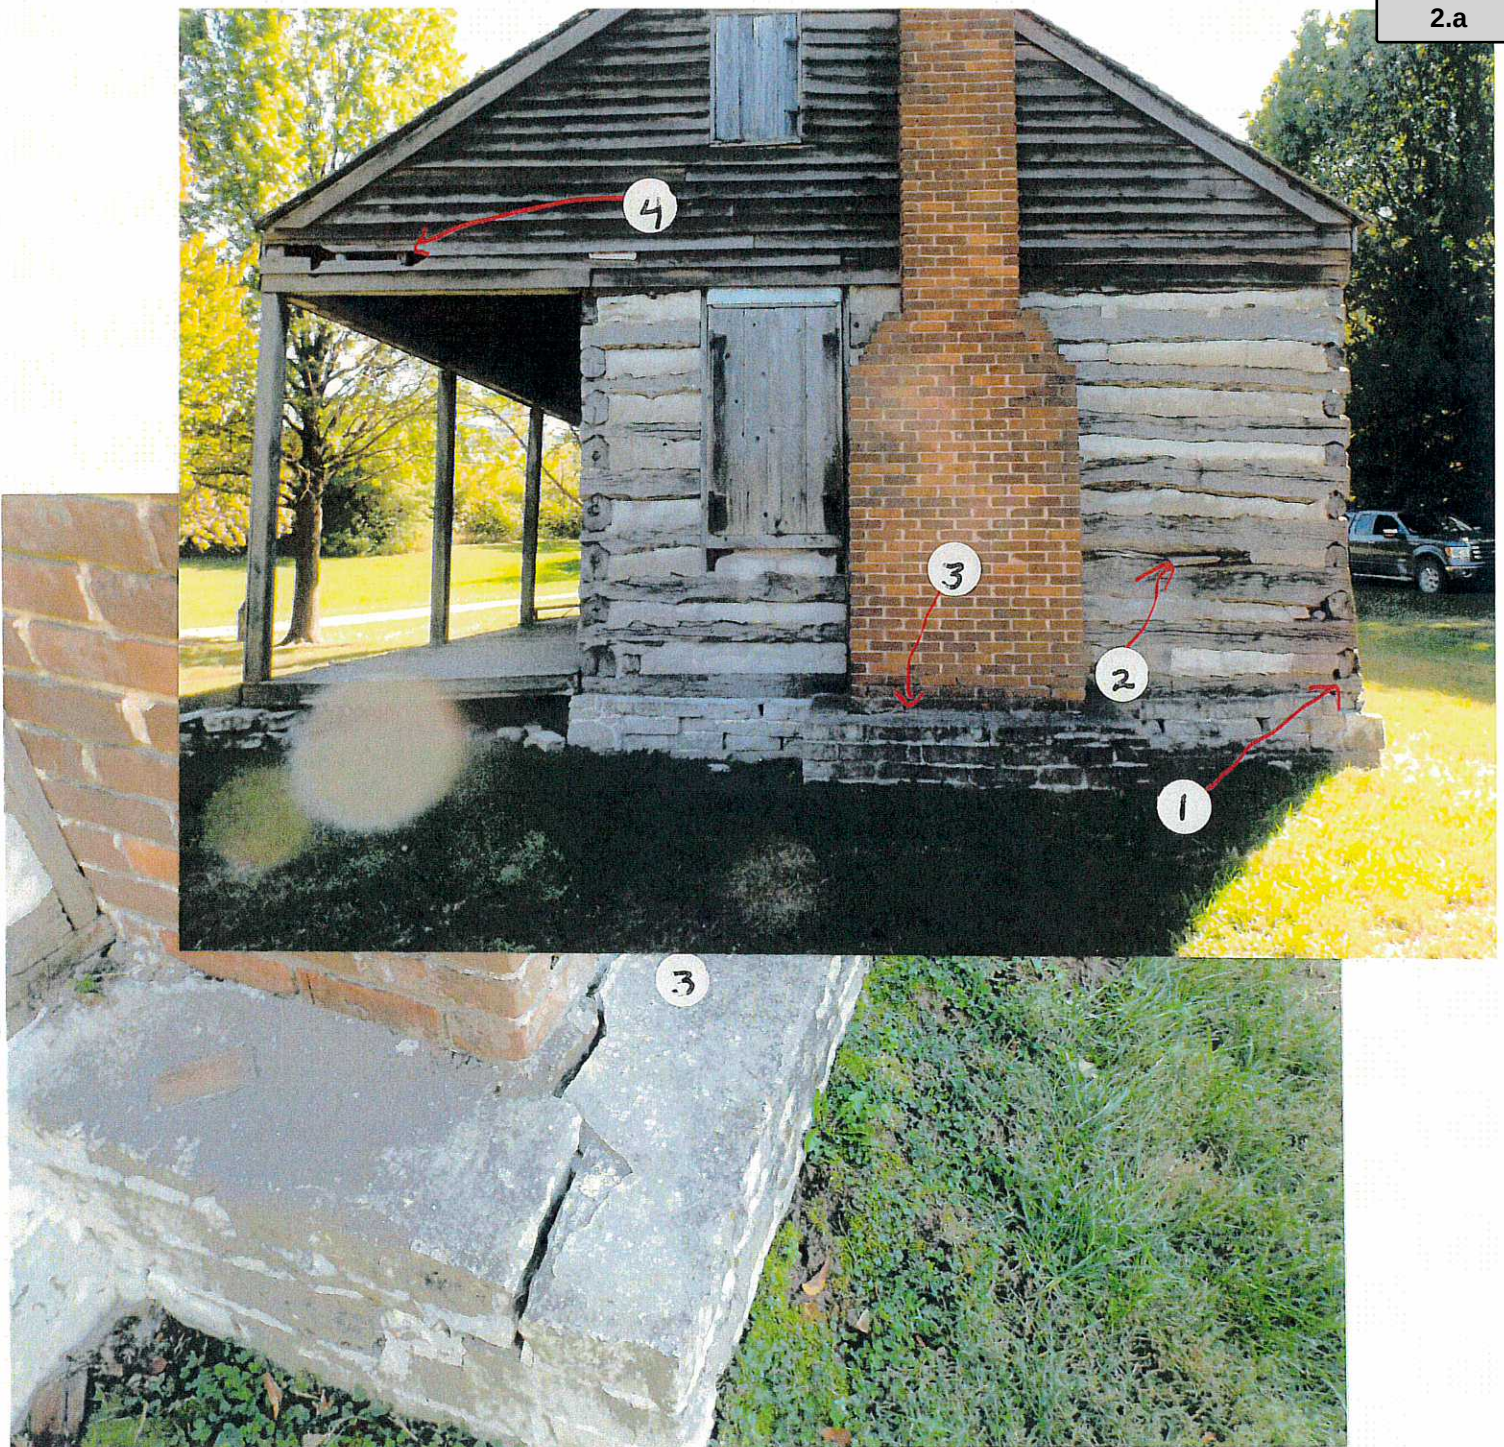
**Wall 2:** With the exception of issue one (log 2-10) logs are sound.

- 1) Epoxy repair void on end grain of log 2-10. Clean void and borate prior to applying epoxy system.
- 2) Re-chink all voids without chinking. Clean and borate void prior to chinking.
- 3) Fireplace footing has large cracks on the top and edge faces. Properly fill voids with mortar and/or masonry epoxy.
- 4) Replace any missing or overly worn lap siding.

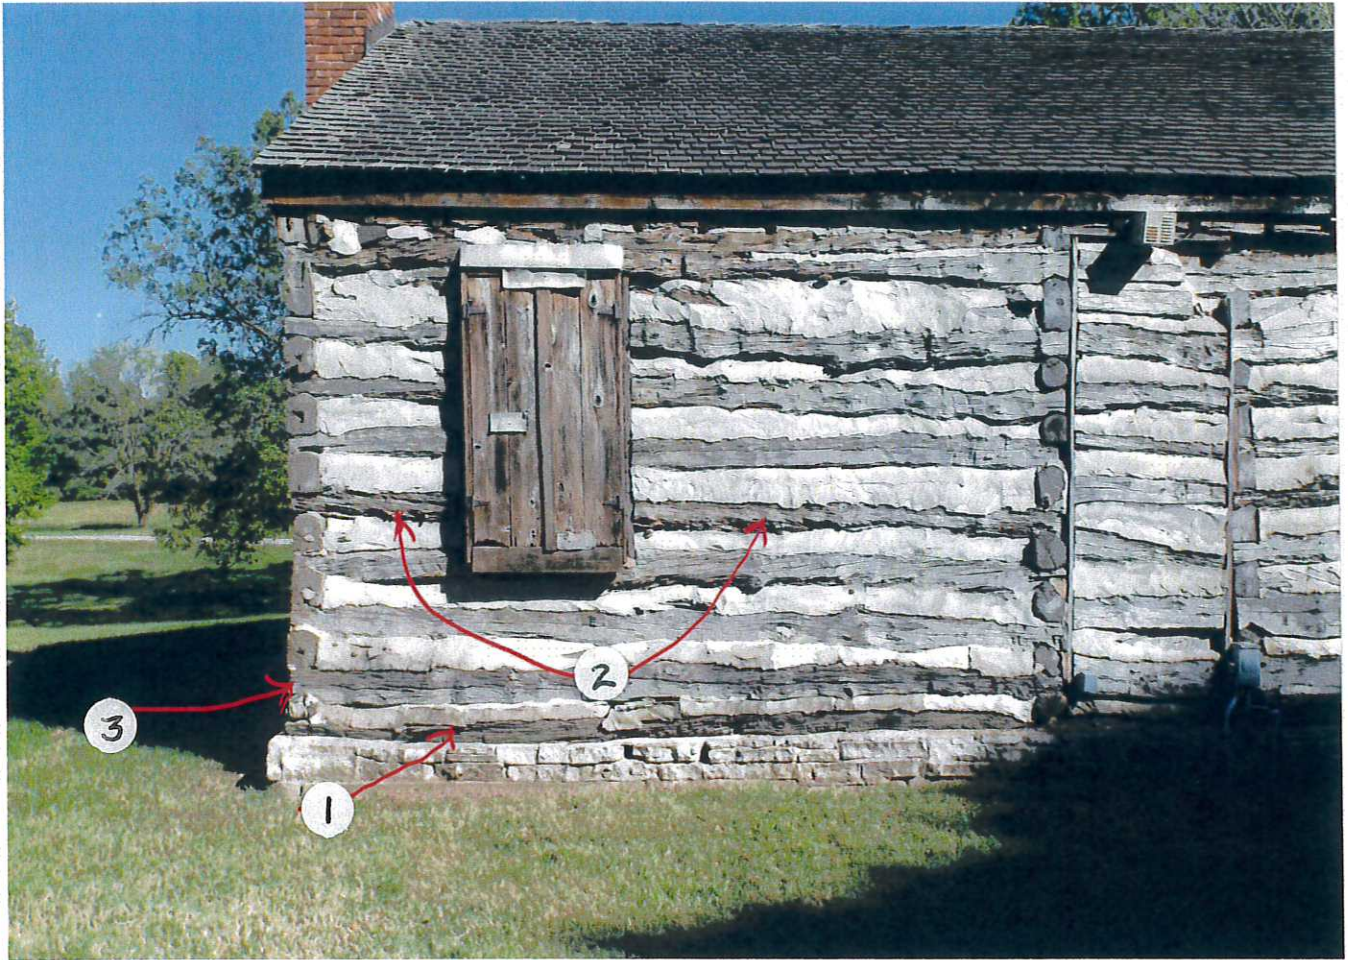
- 1) The entire sill (3-1) needs to be replaced. New sill should be of sound period timbers, if not available, new timbers measuring approx. 7" x 9" x 16' sawn from new white oak logs. Chinking will have to be removed to replace any logs in this cabin. Original chinking is mud. Replace with same leaving texture same as original daubing. Borate new logs prior to install.
- 2) Logs 3-5 and 3-11 are structurally sound but extremely weathered. Option to replace for cosmetic purposes with like log.
- 3) Log 3-2 has begun to hollow due to split in end grain of log. Clean out old wood, borate and epoxy repair void. Tool new repair to match existing log end.

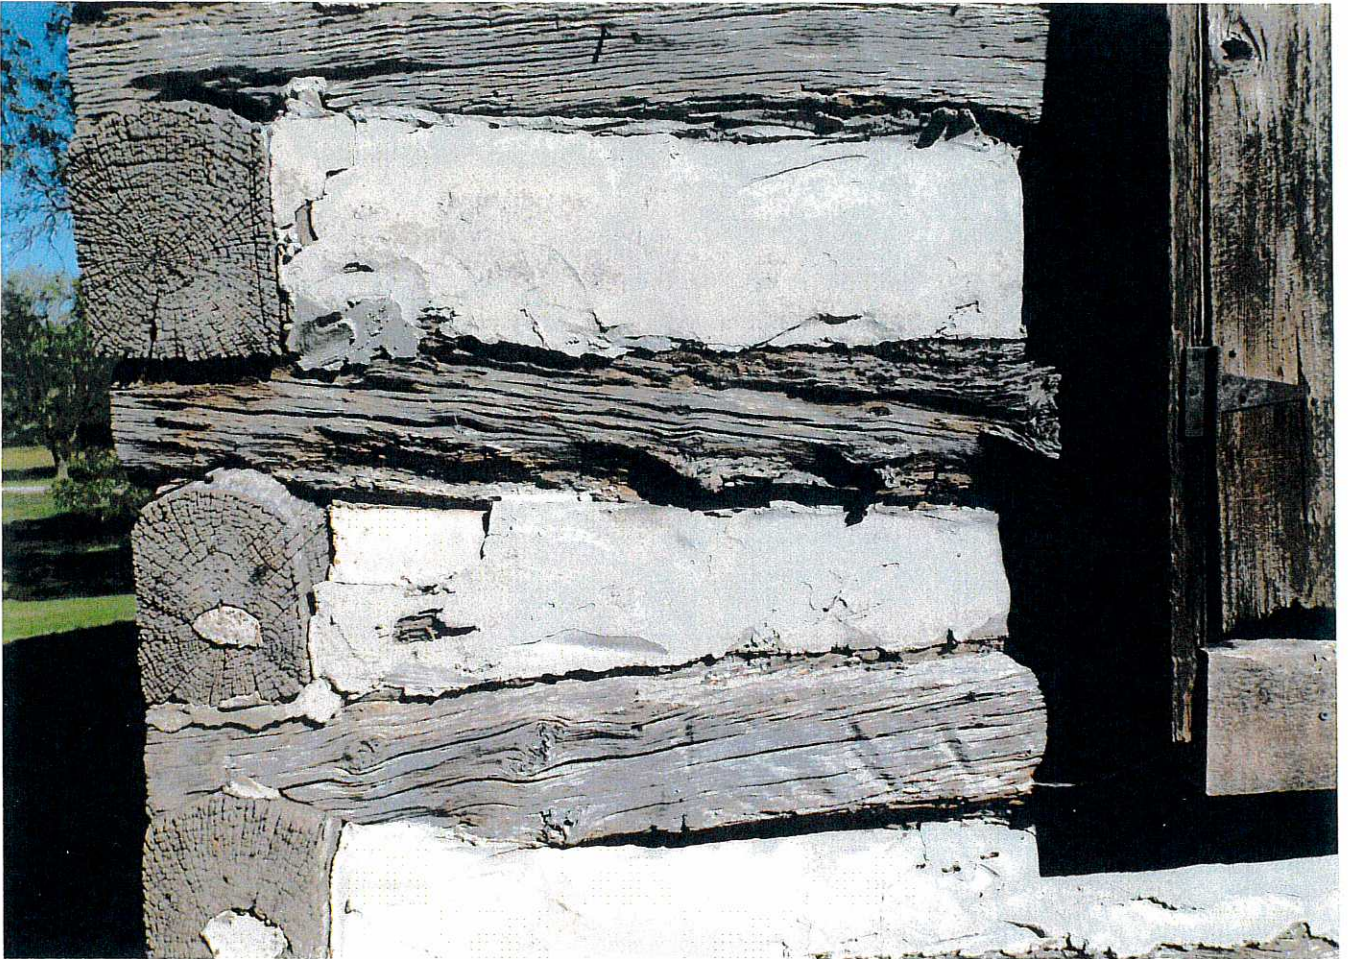
The exterior chinking on this cabin is a detriment to the longevity of the structure. As the logs have lost girth over the years, the chinking has been added layer by layer and is not water tight at all. In many areas the chinking extends past the face of the logs allowing water to come down the wall and be drawn into the building. This must be addressed.

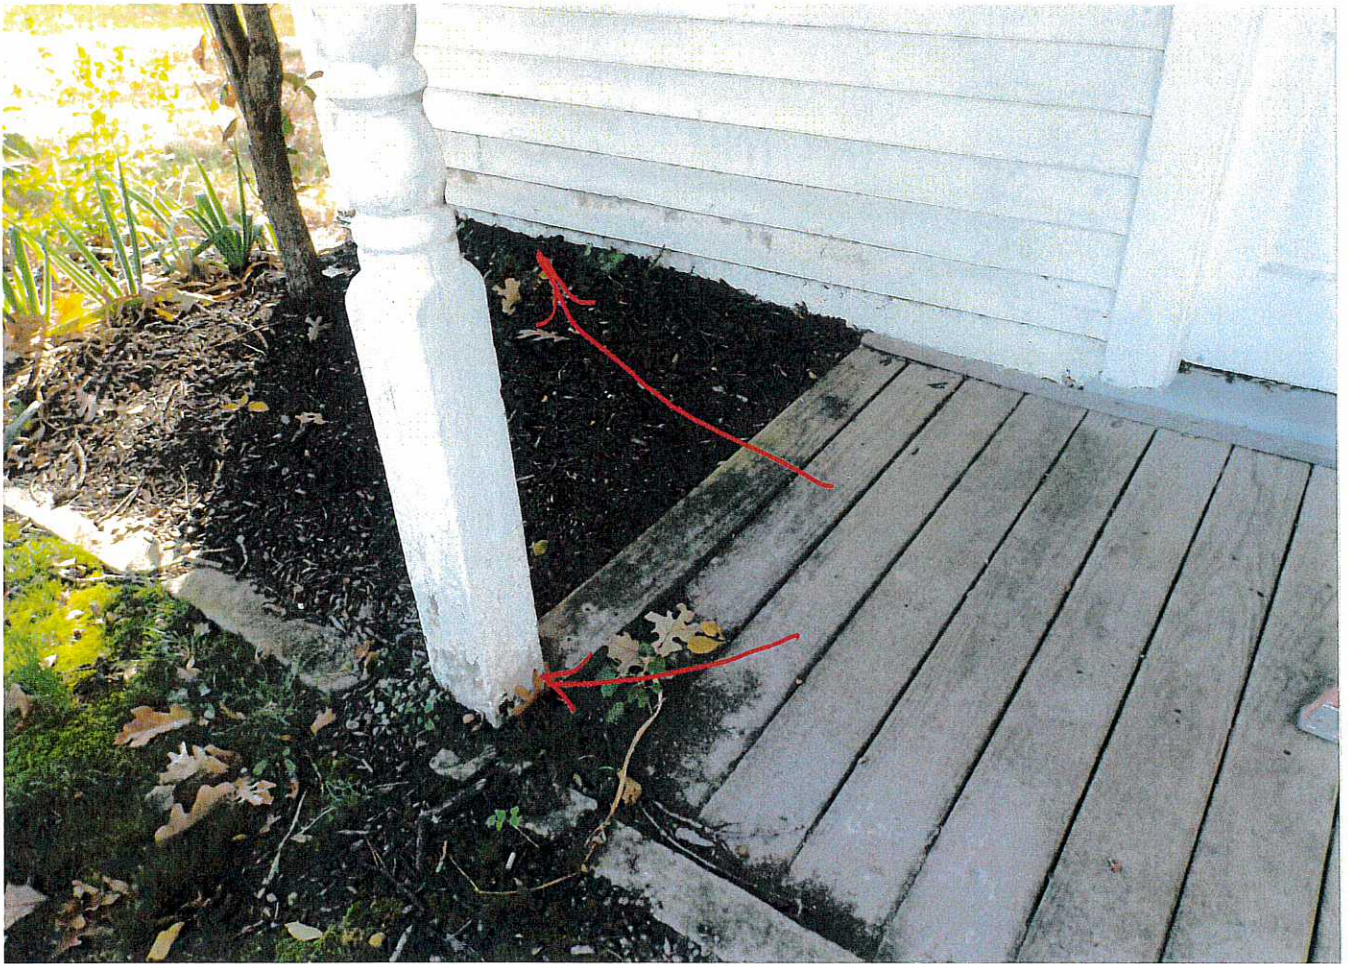
- 1) The grade on the front elevation is about 1' (foot) too high and dirt is up against the structure as well as the deck and porch post sitting in the dirt. The entire front needs to be re-graded so water flows away from the building. Rebuild the entry approach with either treated wood or masonry, with raised masonry units under the porch post. Borate any raw wood newly exposed and paint.

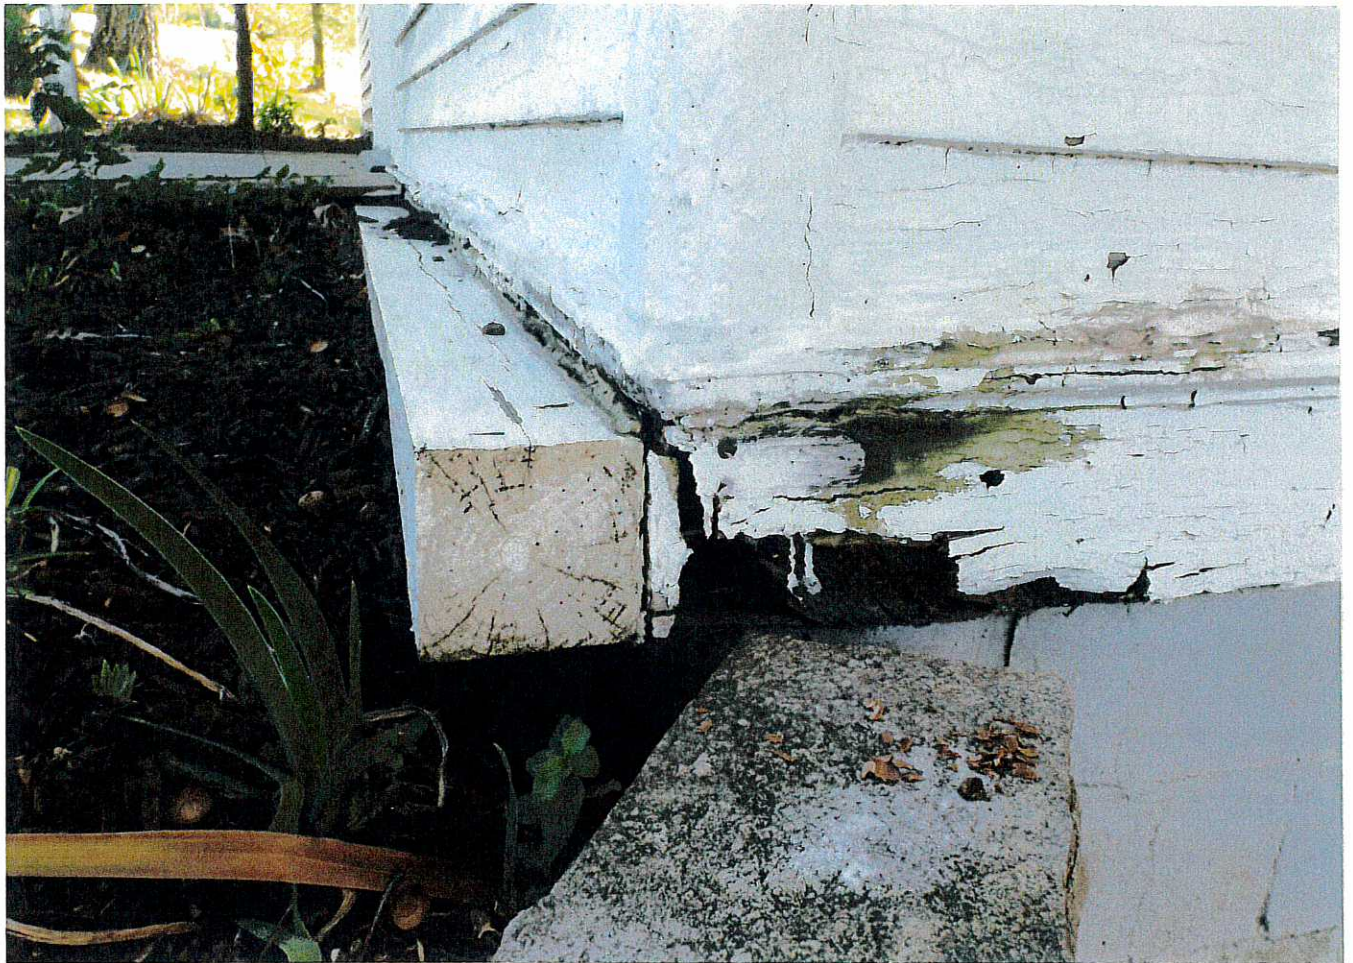
- 2) On the right side of the front elevation, a landscape timber has been placed against the wood water table of the structure. Remove timber and repair any damage hidden behind rotted water table. Borate all exposed wood prior to painting.

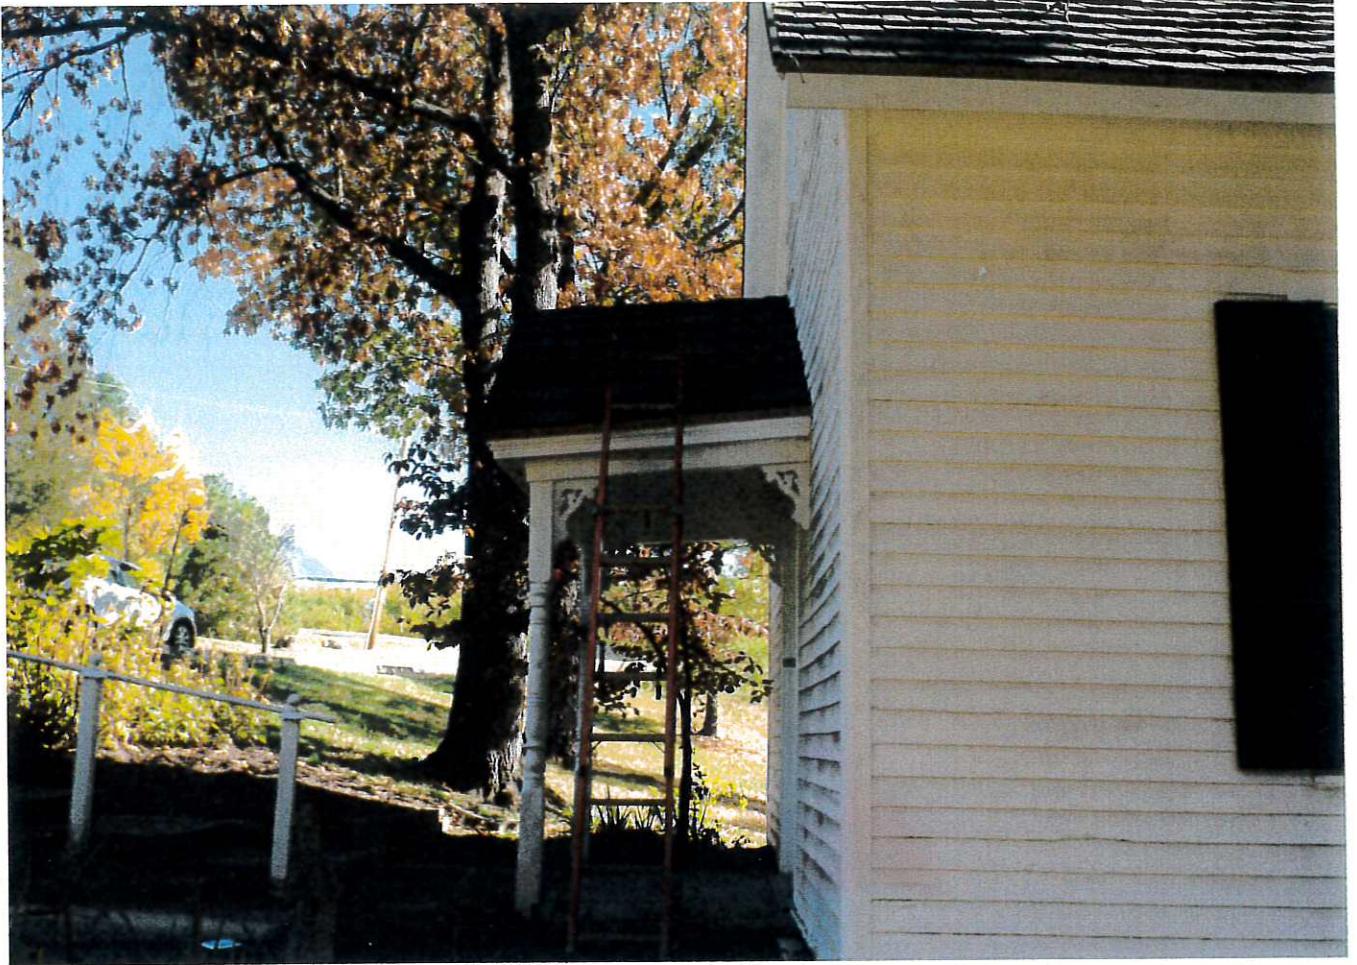
- 3) The porch post have either sunk or rotted at the bottom causing the porch's upper structure to be un-level. After the front has being excavated for its water issues, recommend *trying* to jack the porch to a level position. While doing this, be very aware of how the new roof is reaction to being moved. It may be necessary to stop jacking prior to getting it level. This is cosmetic and not a structural issue.

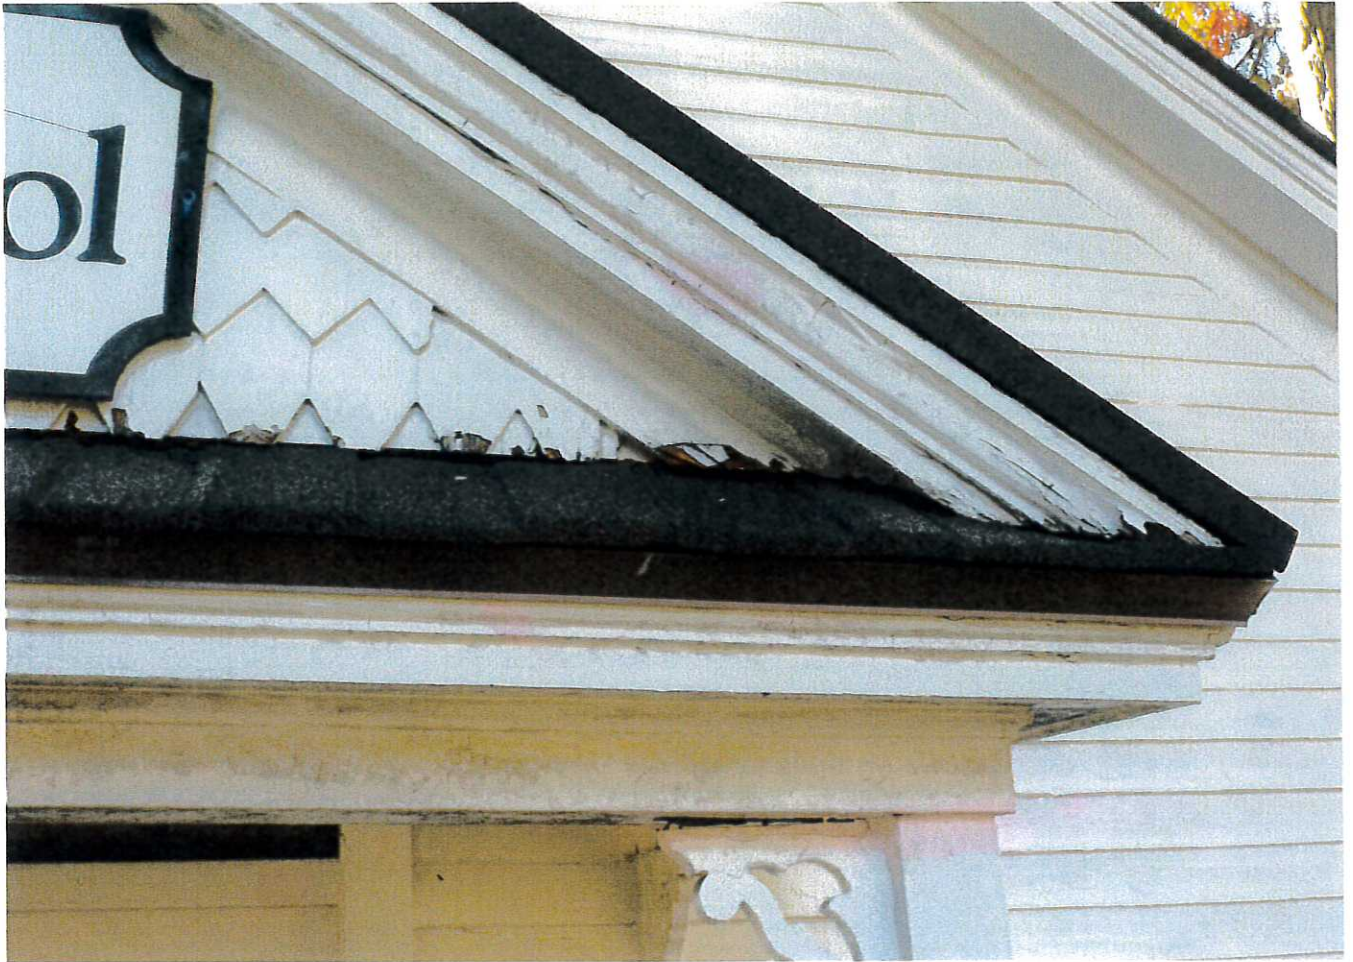
- 4) Throughout the structure there are several small pieces of trims and siding that have nicks, chipped areas and missing parts. This is cosmetic only. A lot of bad looking areas are merely missing paint. At a minimum scrape and repaint the structure. Replace worn wood parts as desired.

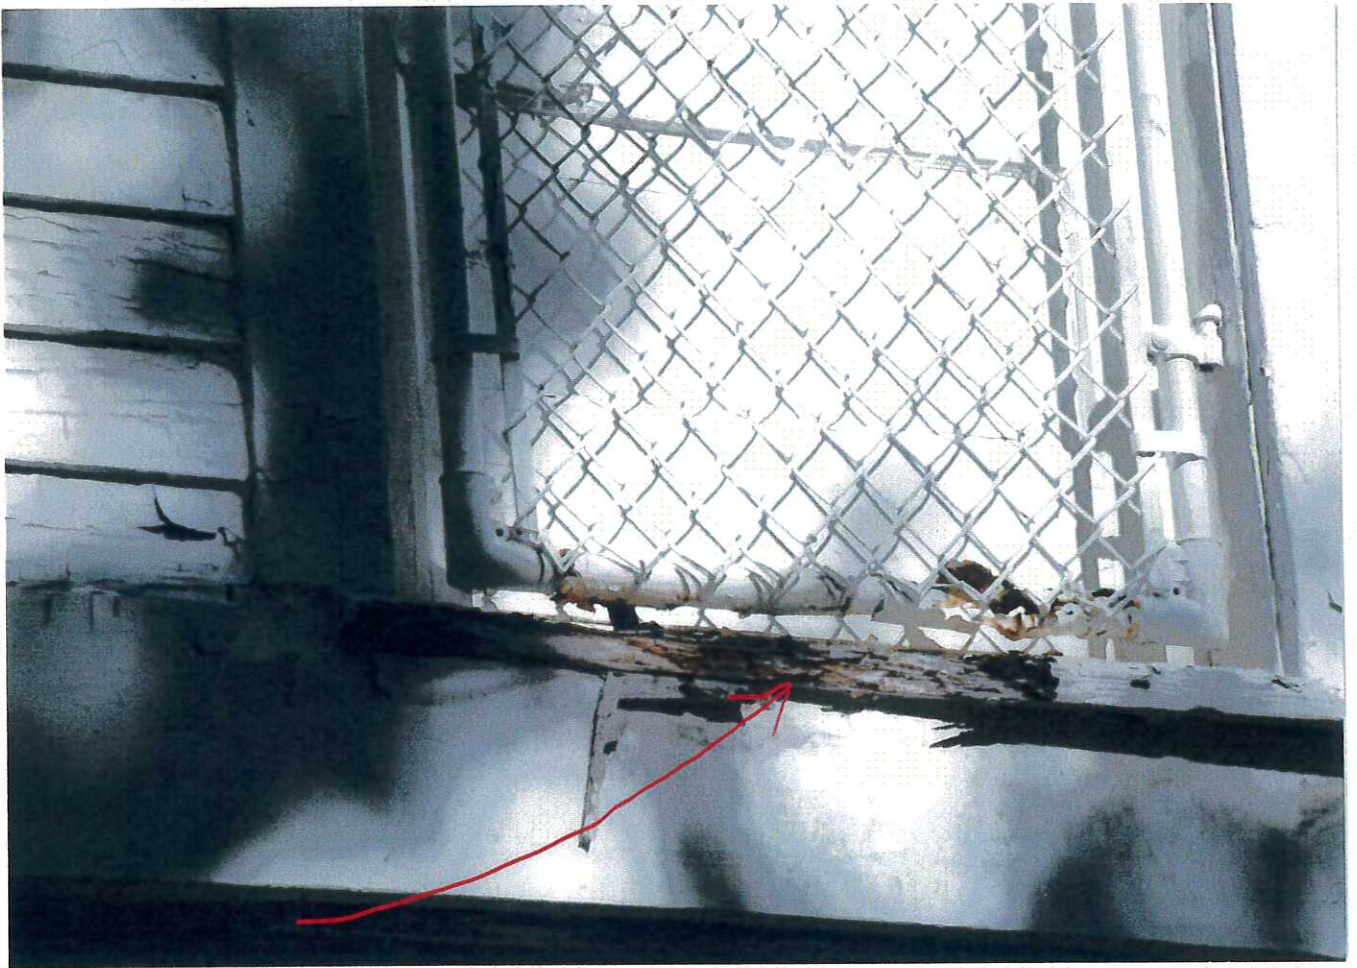
5) In the rear of the building, replace door sill.

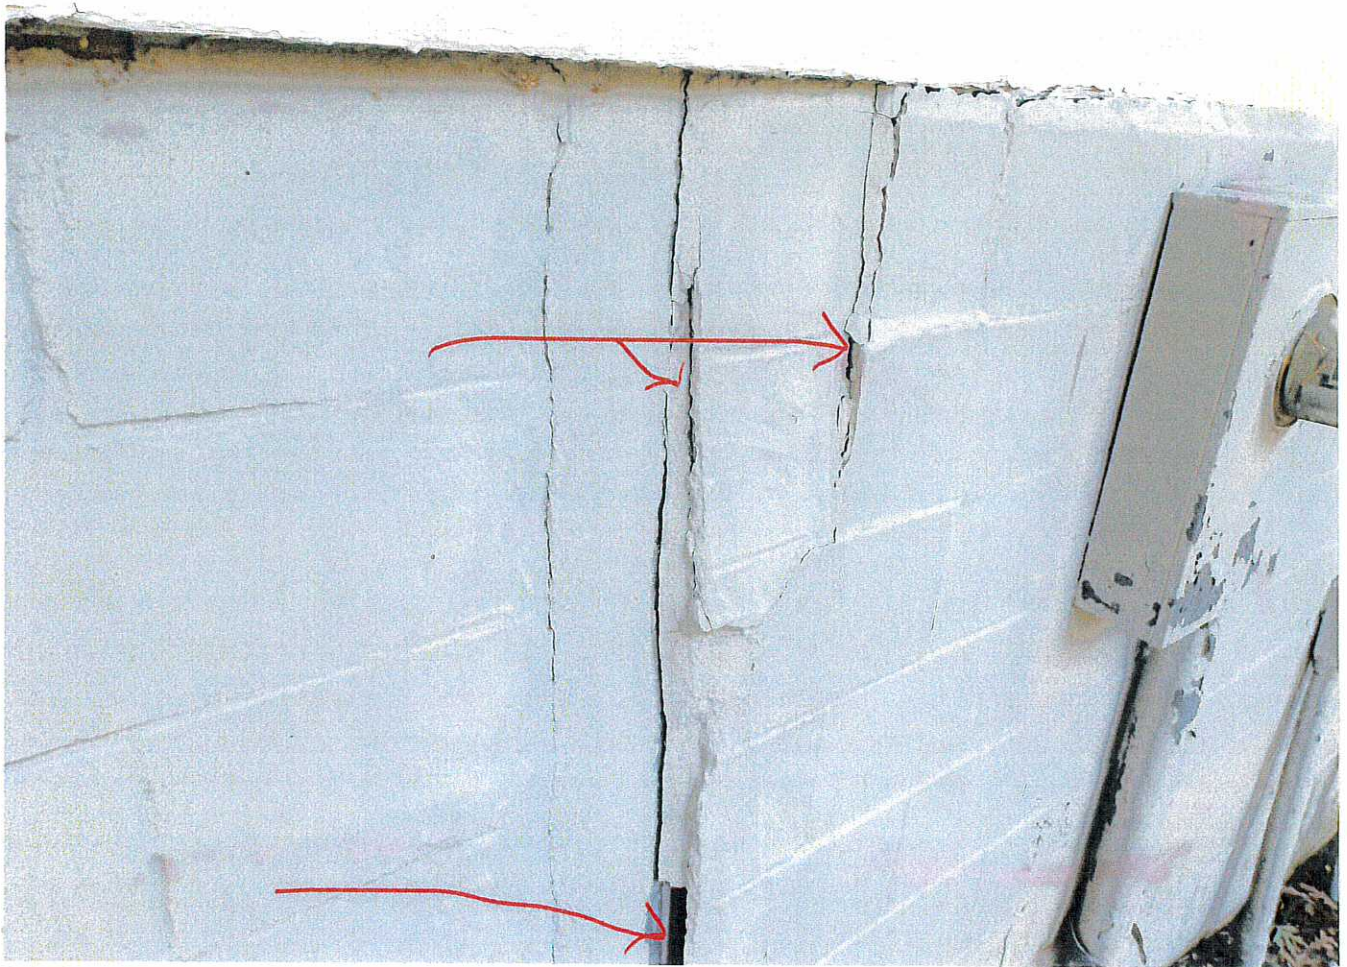
- 6) The block fill between the vertical piers has cracks in multiple places. Fill with Abatrons "Abocast 8007-2" or equivalent.

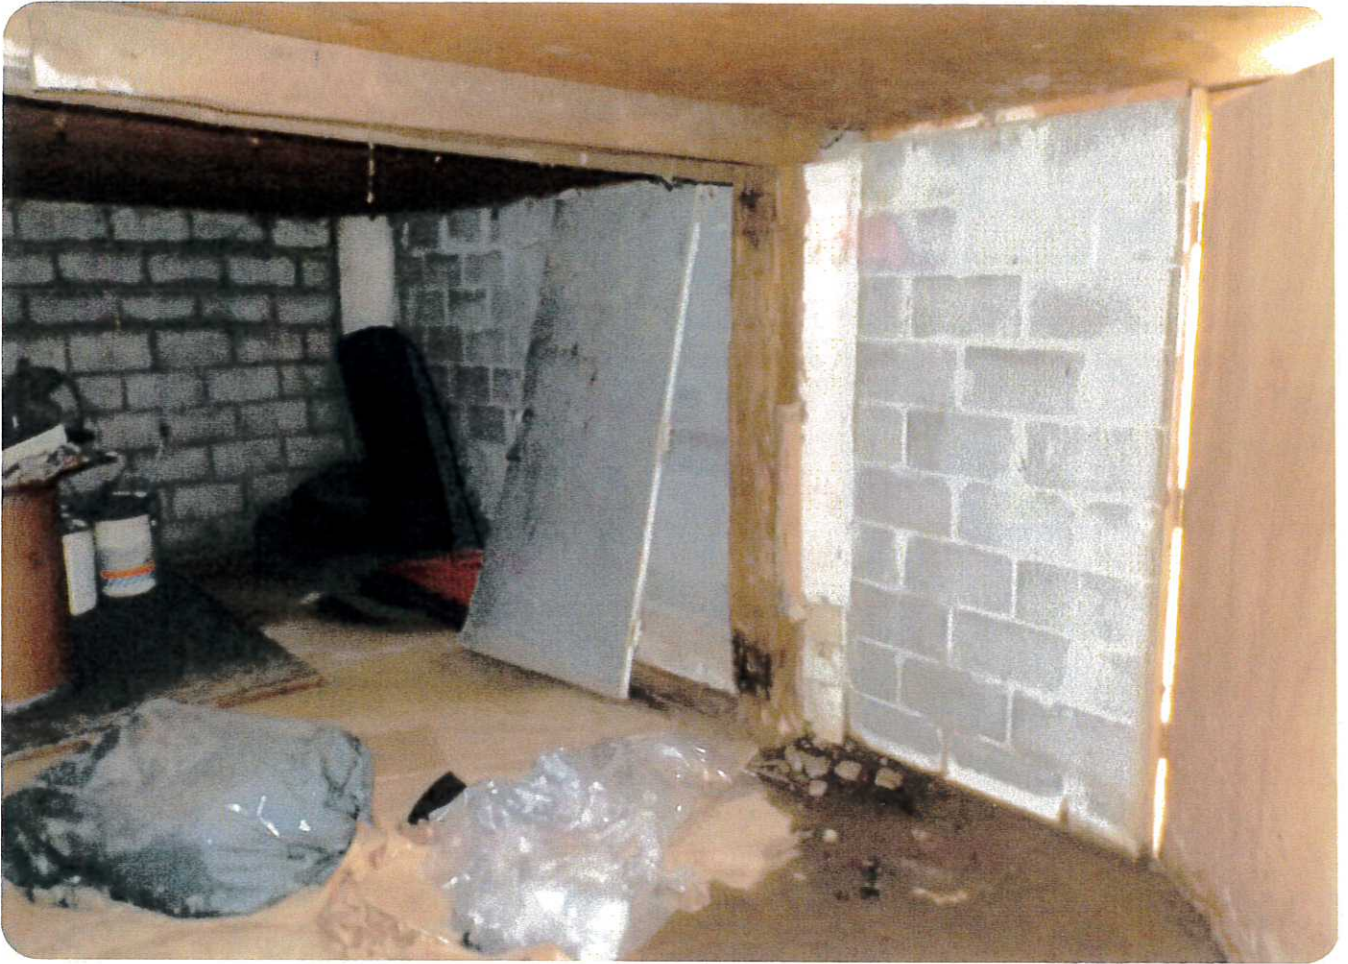
- 7) In the interior of the basement on the rear wall there is hewn post supporting the center carrier beam. This post is sitting in the mud which has accumulated on top of the slab, causing it to start rotting. Recommend removing the old post and replace with a new 8x8" treated post with a short header beam on top to span the width of the carrier beam. This new post to sit on a new masonry unit at least 8" high. Fasten post to concrete pier top and bottom as well as to the carrier beam. The post needs to be there due to inadequate bearing on the concrete pier.
