**AGENDA**  
**CITY OF CREVE COEUR**  
**FACILITIES TASK FORCE**  
**CITY OF CREVE COEUR, MISSOURI**  
**JANUARY 9, 2023**  
**10:30 AM**

## CREVE COEUR ICE ARENA ICE ARENA REFRIGERANT SYSTEM REPLACEMENT

**EXISTING BUILDING ASSESSMENT  
AND DEFICIENCY REPORT FOR:**

CITY OF CREVE COEUR MISSOURI  
BUILDING ASSESSMENT REPORT

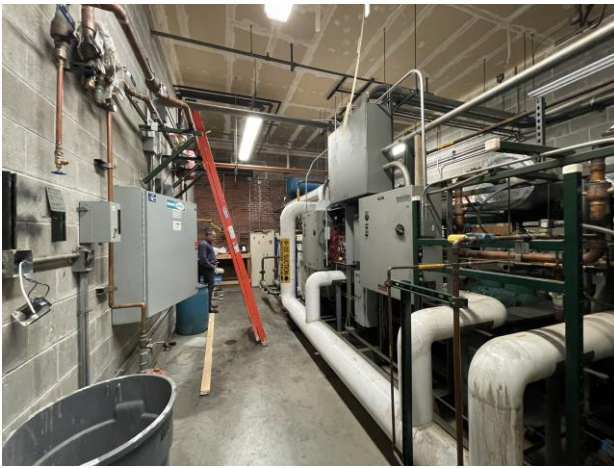
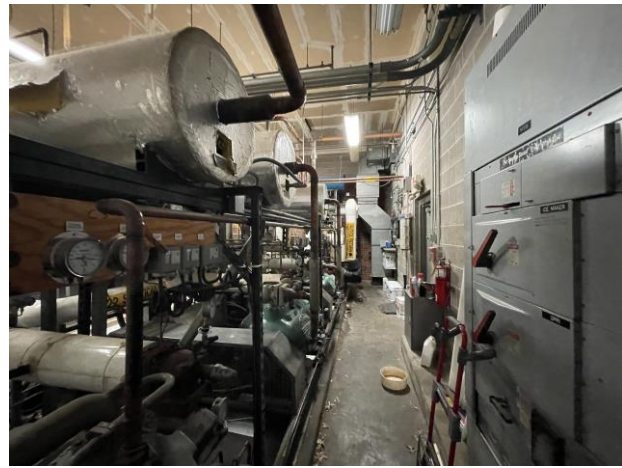
Photos 1 & 2 – Existing refrigeration system

The existing refrigeration includes: three Carlyle reciprocating compressors Model 5H120-A219 with capacity of approximately 20 tons each at a 0-degree saturated suction temperature providing a total capacity for the refrigeration system of approximately 120 tons; flooded-type plate and frame chiller system with two plate and frame chillers and one surge drum; rink floor pumps, one evaporative condenser, a control system and a waste heat recovery system. The existing system is considered a “skid package” system where the majority of the components are built and delivered on a single steel frame or “skid”.

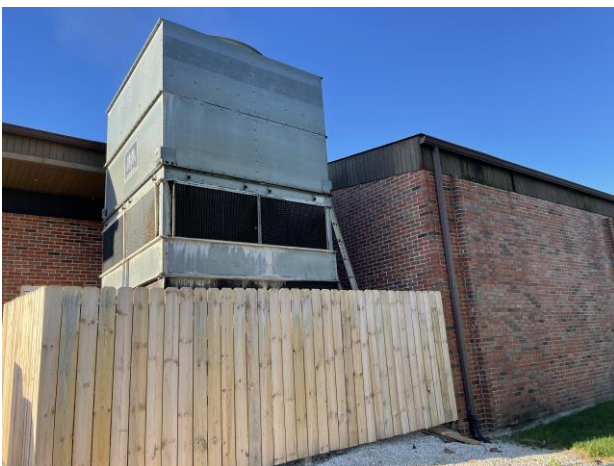
Photo 3 – Existing evaporative condenser

There is a waste heat recovery system that serves the subfloor heating system under the rink floor and the snowmelt pit in the resurfacer room. This system essentially provides free heat from the refrigeration system. The subfloor heating system is reportedly in good working order and there are no concerns with frost building up under the ice rink floor. The snowmelt pit heating system is reportedly performing well.

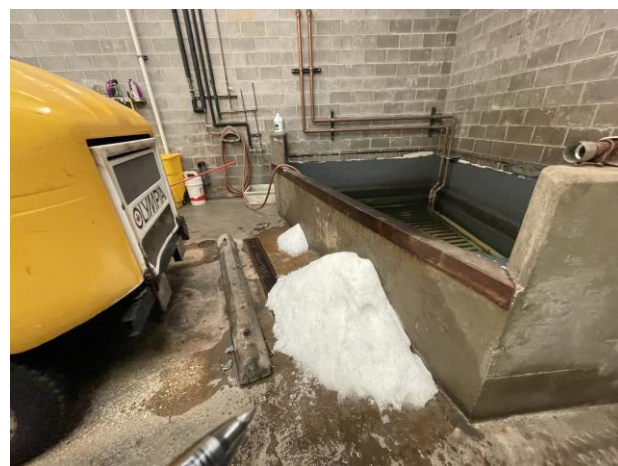
Photo 4 – Existing snow melt pit and coil

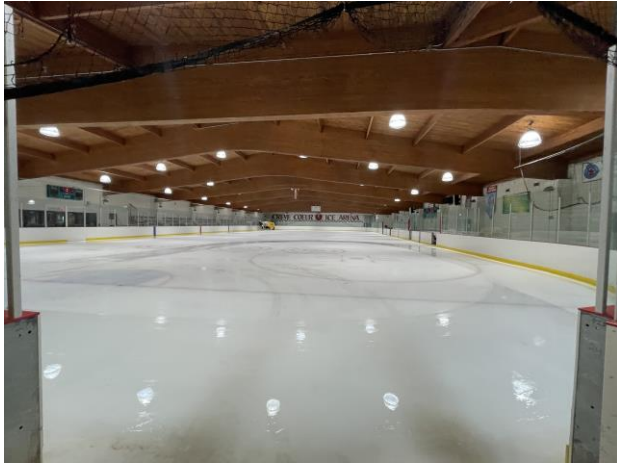
Photo 5 – Overall ice rink floor

The existing concrete ice rink floor was installed with the original building in 2003 and extended to NHL standard size of 200' x 85' in 2008. The fluid in the subfloor heating system is glycol. The concrete is reported to be uneven which leads to uneven ice thickness and possibly increased energy use and ice quality concerns. In 2003-04 the subfloor header piping system under score keeper's box was replaced. In 2008 the size of the rink floor was extended to the NHL standard size of 200'x85'.

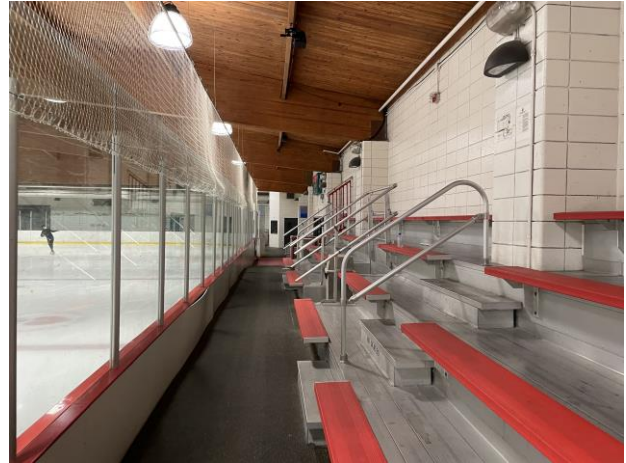
Photo 6 – Bleacher seating in ice arena

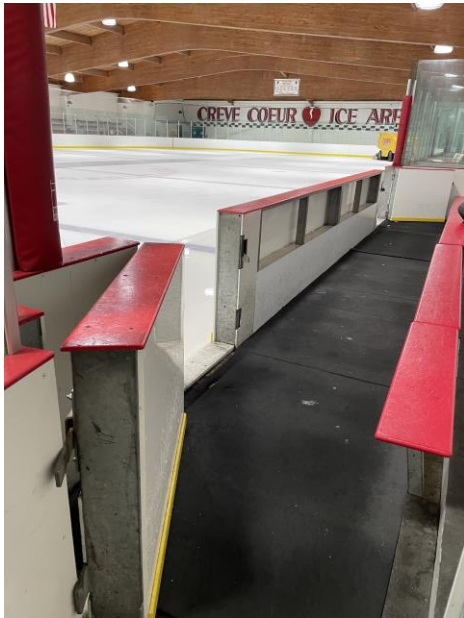
Photo 7 – Existing dasher board system

The existing dasher board system was installed in 2003 (18 years old) and is reaching its typical life expectancy of 20-25 years. Some improvements to the existing system were completed and include the replacement of the white poly facing and the modification of the boxes and doors to meet the requirements of the Americans with Disabilities Act (ADA) in 2008. The manufacturer of the dasher board system is not known. The system appears to be in fair condition and no other concerns have been reported.

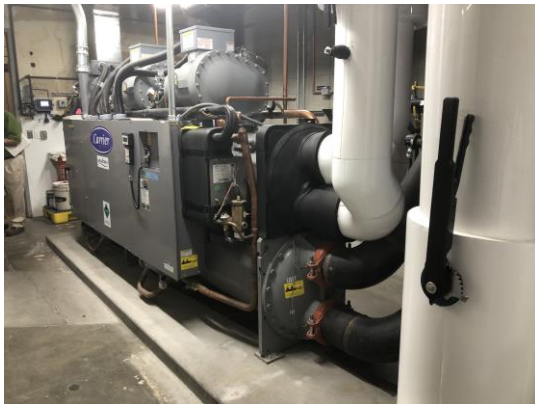
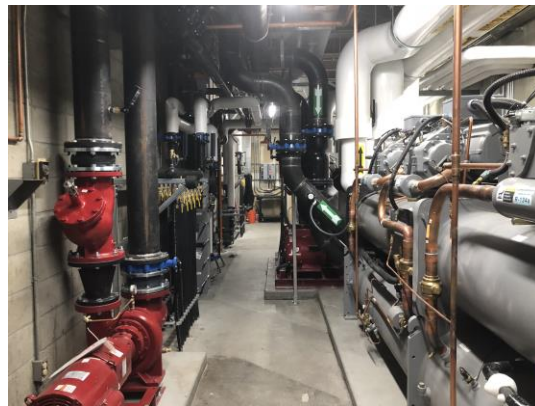
*Description:* Replace the existing R-22-based indirect refrigeration system with a new R-513-based refrigeration system, or similar type refrigerant, located inside the existing refrigeration room with a water fluid cooler. The equipment used in this type of system is more commercial grade quality and may include direct expansion chillers (vs flooded), blended HFC or HFO refrigerant, semi-hermetic compressors (vs open drive) and pumps. B32 can provide a conceptual drawing of this system if desired.

Photo 9 - Example of a Carrier or Trane package systems

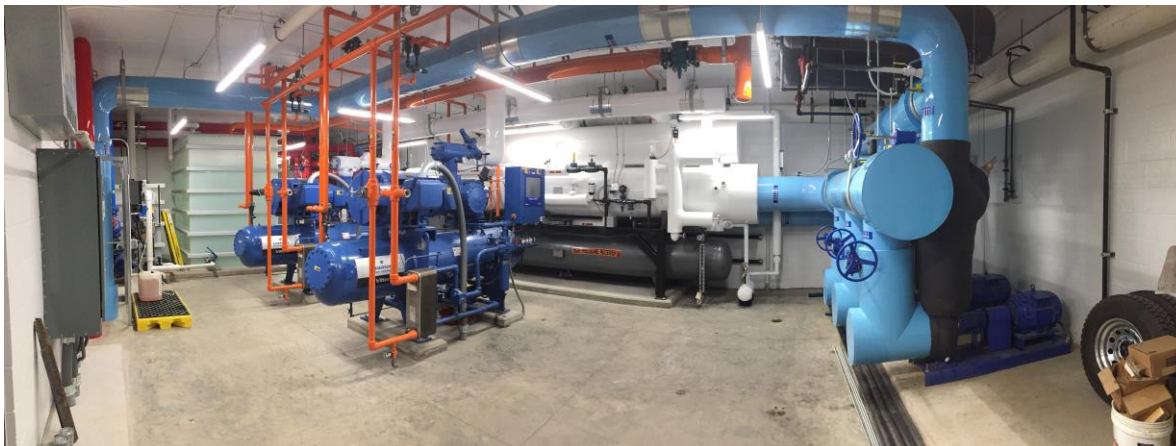
**Description:** Replace the existing R-22-based indirect refrigeration system with a new ammonia-based refrigeration system in existing refrigeration room. See figure at the end of this report for conceptual location and equipment layout.

Photo 10 - Example of a stick-built industrial grade, flooded ammonia-based system

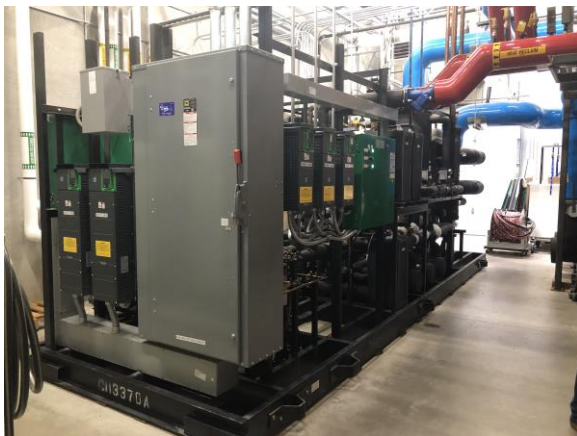
**Description:** Replace the existing R-134a-based refrigeration system with a new CO2-based indirect refrigeration system located inside the refrigeration room and using an air-cooled gas cooler system. The use of CO2 refrigerant may likely be the next substantial "innovation" in the ice rink industry. This option is based on a multiple semi-hermetic compressor system of approximately 200-ton, plate and shell chiller, pumps, etc. operating at leaving glycol temperatures of 10°F and entering glycol temperatures of 13°F. It's likely that this option will fit in the existing refrigeration. B32 can provide a conceptual drawing of this system to confirm. See the Future of Refrigerants section in this report for additional information on CO2 and the use of CO2 in ice rink facilities.

Photo 11 - Example of an Indirect CO2 Chiller Package

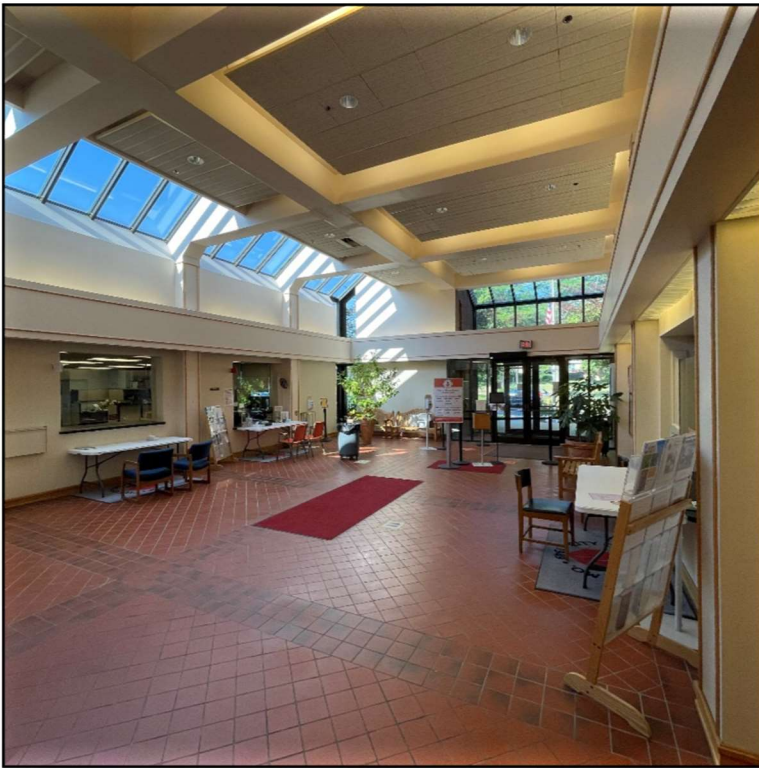
*View of Existing Main Entrance Lobby / Public Gathering Space*

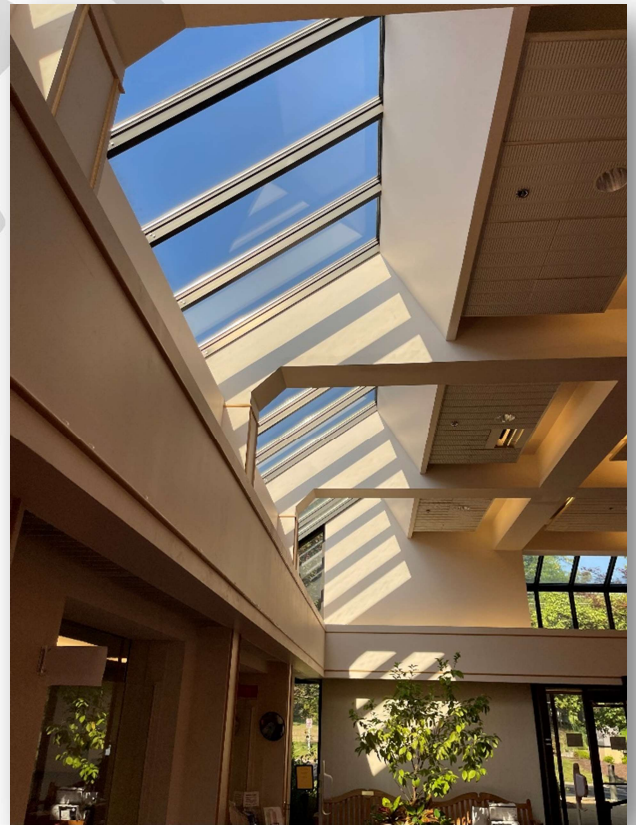
*View of Existing Main Entrance Lobby / Skylights along South side of Lobby*

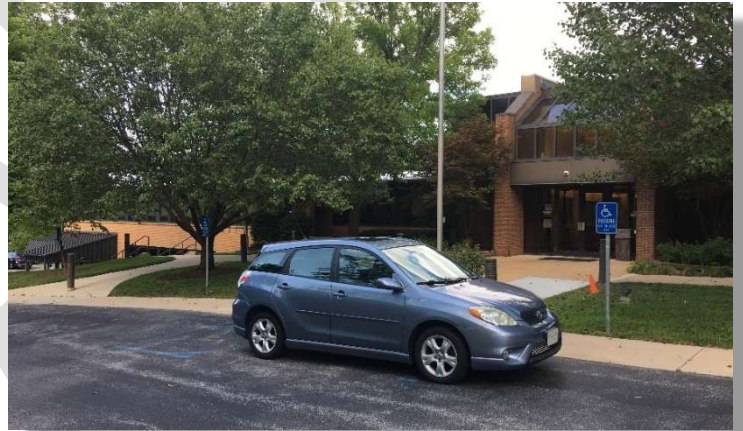
There are two parking spaces designated as ADA parking located at the main entrance parallel to the curb/sidewalk. These spaces do not appear to be in compliance with current standards of design and cross slopes. This area will require a current survey to be conducted for verification. There are three additional parking spaces designated as ADA parking located near the entrance to the lower-level community room. These parking spaces are designed as head-in parking stalls but do not appear to have the correct

*Handicap parking stalls at City Hall Main Entrance*

size, striping and signage requirements. These should be redesigned when new striping occurs. There are also two additional parking spaces designated as ADA parking located at the rear entrance to the building. These will also need to be verified for correct cross slopes and striping conformance.

The pavement slopes at the ADA spaces would need to be designed so that the pavement and approach to the building would not be any steeper than the maximum allowed of 2%.

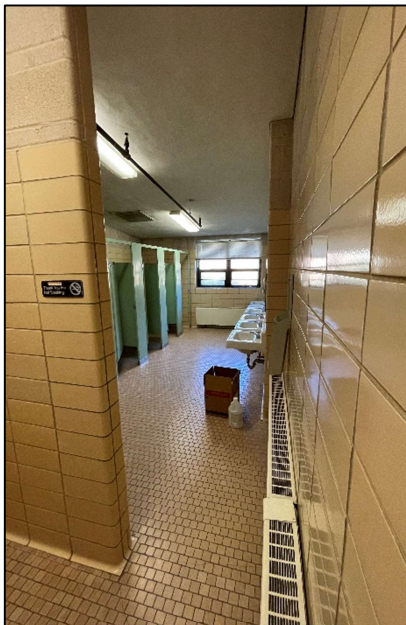
- The plumbing fixtures are also lacking proper drainpipe coverings under exposed lavatories and have toilet accessories that do not meet current code and ADA requirements throughout some of the restroom locations.
- Clearances and turning radii are limited in some of the areas such as restrooms, approaches to doorways and some of the corridor widths. Although the city has utilized the existing facilities and may have made accommodations as needed over the years with current staff, they are still at risk of violating some of the ADA laws.
- The existing building has a several areas that are not being occupied and are deteriorating and causing issues with continuous maintenance. Staff has reported that some of the areas have been shut off due to broken water valves and broken toilets, sinks and faucets.

*Existing Restroom with narrow passage and antiquated plumbing fixtures*

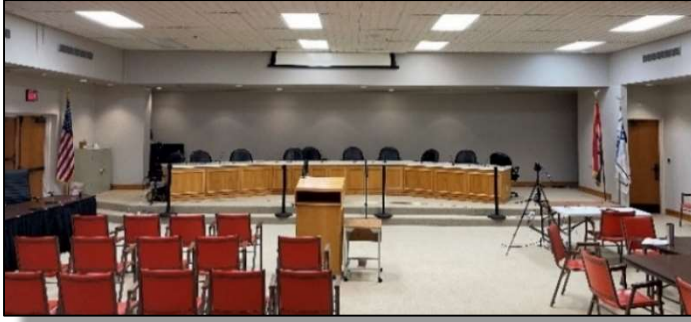
*View of Council Chambers with non-accessible raised dais*

- There are other accessible violations within the building including access to the council chamber's dais. In order to access the dais, the council person will need to ascend two steps one either side of the dais as well as any other citizen wanting to approach the front of the dais. This makes it impossible for disabled persons to utilize the council chambers and be participants with the council members during any of the meetings utilizing the dais.

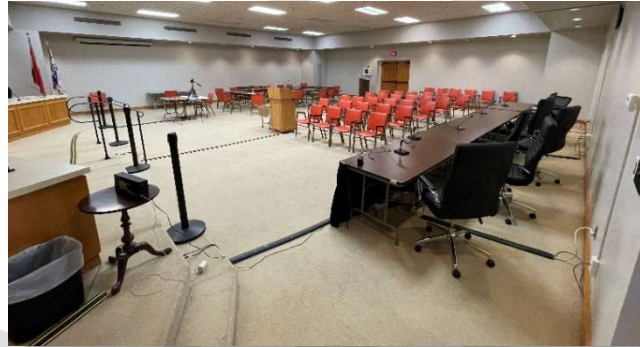
- Within the dais area, there are several electrical and AV chords/cables that transverse through the walking paths of the patrons. This is a tripping hazard to participants and the attending citizens utilizing the facility for functions within the room. The city has utilized tapered rubber surface covers and, in some cases, tape on to the carpet to limit and control the tripping hazard but has not eliminated it from the area.

*View of Council Chambers and wire raceways with wire and cables running on surface of floor being protected by tapered rubber covers.*

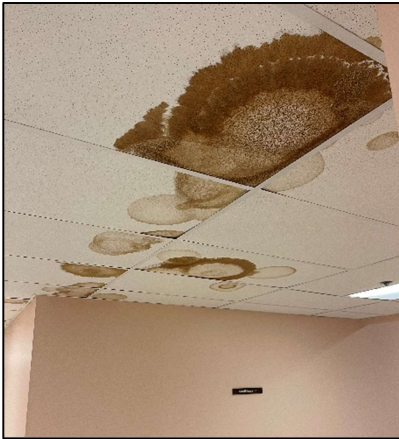
*Views of water leaks above the ceiling*

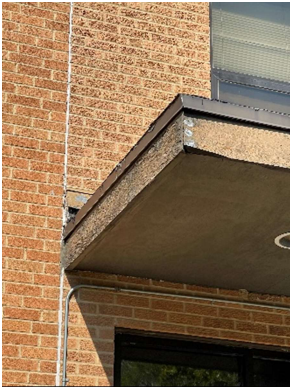
*Peeling paint and deteriorating wood fascia on canopy*

Other areas of concern regarding the exterior envelope are documented in the photos below and should be addressed to maintain weather proofing of the building.

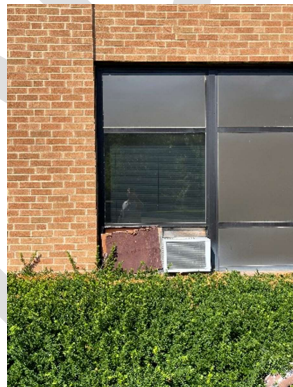
*Plywood filler is falling out of window at air conditioner*

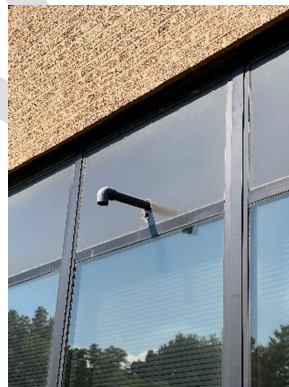
*Condensation Drain out of window panel. No caulk around pipe / water & insect infiltration*

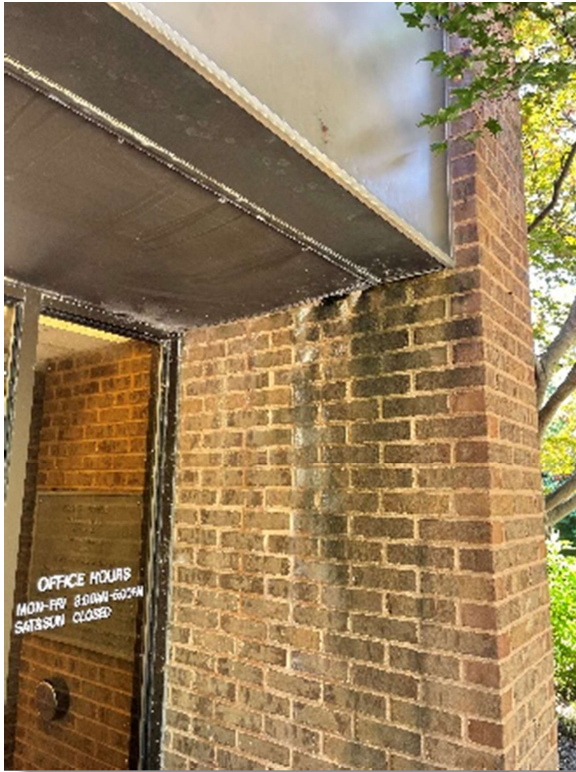
*Water Damage to Canopy at City Hall Main Entrance*

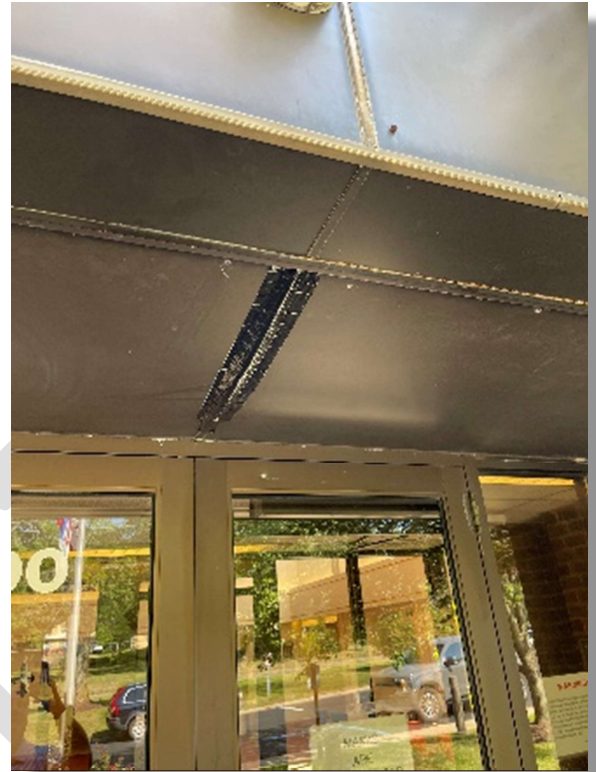
*Entrance Canopy seam repaired with black duct tape at center of canopy over Main Entry Doors.*

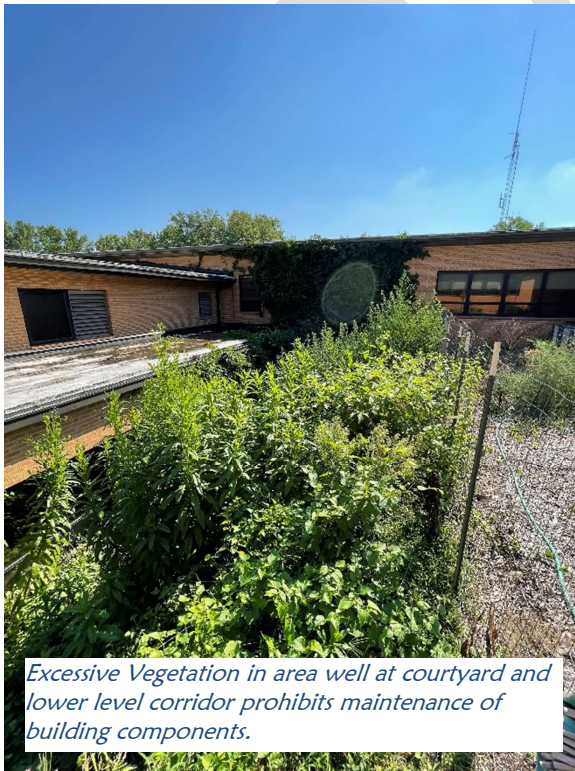
*Excessive Vegetation in area well at courtyard and lower level corridor prohibits maintenance of building components.*

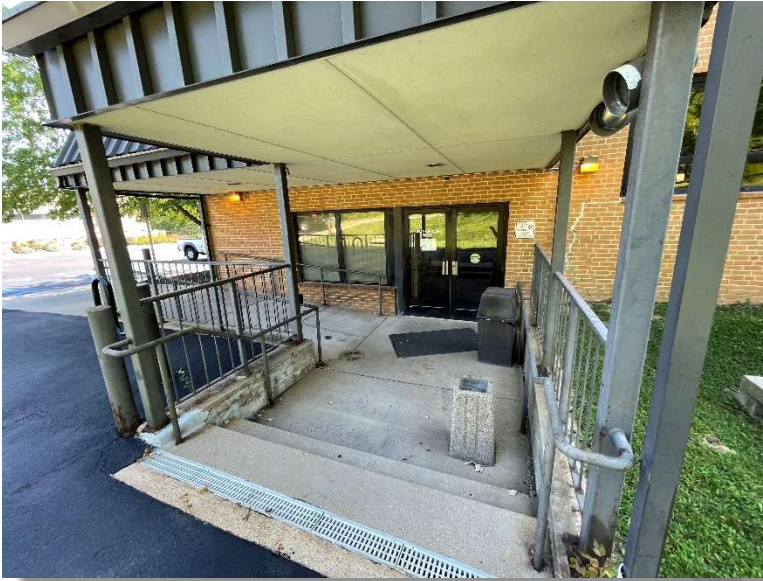
*Existing Entry into Community Room – Despite drain at top of step and area drain at landing, entry doors are subject to flooding should area drain gets clogged or covered.*

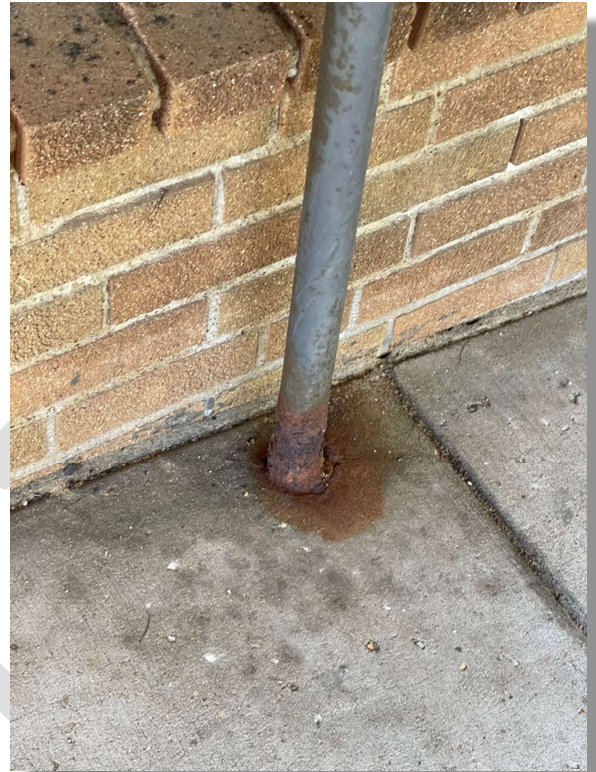
*Many of the guard rails / handrails are rusting through and are not properly anchored*

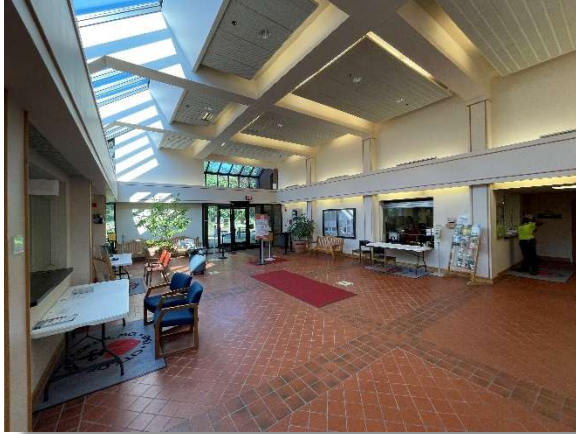
*Main Public Entrance Lobby with service windows on either side and access to council chambers*

- Once in the main lobby, it is difficult to understand where to go for services. There are three large “reception windows” that could be approach, each of them appears to be equally important. Visitors approach the window of choice asking for information in which staff may have to redirect them to a different window for the appropriate service. The service counters have folding tables in front of the windows with chairs for personal service and for separation control as has been recommended by the CDC for disease control. The glass and surrounding areas do not provide any type of ballistic security.

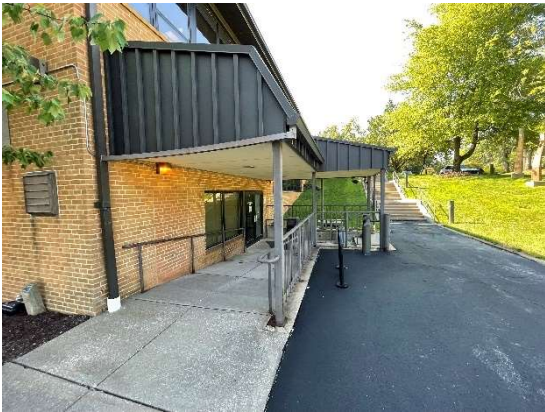
- The building has several additional areas that have public access on limited basis. The first one is the community room on the lower level at the northwest corner of the building. This room is utilized for public and group meetings. It is accessed from the lower parking area to the north by way of a ramp or stairs to the lower entrance. Despite a trench drain at the top of the steps and an area-drain at the landing, this area and entry doors are subject to flooding should the drain get surcharged, clogged or covered.

*Entrance to Community Room at Northwest Corner of Building*

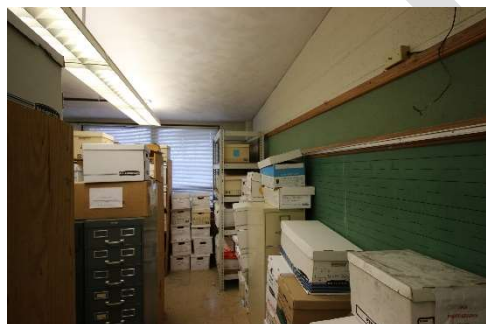
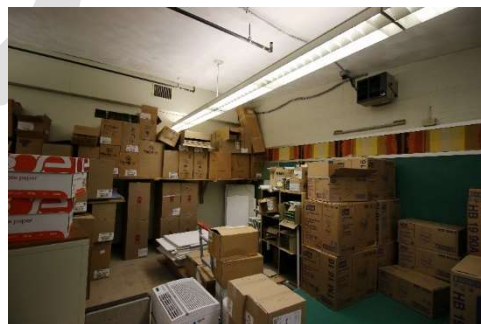
*Excess space within the building has been utilized as storage space*

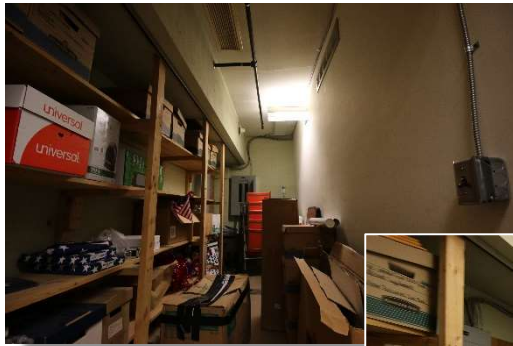
*Electrical closet has been utilized as storage and now electrical panels cannot be accessed resulting in code violations.*

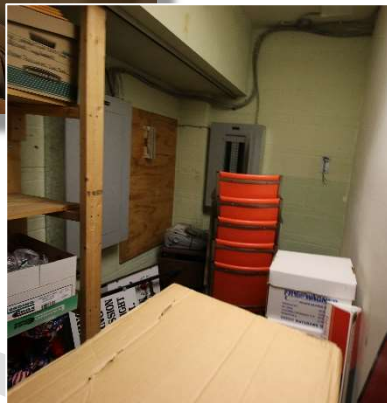
*Electrical panels and switch gear is being blocked by storage items resulting in code violations.*

- There are mechanical/electrical closets that have been converted into storage areas and are now resulting in code violations within the building. Electrical panels require access to them as well as proper clearances surrounding them for safety.

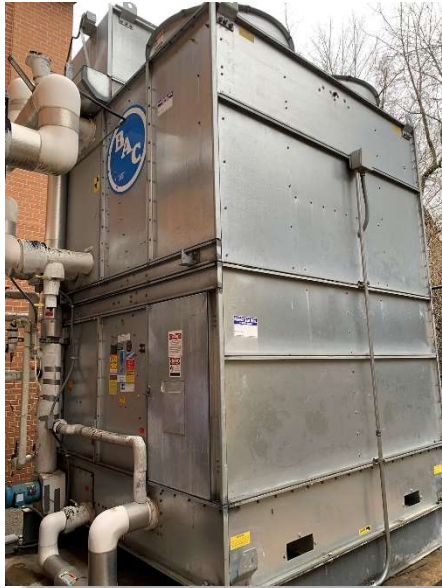
- Condenser water is generated by a single fluid cooler, located in the south equipment yard, and is rated for 95 tons of nominal capacity. The unit is 13 years old and appears to be in fair condition and well maintained. The unit's

life expectancy is approximately 20 years with an estimated 7 years of life remaining. A shell and tube heat exchanger is located on the supply side of the condenser water system which uses the heating hot water system on the shell side to vary the condenser water temperature by modulating a three-way control valve. Two 30-hp, base-mounted, condenser water pumps circulate condenser water throughout the building. Both pumps appear to be in fair working condition but are nearing the end of their useful life. The system's associated air separator and expansion tank appeared to be in poor condition and at the end of useful life. The condenser water is a propylene glycol mixture and is distributed throughout the building to serve the heat pumps. The piping is uninsulated Schedule 40 PVC pipe. The age of the piping varies throughout the building with several instances of piping leaks. The piping is mostly in poor condition and should be replaced throughout the entire building. A filtration system was added to the condenser water system in 2020.

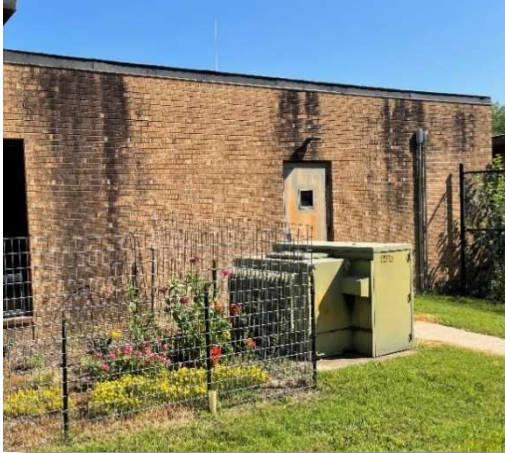
- Normal Electrical power service for the facility is supplied from a pad mounted 3-phase 120/208 volt utility transformer located on the south side of the building. This pad mount transformer is fed underground from the utility pole mounted overhead conductors running east-west about 75 feet south of the building.
