**AGENDA**  
**CITY OF CREVE COEUR**  
**FACILITIES TASK FORCE**  
**CITY OF CREVE COEUR, MISSOURI**  
**MARCH 6, 2023**  
**10:00 AM**

**Dielmann Recreation Center  
11400 Olde Cabin Road  
Creve Coeur, MO  
Structural Evaluation**

## Executive Summary

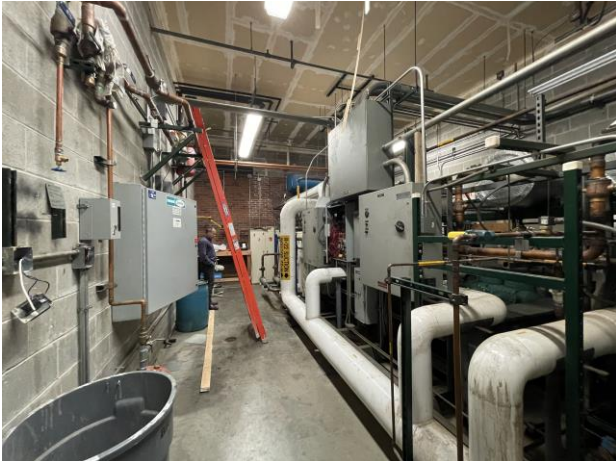
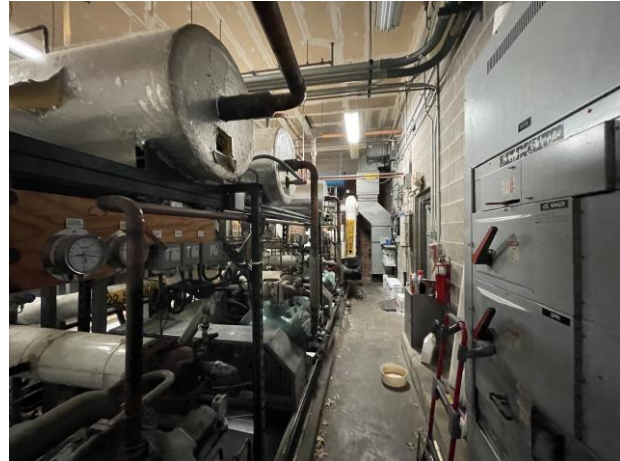
Photos 1 & 2 – Existing refrigeration system

approximately 20 tons each at a 0-degree saturated suction temperature providing a total capacity for the refrigeration system of approximately 120 tons; flooded-type plate and frame chiller system with two plate and frame chillers and one surge drum; rink floor pumps, one evaporative condenser, a control system and a waste heat recovery system. The existing system is considered a “skid package” system where the majority of the components are built and delivered on a single steel frame or “skid”.

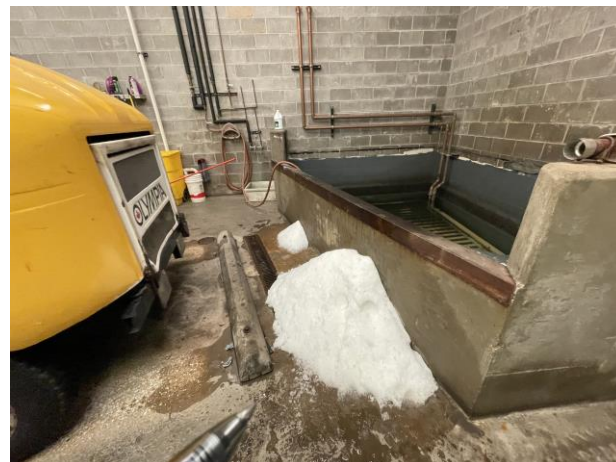
Photo 4 – Existing snow melt pit and coil

There is a waste heat recovery system that serves the subfloor heating system under the rink floor and the snowmelt pit in the resurfacers room. This system essentially provides free heat from the refrigeration system. The subfloor heating system is reportedly in good working order and there are no concerns with frost building up under the ice rink floor. The snowmelt pit heating system is reportedly performing well.

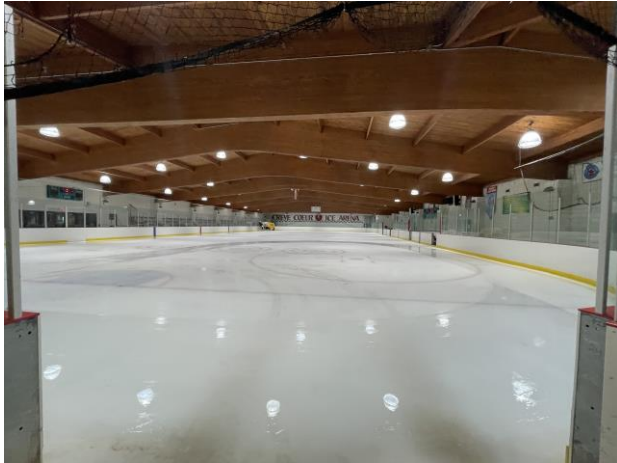
Photo 5 – Overall ice rink floor

size of 200' x 85' in 2008. The fluid in the subfloor heating system is glycol. The concrete is reported to be uneven which leads to uneven ice thickness and possibly increased energy use and ice quality concerns. In 2003-04 the subfloor header piping system under score keeper's box was replaced. In 2008 the size of the rink floor was extended to the NHL standard size of 200'x85'.

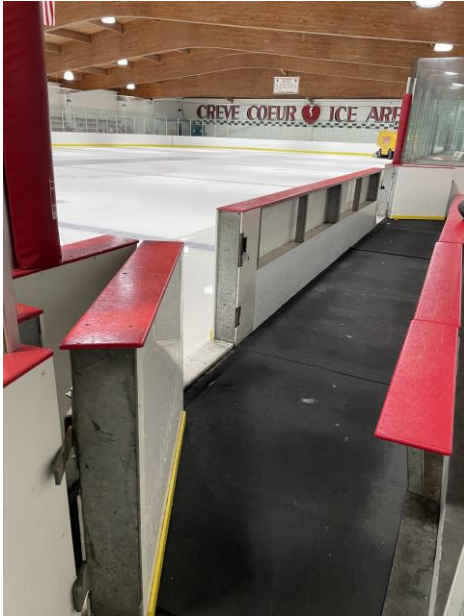
Photo 7 – Existing dasher board system

The existing dasher board system was installed in 2003 (18 years old) and is reaching its typical life expectancy of 20-25 years. Some improvements to the existing system were completed and include the replacement of the white poly facing and the modification of the boxes and doors to meet the requirements of the Americans with Disabilities Act (ADA) in 2008. The manufacturer of the dasher board system is not known. The system appears to be in fair condition and no other concerns have been reported.
