**EXISTING BUILDING ASSESSMENT
AND DEFICIENCY REPORT FOR:**

CITY OF
CREVE COEUR
MISSOURI

September 1, 2022

EXISTING FACILITY CITY OF CREVE COEUR GOVERNMENT CENTER 300 N. New Ballas Road, Creve Coeur, MO 63141

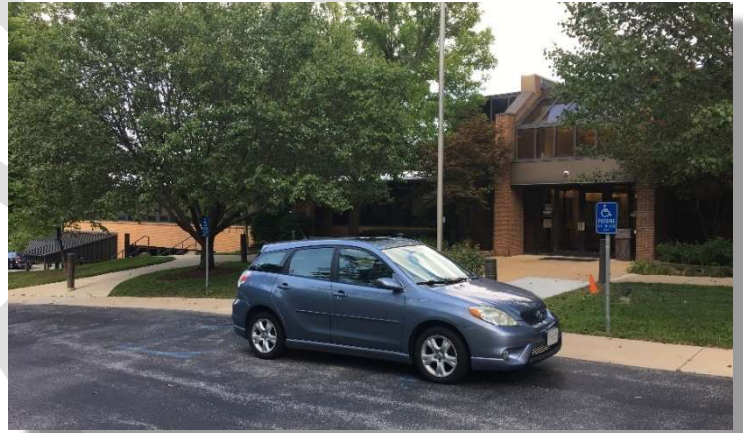
There are two parking spaces designated as ADA parking located at the main entrance parallel to the curb/sidewalk. These spaces do not appear to be in compliance with current standards of design and cross slopes. This area will require a current survey to be conducted for verification. There are three additional parking spaces designated as ADA parking located near the entrance to the lower-level community room. These parking spaces are designed as head-in parking stalls but do not appear to have the correct size, striping and signage requirements. These should be redesigned when new striping occurs. There are also two additional parking spaces designated as ADA parking located at the rear entrance to the building. These will also need to be verified for correct cross slopes and striping conformance.

Handicap parking stalls at City Hall Main Entrance

The pavement slopes at the ADA spaces would need to be designed so that the pavement and approach to the building would not be any steeper than the maximum allowed of 2%.

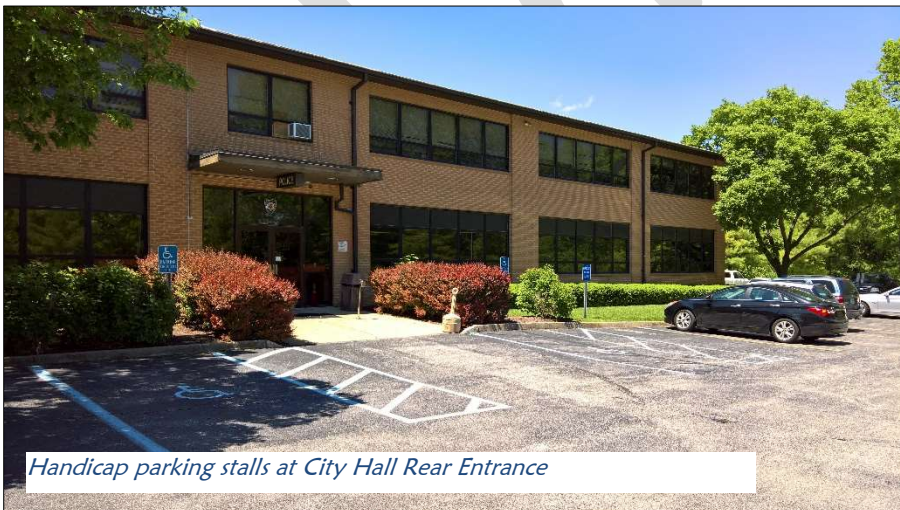
Handicap parking stalls at City Hall Rear Entrance

There are three additional parking spaces designated as ADA parking located near the entrance to the lower-level community room. These parking spaces are designed as head-in parking stalls but do not appear to have the correct size, striping and signage requirements. These should be redesigned when new striping occurs. There are also two additional parking spaces designated as ADA parking located at the rear entrance to the building. These will also need to be verified for correct cross slopes and striping conformance.

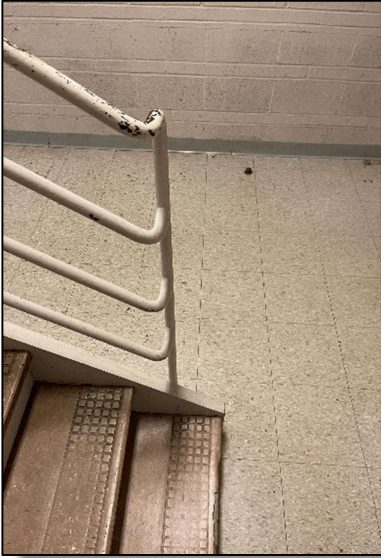
View of horizontal guardrails and shortened rail extensions.

- The existing stairwells are in violation of the current codes with respects to the hand/guard rails. They incorporate horizontal guard rail tubing which creates a ladder effect in lieu of the standard vertical pickets spaced no more than 4" o.c. to meet current codes. The handrails are also short and do not extend the correct distance past the top and bottom treads as required by current codes.

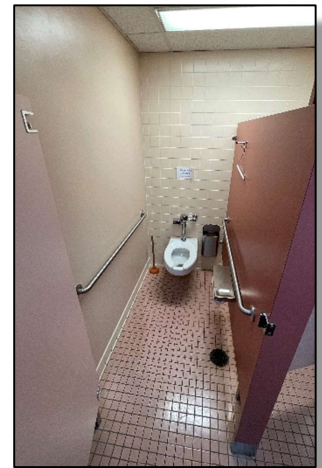
- Various restroom facilities are in violation of code and ADA requirements. Turning clearances, heights and fixture designs do not meet the requirements in addition to the lack of grab bars. There are several restrooms that have been retrofitted with grab bars but do not provide the clearances required to meet code.

Modified Handicap toilet stall (non-compliant)

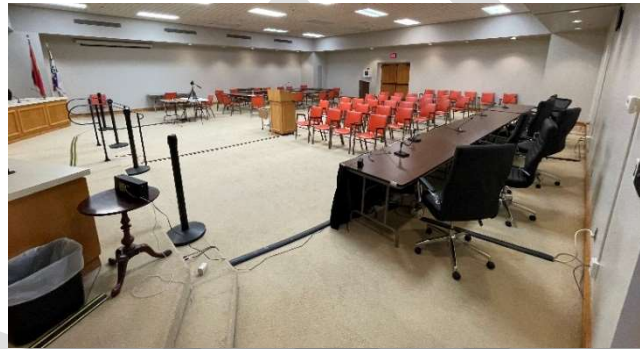
- Within the dais area, there are several electrical and AV chords/cables that transverse through the walking paths of the patrons. This is a tripping hazard to participants and the attending citizens utilizing the facility for functions within the room. The city has utilized tapered rubber surface covers and, in some cases, tape on to the carpet to limit and control the tripping hazard but has not eliminated it from the area.

View of Council Chambers and wire raceways with wire and cables running on surface of floor being protected by tapered rubber covers.

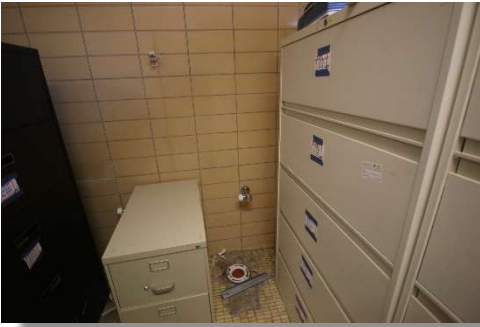
Old restroom was converted into file storage room. Existing infrastructure was left in place.

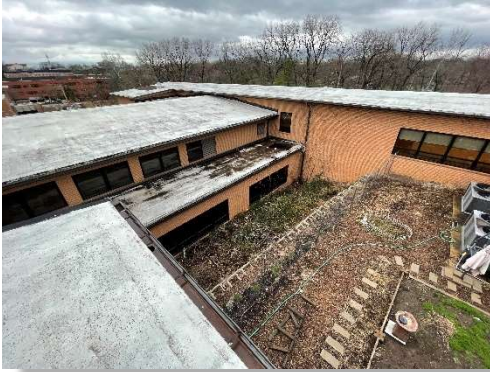
- Overall, the building structures that make up the facility appear to be in good condition and well maintained. No overt signs of global structural issues related to distress, deflection, settlement, and/or deferred maintenance were noted. Some localized areas of distress and settlement were noted and discussed in more detail below.

- The facility is founded on a sloping site with the high point at the southwest corner of the site sloping down to a low point along the north and east elevations. The sloping site drops one full story across the width of the building and provides walk-out egress from the Lower Level along north and east elevations. Based on observations and discussions with staff, groundwater infiltration has been an ongoing issue and in our opinion this issue is aggravated by the sloping nature of the site and interior courtyard condition.

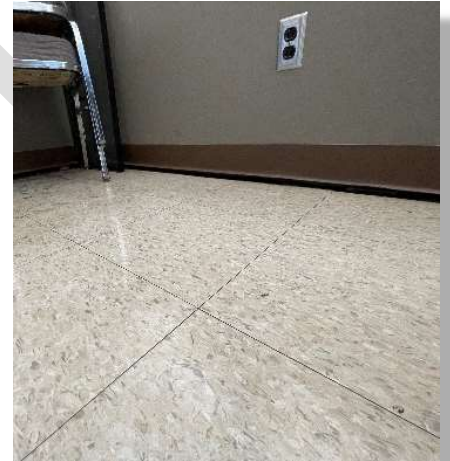
- Settlement of the slab on grade was noted in two areas of the building including the northeast corner of the Lower-Level which appears to have settled a few inches sloping down from west to east with the low point at the far northeast corner of the building, and within the breakroom/kitchen on the Main Floor. Although the slab on grade settlement is undesirable, based on our observations, it appears to be associated with poorly compacted subgrade soils and not a global foundation issue for the building structure.

Cracks observed in the exterior wall near the northeast and northwest corners of the building will be discussed in more detail below but are believed to be unrelated to the observed slab on grade settlement.

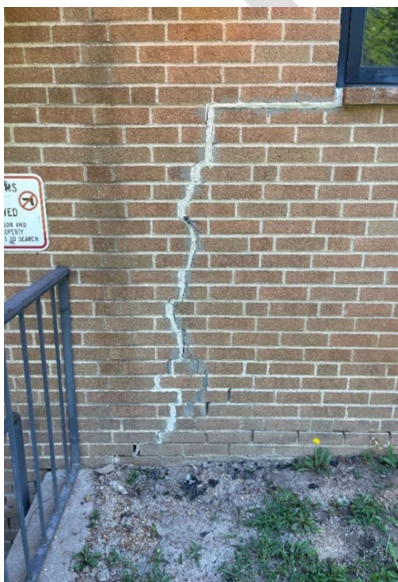
- The existing facility is founded on a system of drilled piers and grade beams. Although an original soils report was not available for review, the type of foundation system used for the existing facility is a good indicator that the site is underlain by soft or poorly consolidated soils. It would be difficult to complete a soils investigation with the existing building in place, but it is very likely any future additions would also require drilled pier foundations and should be considered in planning for construction access to the site and budgeting.

- Cracks were noted in the exterior wall portion of the building and near the northeast corner. The cracks are generally vertical and linear cracks characteristic of normal masonry movement due to moisture related expansion and shrinkage, as well as seasonal changes. It is further noted that very few control joints were observed in the existing exterior masonry walls. In our opinion the observed cracks are not a structural or foundation settlement issue.

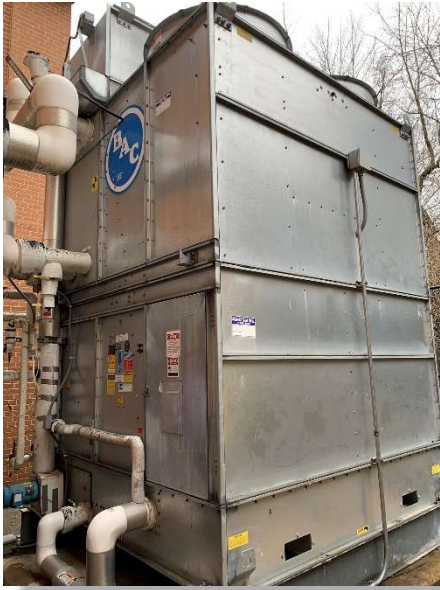
life expectancy is approximately 20 years with an estimated 7 years of life remaining. A shell and tube heat exchanger is located on the supply side of the condenser water system which uses the heating hot water system on the shell side to vary the condenser water temperature by modulating a three-way control valve. Two 30-hp, base-mounted, condenser water pumps circulate condenser water throughout the building. Both pumps appear to be in fair working condition but are nearing the end of their useful life. The system's associated air separator and expansion tank appeared to be in poor condition and at the end of useful life. The condenser water is a propylene glycol mixture and is distributed throughout the building to serve the heat pumps. The piping is uninsulated Schedule 40 PVC pipe. The age of the piping varies throughout the building with several instances of piping leaks. The piping is mostly in poor condition and should be replaced throughout the entire building. A filtration system was added to the condenser water system in 2020.

- Heating hot water is generated by two, gas-fired, condensing water boilers each sized for 1300 MBH capacity. The boilers were manufactured in 2012 and are in good condition and well maintained. Two, 20 hp, base mounted pumps circulate heating hot water throughout the building to serve the two ventilation air units, cabinet unit heater and unit heaters. The pumps are in good working condition. The age of the piping varies throughout the building with most of the piping original to the installation date. Piping near the boiler was replaced with the boilers and is in good condition. The heating hot water system, in general, is in good condition and will be reused to accommodate the proposed renovation. The capacity of the existing system will need to be evaluated to determine if additional capacity is required for new building loads.

- Existing fluid cooler is reportedly in good condition with 7 years of useful life remaining. Existing fluid cooler may be reused in renovation however the system will require evaluation to ensure the existing capacity is adequate. The system's associated heat exchanger, air separator, expansion tanks and pumps are in fair to poor condition. With the use of propylene glycol mixture, these components are subject to further corrosion and deterioration internally. These components should be replaced.

- The condenser water distribution piping is in poor condition and failing. The piping should be replaced in its entirety.
- The existing heating hot water system is in good condition and can be reused to accommodate the proposed renovation. The capacity of the existing system will require evaluation to ensure existing capacity is adequate. Minor modifications to the existing piping will be required to accommodate equipment changes that are served by this system.

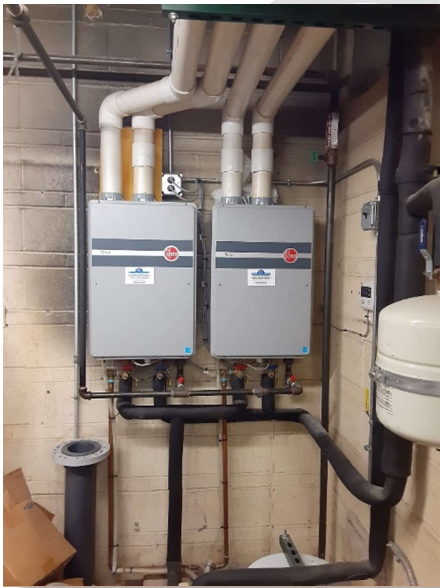
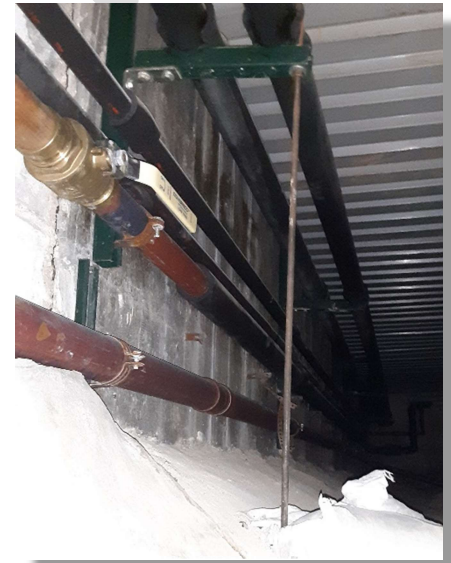
- The incoming water service is provided via a service tunnel that terminates at the lower-level main mechanical room. This service piping was replaced in recent years and is in good condition. At the incoming location in the mechanical room this piping routes above and inside the clearance space of multiple electrical panels which is a potentially hazardous assembly. This incoming piping ties into existing piping prior to making connections into water heaters, domestic cold-water distribution, and backflows for water supplies to mechanical systems and equipment. These various assemblies were in generally good condition with some smaller branches and connection piping needing replacement.

- Domestic branch piping and insulation should be evaluated and repaired/replaced as needed. It is likely, based on what was observed, that much of the branch piping will require replacement.

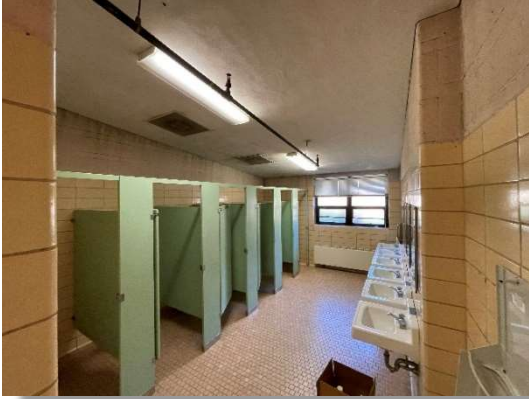
- The facility did not report that water pressure is an issue in the building although some fixtures produced limited flow, likely due to calcified branch piping and failing fixture internals.
- Hot water is supplied to the existing building via two instantaneous water heaters and a small storage type heater located in the main mechanical room. These water heaters are in like-new condition and appeared to be operating at time of visit.
- The building is served by a hot water return system and pump located within the lower-level mechanical room. The pump has been replaced at some time during the life span of the building and appears to be in good working condition. Based on existing drawings the return loop is serving the majority

of hot water producing fixtures in the building. Some fixtures appear to be too far from the loop to deliver hot water in adequate time or they are not served by the loop at all. Some expansion of the loop would be required to comply with current code-established standards.

- A large number of the plumbing systems have code or operational deficiencies that should be addressed.
- The domestic hot water loop should be extended to cover all fixtures and reduce delivery times enough to be code compliant.

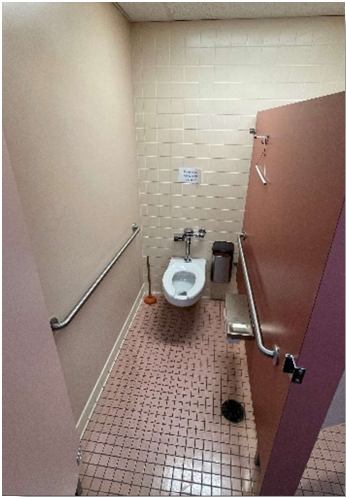
- Existing fixtures at bathrooms appear to be original fixtures in many locations. These fixtures are likely not compliant with local and national codes regarding sill heights, accessibility, and flow rates. Some existing toilets had damaged seat hinges and arms, discoloration on bowls, and signs of wear on fixture bodies. Some existing lavatories had damaged or non-functioning aerators and wobbly handles.

- Plumbing fixtures, in most cases should be replaced with new ADA compliant (where necessary) fixtures with proper sill heights, sanitary surface treatments, and flow requirements to achieve current standards.

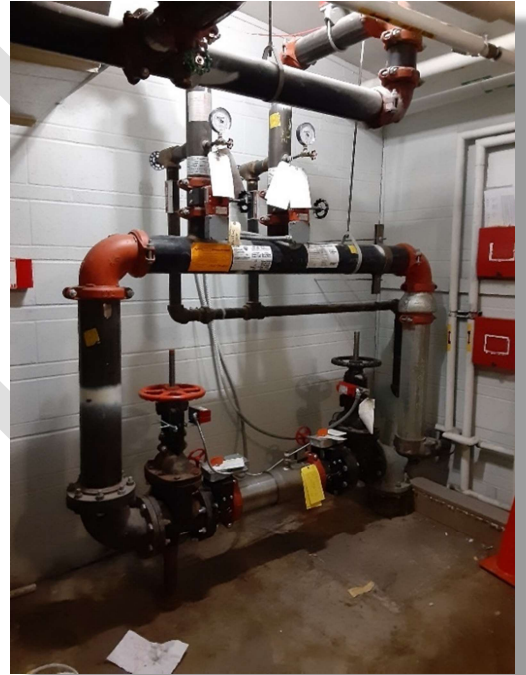
- The Fire Service and Sprinkler room is located adjacent to the Gymnasium. The incoming service piping is in good working condition and the backflow assembly has been replaced in the last few years. The valves and piping mains visible within this room are all in good working condition.

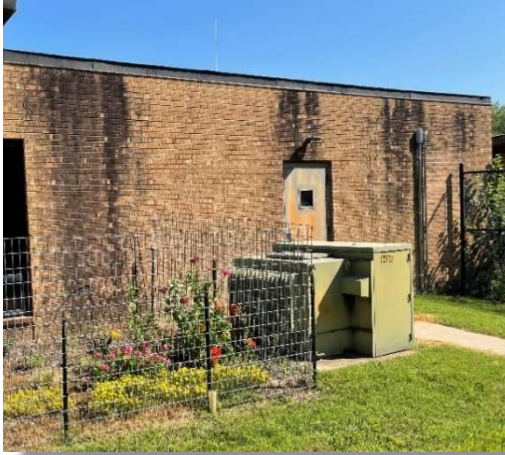
- Normal Electrical power service for the facility is supplied from a pad mounted 3-phase 120/208 volt utility transformer located on the south side of the building. This pad mount transformer is fed underground from the utility pole mounted overhead conductors running east-west about 75 feet south of the building.

- Electric service into the building is fed from the pad mounted transformer to a pad mounted NEMA 3R Main 1200-amp service entrance rated disconnect switch through a 1200 amp pad mounted NE-MA 3R automatic transfer switch then into a new distribution panel in the basement. The new distribution panel was just installed in 2021. Most other distribution panels are circa 1988 when the building was renovated.
