### **Historic Building Assessment**

Tim Kilby, the proprietor of the Country Gentleman Historic Restorations and Woodwright Shop, will present his assessment of the Clester Cabin, Hackmann Cabin, and Lake School House. The Parks and Historic Preservation Committee has been invited to participate in the discussion.

## *Clester Cabin in Conway Park*

## *Hackman Cabin in Conway Park*

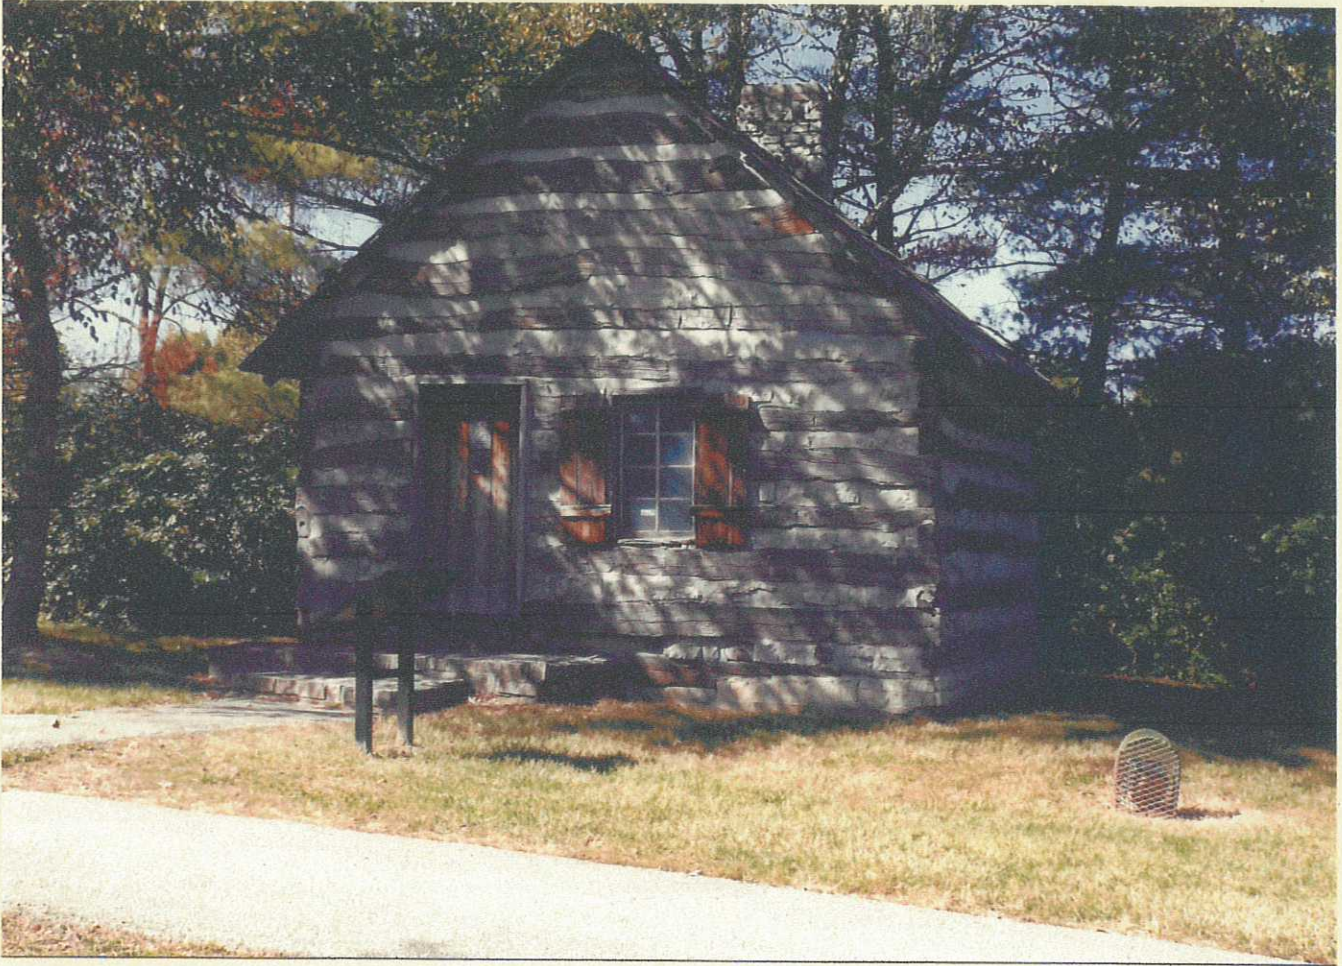
The cabin is constructed of a mix of Oak logs (red, black and white Oak). The logs are hewn on both the inside and outside leaving the barked edges top and bottom and joined using the "v" notch at the corners. The foundation would have been on dried laid stone.

- All issues addressed in this report should be done for the longevity of this cabin. Most issues are simple repairs. The log replacement will be the most involved.

- You may get a year or two more out of the roof, but it may as well get replaced during this restoration. Considering the cabin sits under the canopy of the trees, any wood roofs life span will be shortened. A new medium shake sill last maybe 15 years. You may want to consider going to a heavy shake instead (thicker shake). The heavy shake would be in keeping with the period of this structure and have more longevity.

- The chinking could remain but it is causing problems that we don't yet see.....recommend trying re-parging the exterior. It would be the most cost effective approach.

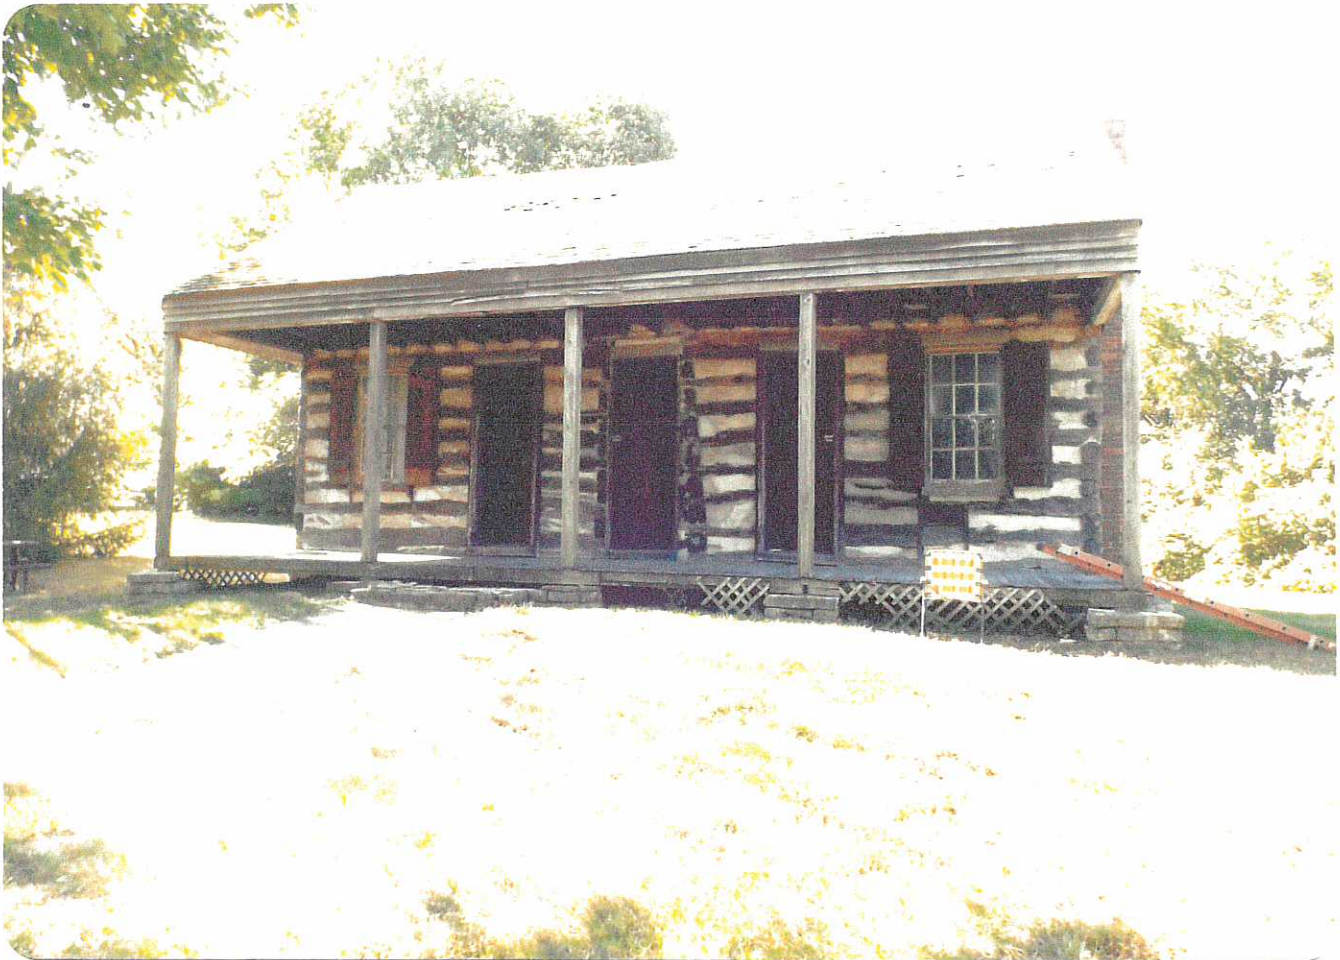
Cabin 2 still retains its original mud chinking (daubing) and is in very good condition. This should be considered when deciding on restoration approaches.

The existing shake roof needs to be replaced but I did not see evidence of the roof leaking.
